U.S. NUCLEAR REGULATORY COMMISSION
REGION I

Report Nos. 50-387/89-37
50-388/89-36

Facility Name: Susquehanna Units 1 & 2

Meeting Topic: Susquehanna Emergency Diesel Generator Crankcase
Explosions of Cooper EDGs

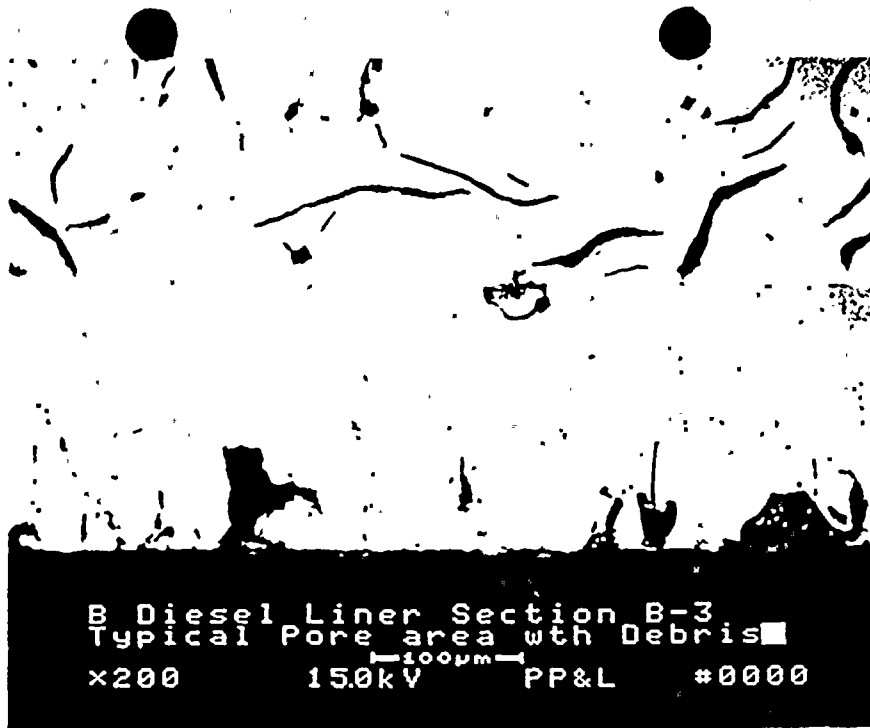
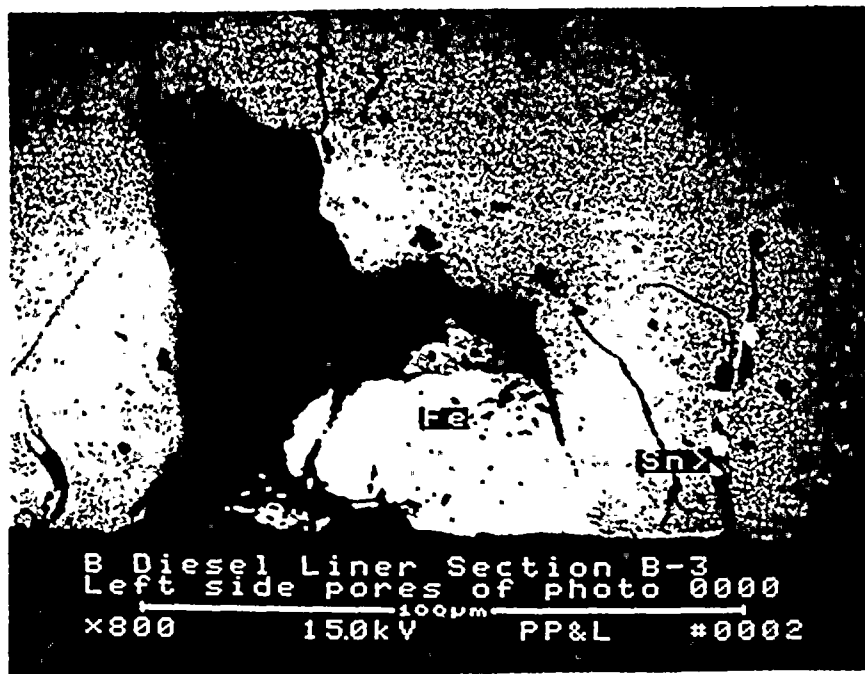
Figure B-54. SEM micrographs of longitudinal cross-section 'C' part B-3 of the B diesel liner at a level 16.5 inches from the bottom. Elements shown were identified as being present in the pores indicated.
