Dresden Unit 2 Core Spray Flaw Evaluation Report

September 10, 1995

DRESDEN UNIT 2 - CORE SPRAY FLAW EVALUATION REPORT

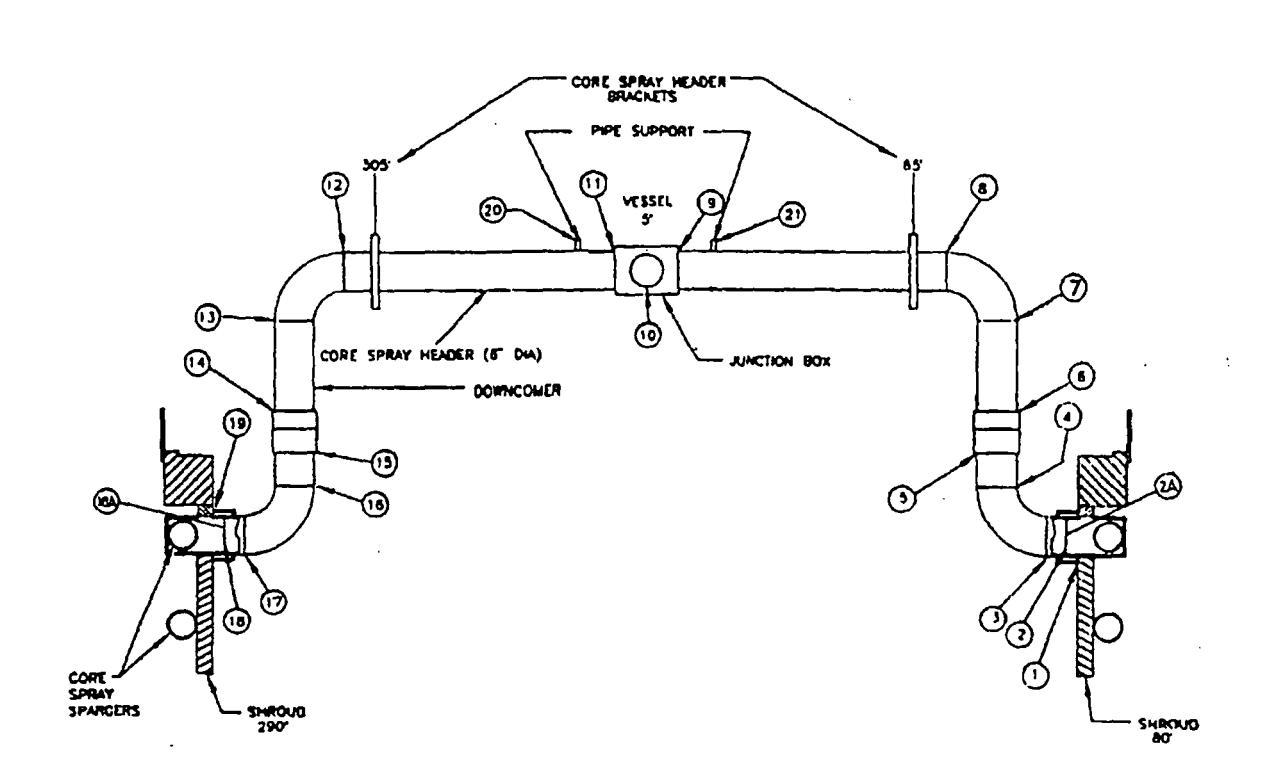
Figure 2.1 Core Spray Piping in the RPV Annulus

The flaw is located in the thermal sleeve collar at approximately 0.5 inches back from the face of the collar adjacent to weld 18 (See Figure 2.1). The flaw is located between the 4:00 position and 5:00 position with an estimated total length of 2 inches.

Cracks were found in the core spray loop A 290° upper sparger inlet thermal sleeve collar, the core spray loop B 260° lower sparger inlet thermal sleeve collar, and core spray loop B 260° lower sparger inlet elbow, (See Figures 2.1 and 2.2). A detailed review of the video tapes of all three crack locations revealed surface crack characteristics that were both jagged and branched. All of the cracks observed were initiated in the base material heat affected zones (HAZ). The thermal sleeve collar cracking appears to have initiated at the inside corner of the collar next to the collar to sleeve weld. The collar was machined from heavy wall tube resulting in a radius located in the HAZ, where large axisymetric residual stresses may be present. Consequently both the appearance and location of the cracking is consistent with Intergranular Stress Corrosion Cracking (IGSCC). This particular degradation mechanism is well documented for stainless steel components exposed to the high temperature reactor water of BWRs. Several other BWRs including Dresden Unit 3 and Quad Cities 1 have reported core spray piping cracks which were identified as IGSCC.

As previously stated the elbow flaw is located in the HAZ of a 100% GTAW weld. The thermal sleeve flaws are located in the collar adjacent to the collar to sleeve weld and are running circumferentially around the collar (see Figures 2.1 and 2.2). Consequently, these flaws, which are located in the HAZ of a non-flux weld and in the thermal sleeve collar base metal were evaluated using the base metal and GTAW evaluation formulas.

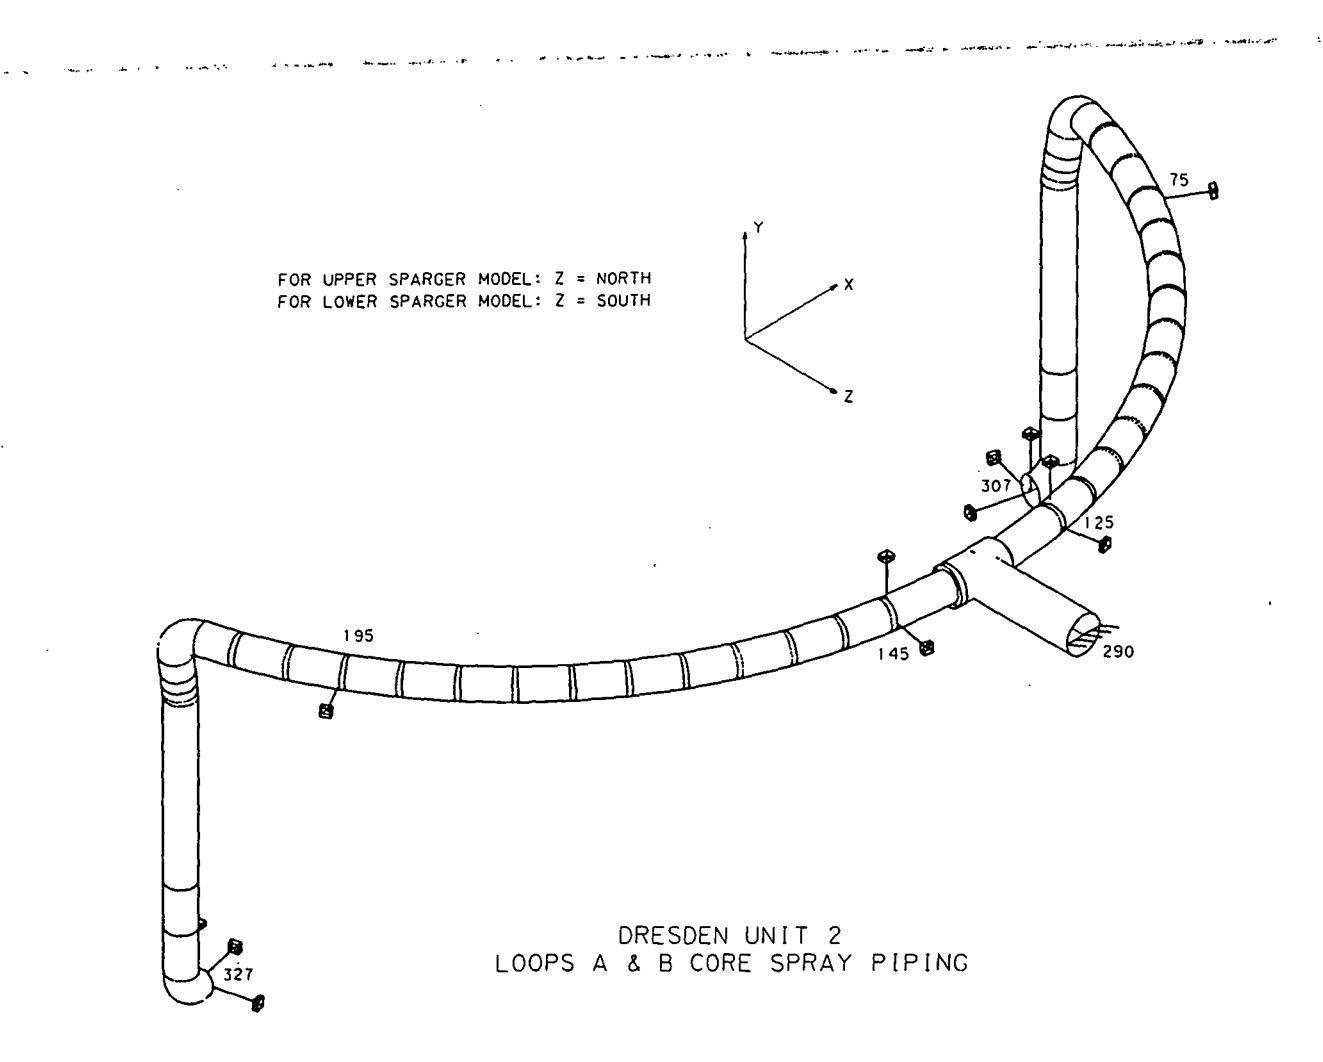
Figure 5.1 Core Spray Piping Analysis Model

The piping model is based on the design basis drawings (References 11 through 15) and is shown in Figure 5.1. It consists of core spray piping inside the reactor. From the 8" RPV nozzle and 8"X6" Tee-Box, the 6" piping follows the circumference of the reactor above the core shroud to two vertical legs which drop down and penetrate the core shroud horizontally after a 90° elbow. The model ends at these anchored shroud penetrations, NP 307 and NP 327. The piping is supported directly to the RPV at NP's 75, 125, 145, and 195.

To evaluate the effects of crack compliance at the upper end of the 260° azimuth elbow of the lower sparger supply piping, a refined model was created to simulate the reduced stiffness of the cracked elbow. To accomplish this, a non-pipe element with a reduced moment of inertia about the weakened axis was inserted at the top of the elbow. This model was used to simulate a 60° circumferential pipe crack at the top of the elbow

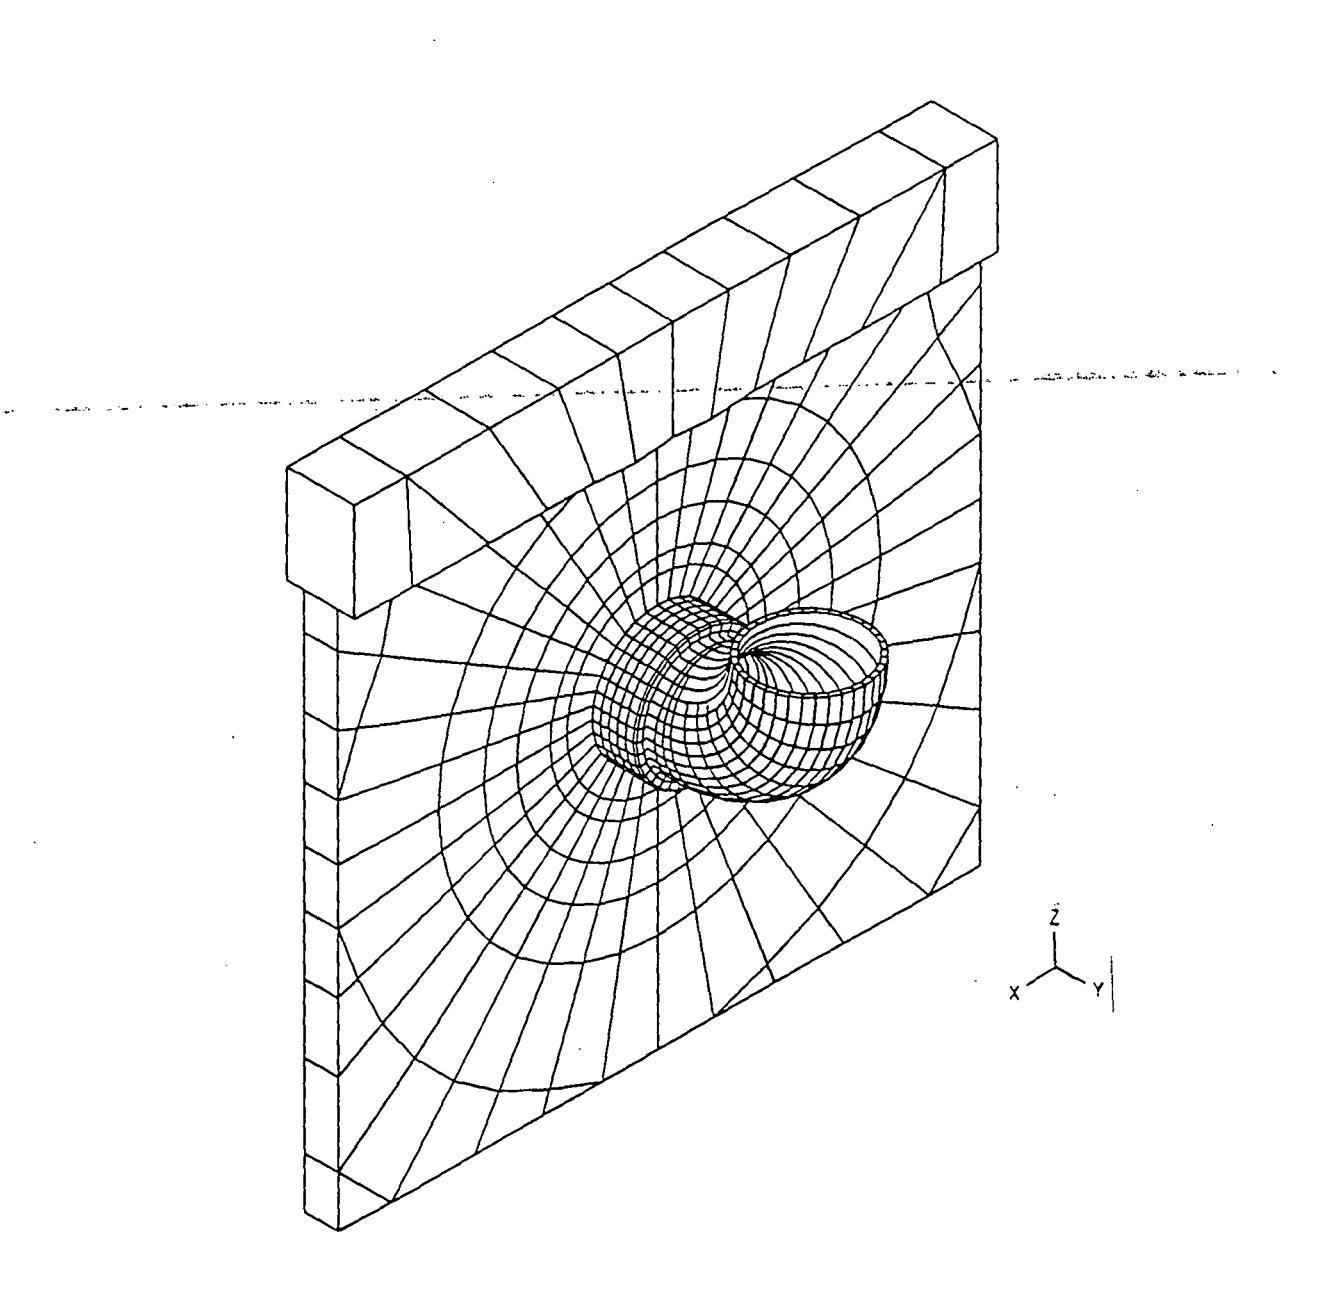
Figure 6.1 Three Dimensional View of FEA Model

The elbow, pipe, sleeve, gussets and shroud are modeled by four-node quadrilateral shell elements. This is a non-flat (nodes need not be co-planar) general shell element for linear and non-linear analyses and is applicable to the analysis of thick and thin shells. A three dimensional view of the model is shown in Figure 6.1 as well as a vertical cross section in Figure 6.2. The cartesian global system of coordinates is located at the center of the 90° elbow. The circumferential pipe nodes are spaced at 10° angles, giving a total of 36 equally spaced nodes and 36 elements. Components of the penetration assembly were modelled at the midsurface of the component. Most of the model was generated using local cylindrical system of coordinates placed along the centerline of the elbow and pipe. Triangular (3-node) shell elements were used only when absolutely necessary and only in areas of the shroud which are far removed from the pipe to shroud interface.

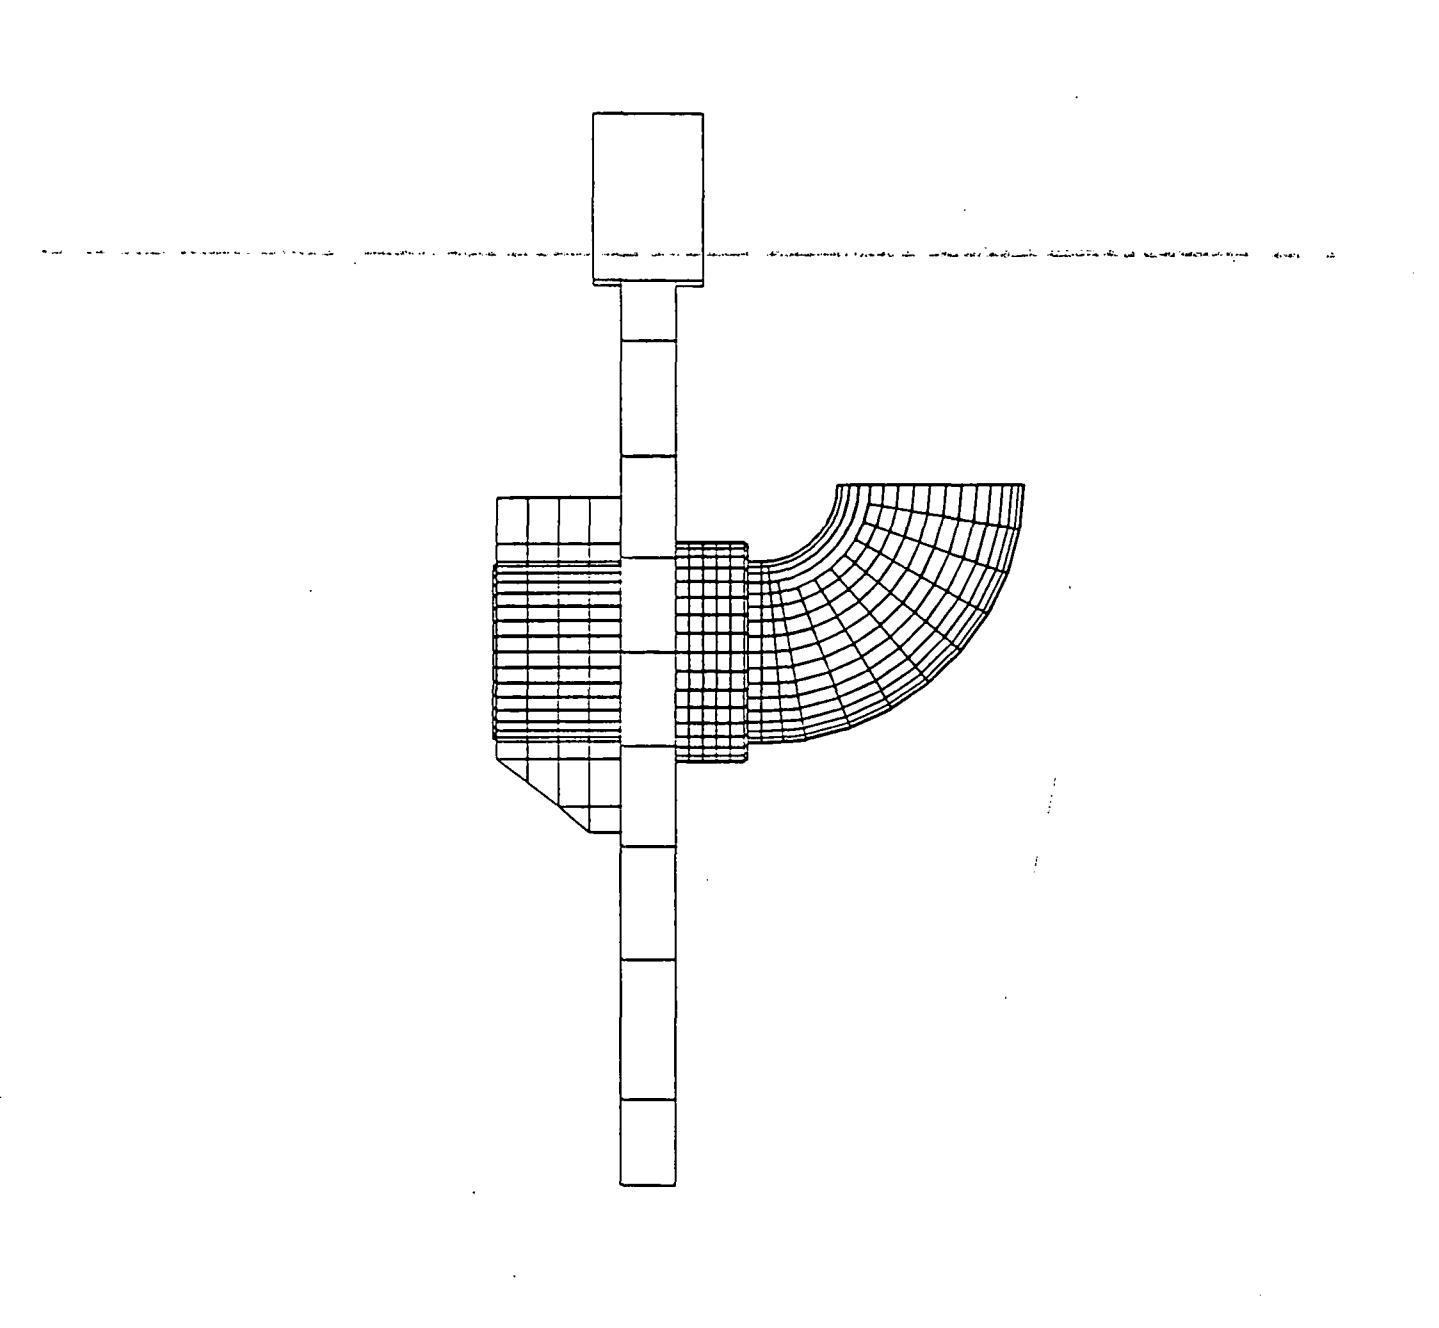
Figure 6.2 Vertical Cross Section of FEA Model

This section describes the finite element modeling and analysis (FEA) of the core spray shroud penetration assembly. The penetration assembly is located at the lower end of the core spray piping. The penetration consists of a 90° relbow, thermal sleeve, pipe and gussets welded to the shroud. A detailed description of the core spray piping and the penetration assemblies is given in the previous section and is illustrated in Figures 6.1 and 6.2.

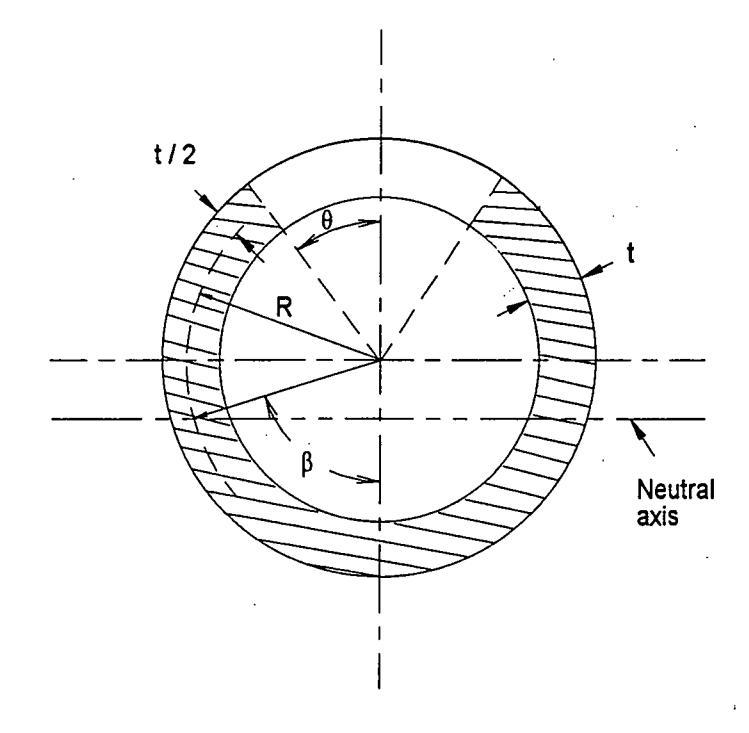
Figure 7.1 Cross Section of Flawed Pipe

Where θ is defined as the half angle as presented in Figure 7.1, and P_M is the membrane stress acting on the flaw. Because the flaws are assumed to be through-wall, the a/t_n ratio is equal to 1.

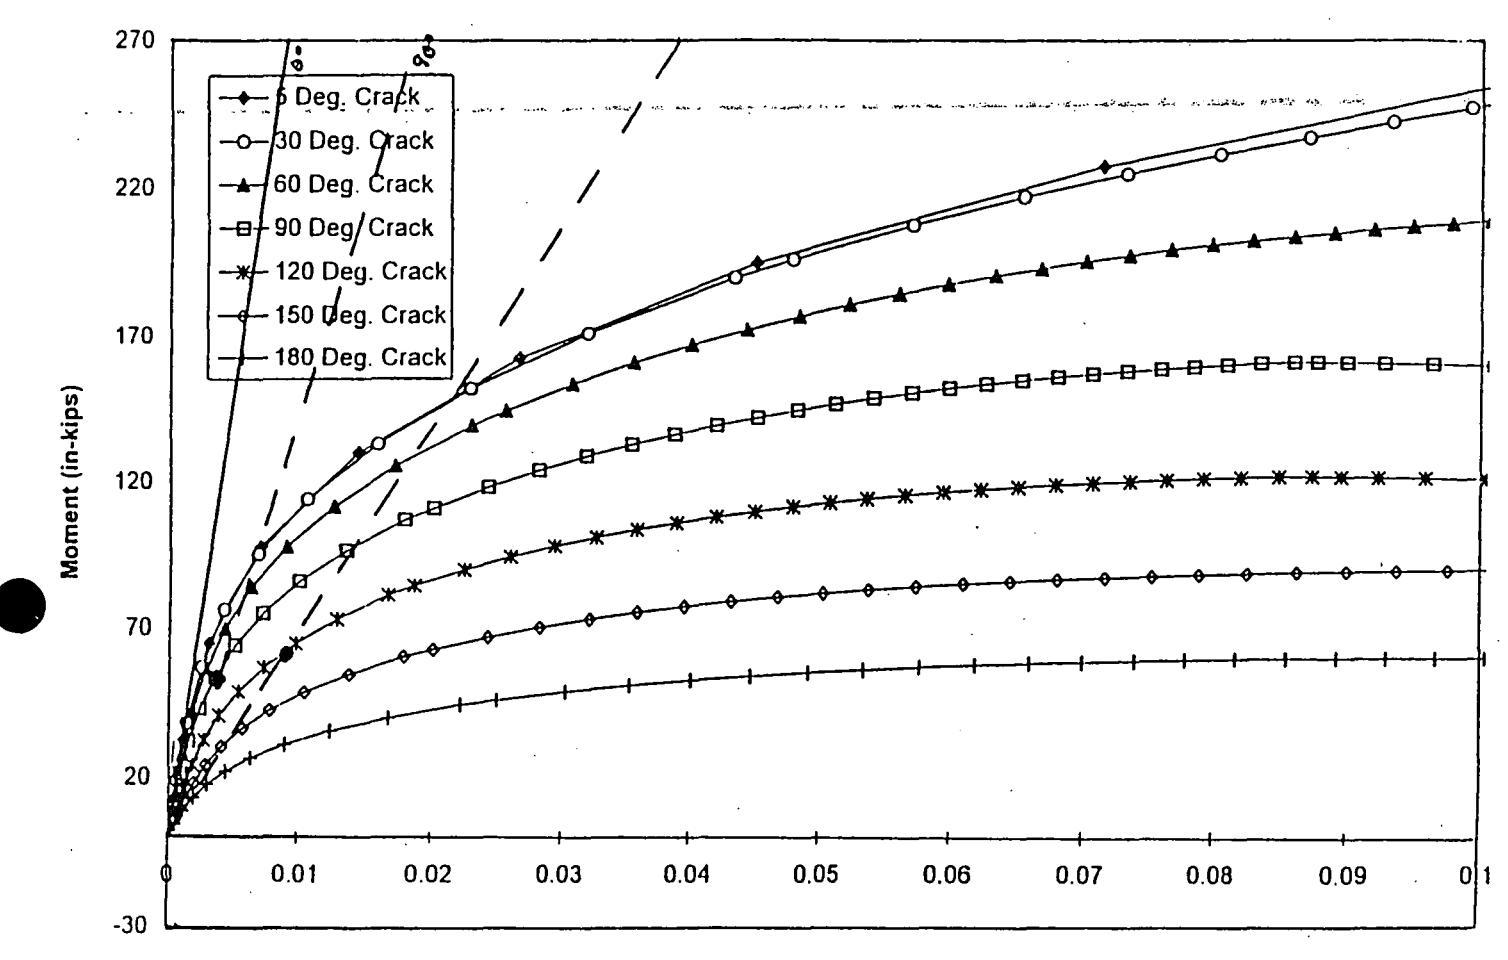
MOMENT vs. ROTATION ANGLE

Examination of the piping analysis results confirms that the core spray piping in the RPV annulus is rigidly supported between the RPV wall and the core shroud. Consequently, the piping response to primary inertia and drag loads is small while the response to secondary, displacement controlled, loads is significantly larger. The magnitude of the loads generated from the differential movement of the core shroud and the RPV during thermal, seismic and LOCA events is dependent on the piping system flexibility. The system flexibility increases with flaw extension, therefore the magnitude of the secondary loads acting on the flaw are reduced. Figure 7.2 presents the results of a study which defined the load-deflection relationship for various flaw lengths (Reference 16). This figure demonstrates the increase in flexibility as a function of crack length.

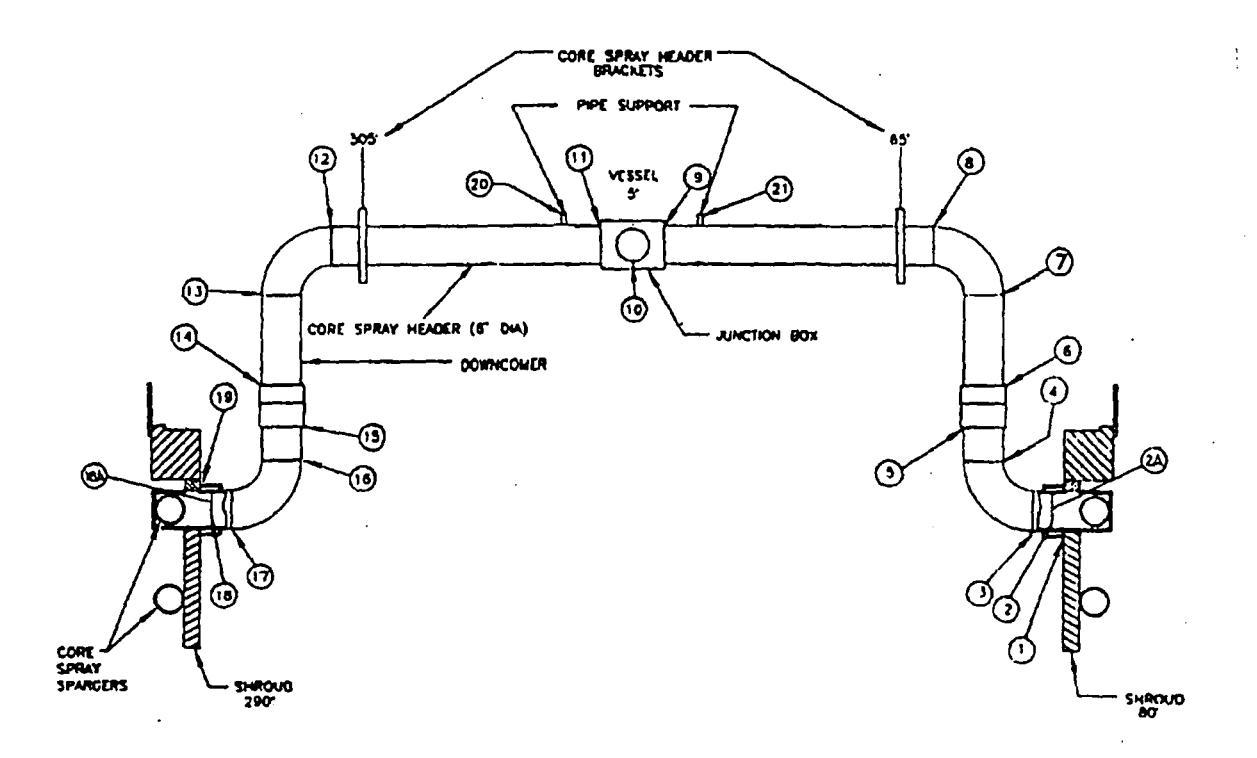
Figure 1.1 Core Spray Piping in the RPV Annulus

The portion of the core spray line addressed by this report is located in the reactor pressure vessel (RPV) annulus of Dresden Unit 2. The RPV annulus portion of the core spray lines consists of two symmetrical loops with RPV penetrations at the 5° and 185° azimuths. These two loops feed the two upper and two lower core spray spargers through four core shroud penetrations." The RPV annulus portion of the core spray system is illustrated in Figure 1.1.

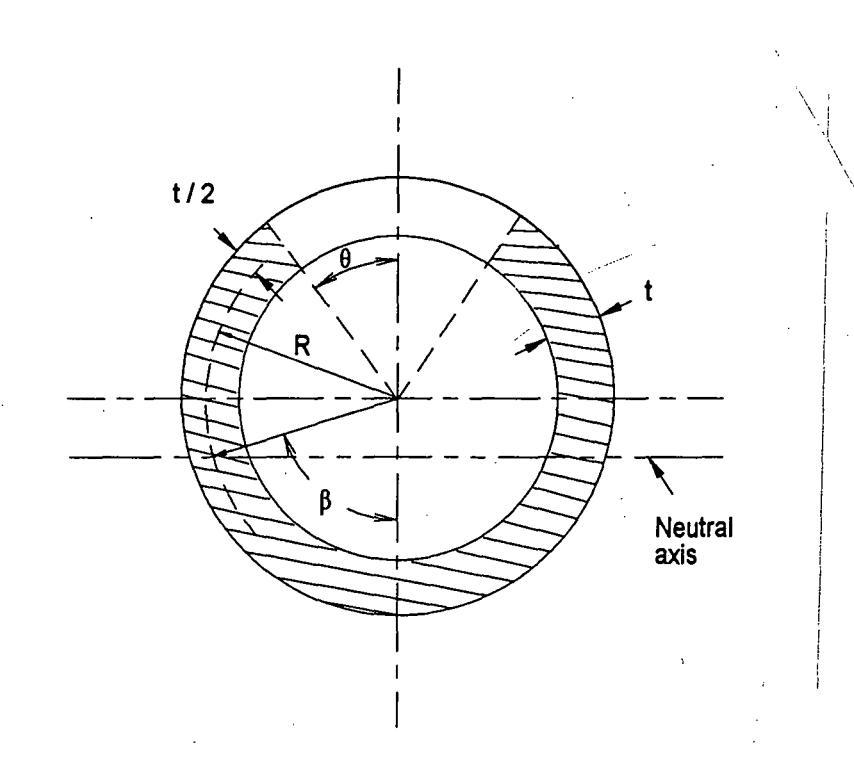
Figure 5.1 Cross Section of Flawed Pipe

Where θ is defined as the half angle as presented in Figure 5.1, and P_M is the membrane stress acting on the flaw. Because the flaws are assumed to be through-wall, the a/t_n ratio is equal to 1.

5.4 Flaw Evaluation Conclusions

Based on the results presented in Table 5.2, the minimum design basis load margin for the end of evaluation period flaw size is 38 and would require 182 months of operation to reach a critical flaw size. For the additional faulted condition load combination of RRLB LOCA plus an SSE, which is beyond the design basis of the Dresden Station, the minimum load margin is 31 and would require 178 months of operation to reach a critical flaw size. These results demonstrate that the flaws, projected to grow at a conservative IGSCC rate of $5x \ 10^{-5}$ in/hr for 13,608 hours, will remain structurally stable when subjected to design basis accident conditions. These results also demonstrate that reactor operation for more than 180 months can occur before the flaws are predicted to reach a critical length.
Rev. 0 September 10, 1995
