Rev. 1
September 18, 1995

Dresden Unit 2 Core Spray Flaw Evaluation Report

CORE SPRAY FLAW EVALUATION REPORT
REVISION 1

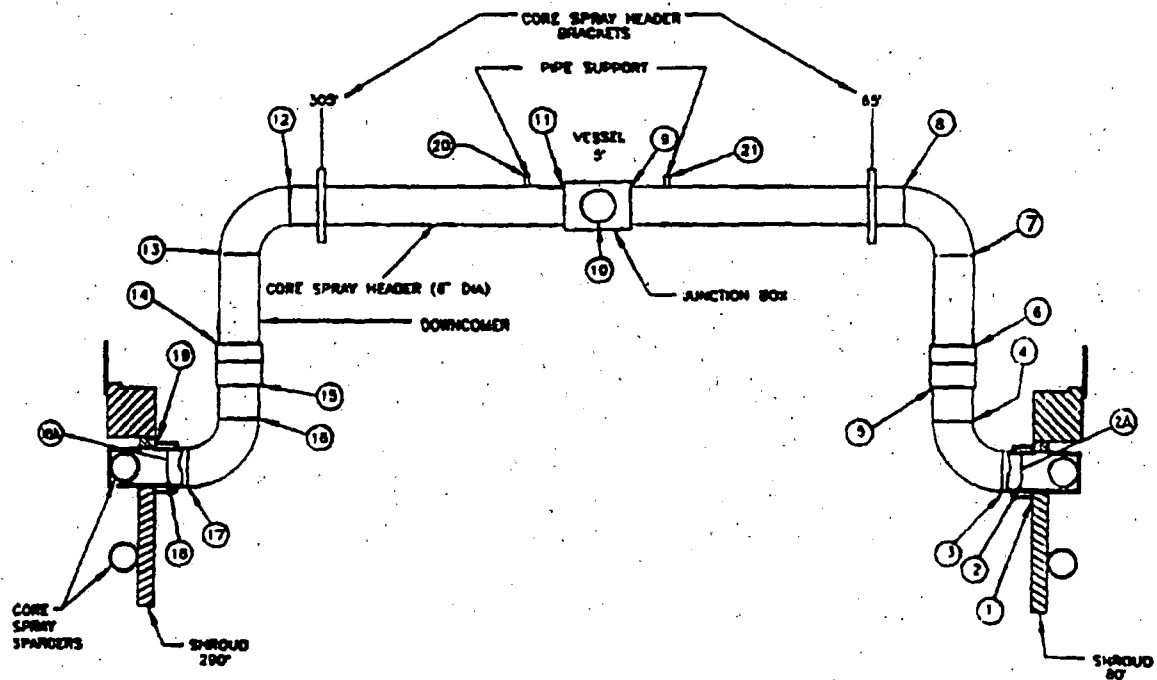
Figure 1.1 Core Spray Piping in the RPV Annulus

The portion of the core spray line addressed by this condition assessment is located in the reactor pressure vessel (RPV) annulus of Dresden Unit 2. The RPV annulus portion of the core spray lines consists of two symmetrical loops with RPV penetrations at the 5° and 185° azimuths. These two loops feed the two upper and two lower core spray spargers through four core shroud penetrations. A representative example of the RPV annulus portion of the core spray system is illustrated in Figure 1.1.

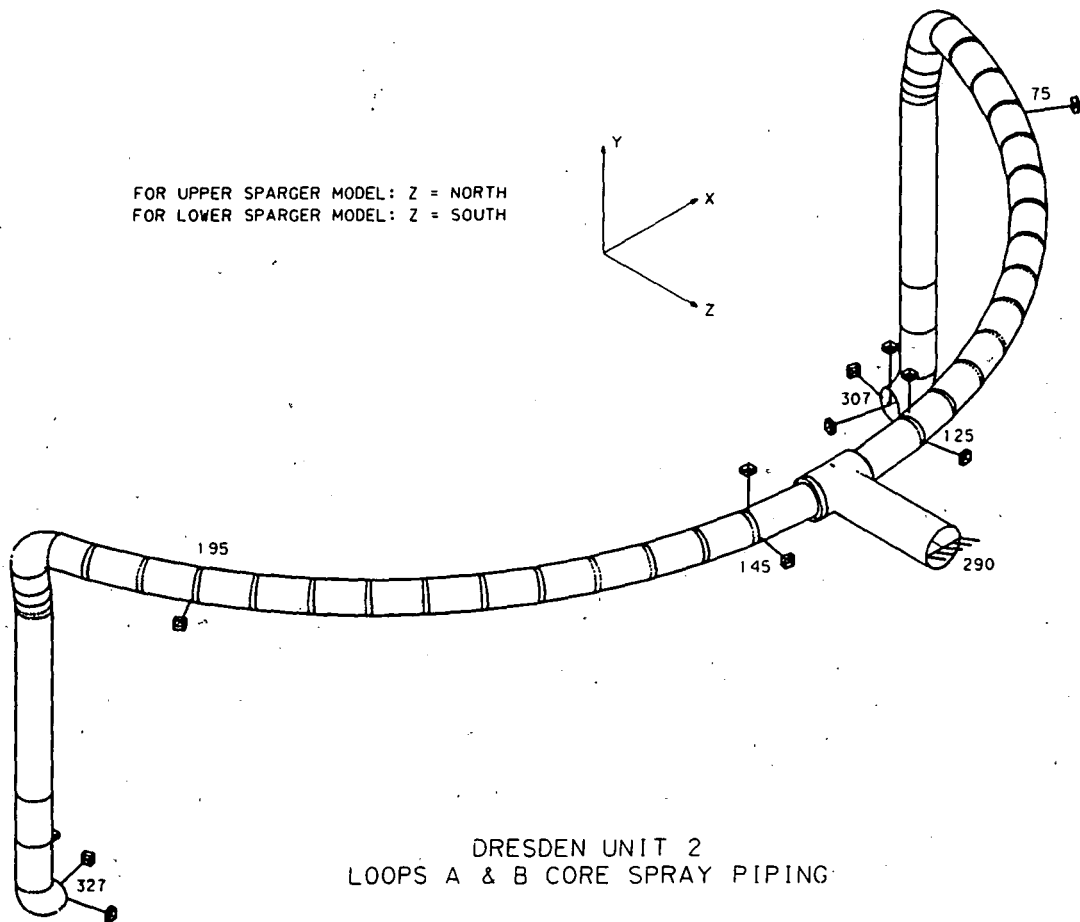
Figure 5.1 Core Spray Piping Analysis Model

The core spray piping is anchored to the core shroud at Node Points (NP) 307 and 327 as shown in Figure 5.1. It is attached to the RPV by supports located at node points 75, 125, 145 and 195. Displacement of the core shroud relative to the RPV results in differential support motion which is analyzed for OBE and SSE seismic events as well as for the RRLB and MSLB events. Two sets of core shroud displacements are analyzed for each of the seismic events. One set is based on the assumption of the core shroud remaining intact. The other set assumes a postulated circumferential break in the shroud at any horizontal weld location (cracked shroud). The bounding results based on the cracked shroud displacements were conservatively used for all flaw evaluations.

The piping model is based on the design basis drawings (References 11 through 15) and is shown in Figure 5.1. It consists of core spray piping inside the reactor. From the 8" RPV nozzle and 8"X6" Tee-Box, the 6" piping follows the circumference of the reactor above the core shroud to two vertical legs which drop down and penetrate the core shroud horizontally after a 90° elbow. The model ends at these anchored shroud penetrations, NP 307 and NP 327. The piping is supported directly to the RPV at NP's 75, 125, 145, and 195.

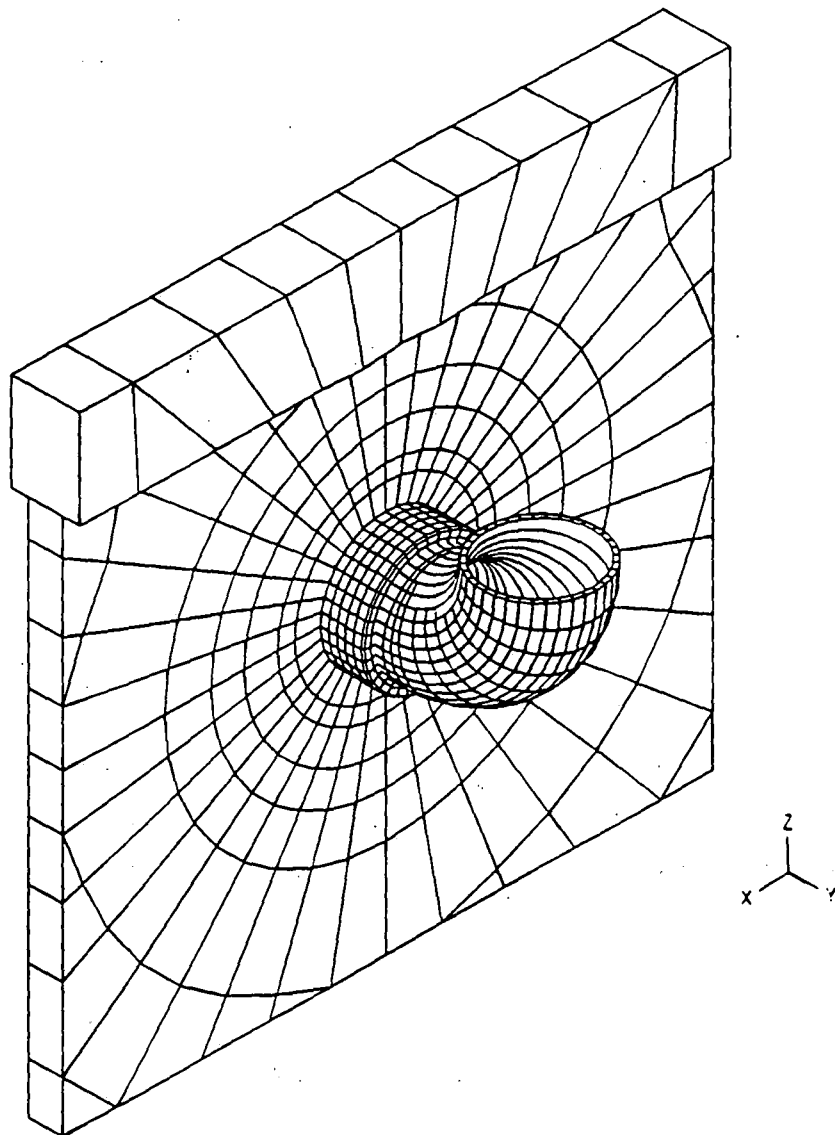
Figure 6.1 Three Dimensional View of FEA Model

This section describes the finite element modeling and analysis (FEA) of the core spray shroud penetration assembly. The penetration assembly is located at the lower end of the core spray piping. The penetration consists of a 90° elbow, thermal sleeve, pipe and gussets welded to the shroud. A detailed description of the core spray piping and the penetration assemblies is given in the previous section and is illustrated in Figures 6.1 and 6.2.

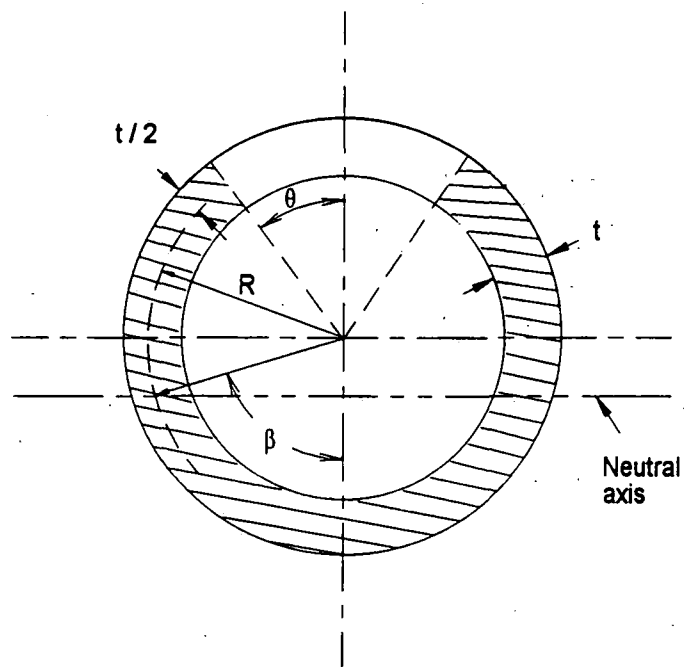
Figure 7.1 Cross Section of Flawed Pipe

Where θ is defined as the half angle as presented in Figure 7.1, and P_m is the membrane stress acting on the flaw. Because the flaws are assumed to be through-wall, the a/t_n ratio is equal to 1.

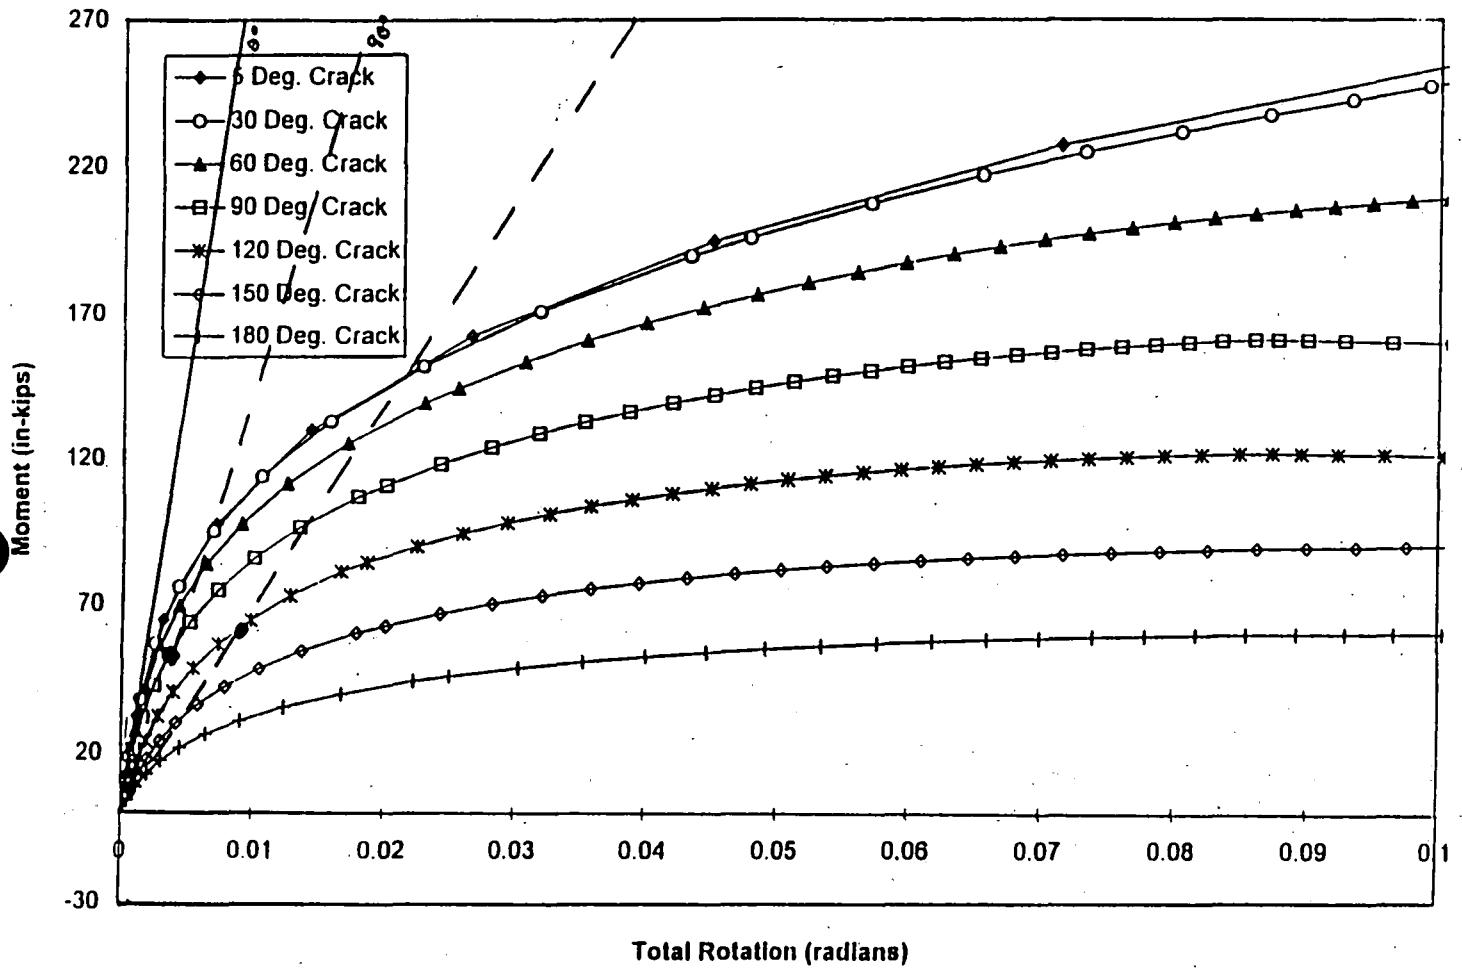
Figure 7.2 Moment - Rotation Angle Relationship

Examination of the piping analysis results confirms that the core spray piping in the RPV annulus is rigidly supported between the RPV wall and the core shroud. Consequently, the piping response to primary inertia and drag loads is small while the response to secondary, displacement controlled, loads is significantly larger. The magnitude of the loads generated from the differential movement of the core shroud and the RPV during thermal, seismic and LOCA events is dependent on the piping system flexibility. The system flexibility increases with flaw extension, therefore the magnitude of the secondary loads acting on the flaw are reduced. Figure 7.2 presents the results of a study which defined the load-deflection relationship for various flaw lengths (Reference 16). This figure demonstrates the increase in flexibility as a function of crack length.
