Rev. 1
September 18, 1995

Dresden Unit 2 Integrated Evaluation Report of Core Spray Flaws

Dresden Unit 2
Core Spray Flaws Integrated Evaluation Report

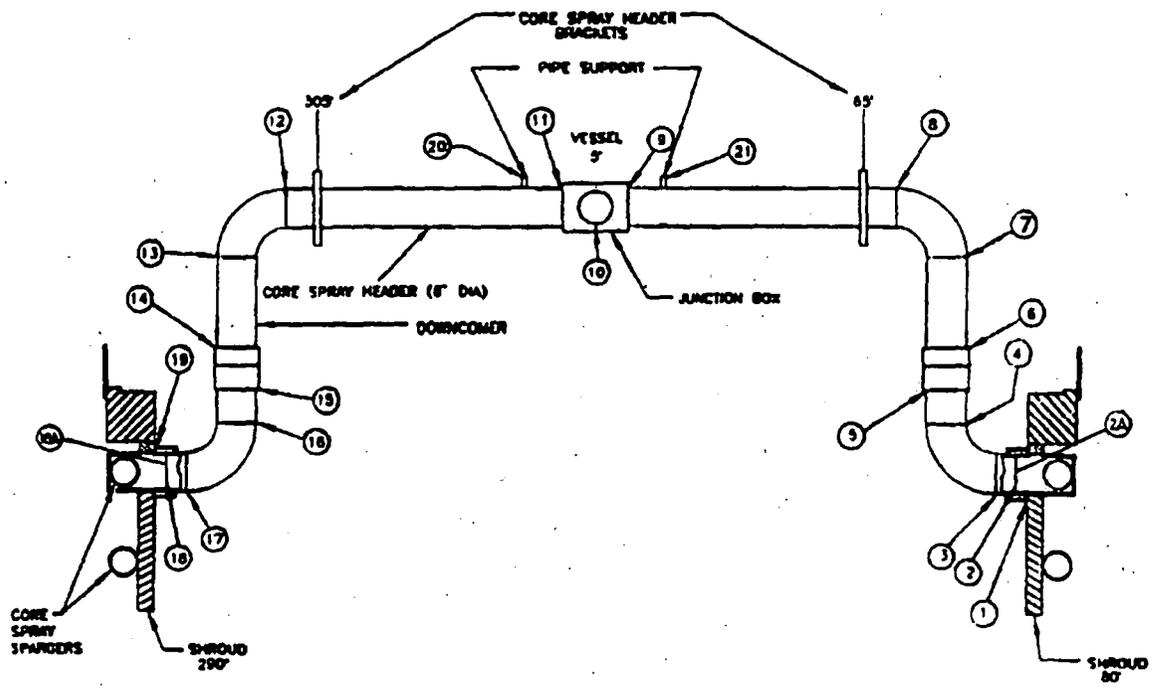
Figure 2.1 Core Spray Piping in the RPV Annulus

Crack like indications were observed at three locations on the core spray downcomers. One each in the "B" loop lower sparger inlet elbow and thermal sleeve collar, and one in the "A" loop upper sparger thermal sleeve collar. The elbow is made of stainless steel and is 6 inches in diameter. The affected piping is located in the reactor annulus between the reactor vessel wall and the core shroud wall. The elbow is not part of the reactor coolant pressure boundary nor is it part of the core shroud. The thermal sleeve collar is attached to the shroud on one side and to the 6 inch diameter pipe on the other side. The thermal sleeve collar has the function of providing a leakage seal between the pipe and the annulus as shown in Figures 2.1 and 2.2. All three of the indications are circumferential.

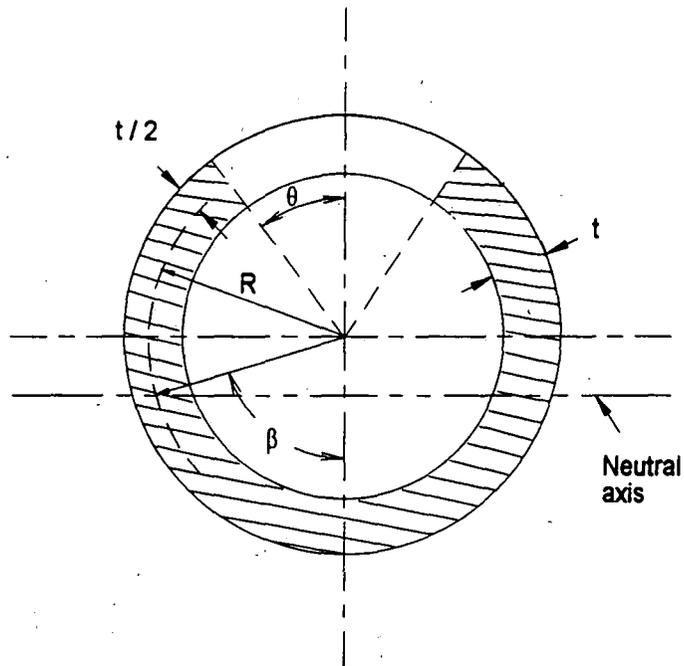
Figure 5.1 Cross Section of Flawed Pipe

Where θ is defined as the half angle as presented in Figure 5.1, and P_m is the membrane stress acting on the flaw. Because the flaws are assumed to be through-wall, the a/t_n ratio is equal to 1.

Based on the results presented in Table 5.2, the minimum design basis load margin for the end of evaluation period flaw size is 38 and would require 181 months of operation to reach a critical flaw size. For the additional faulted condition load combination of RRLB LOCA plus an SSE, which is beyond the design basis of the Dresden Station, the minimum load margin is 28 and would require 175 months of operation to reach a critical flaw size. These results demonstrate that the flaws, projected to grow at a conservative IGSCC rate of 5×10^{-5} in/hr for 13,608 hours, will remain structurally stable when subjected to design basis accident conditions. These results also demonstrate that reactor operation for more than 127 months can occur before the flaws are predicted to reach a critical length.
