U.S. NUCLEAR REGULATORY COMMISSION

REPORT NOS. 50-237/249/96007(DRS); 50-254/265/96007(DRS)

Dresden Nuclear Station, Units 2 and 3  
Quad Cities Nuclear Station, Units 1 and 2  
License Nos. DPR-19; DPR-25; DPR-29; DPR-30

Predecisional Enforcement Conference  
May 1, 1996  
Region III Office  
801 Warrenville Road  
Lisle, IL 60532-4351

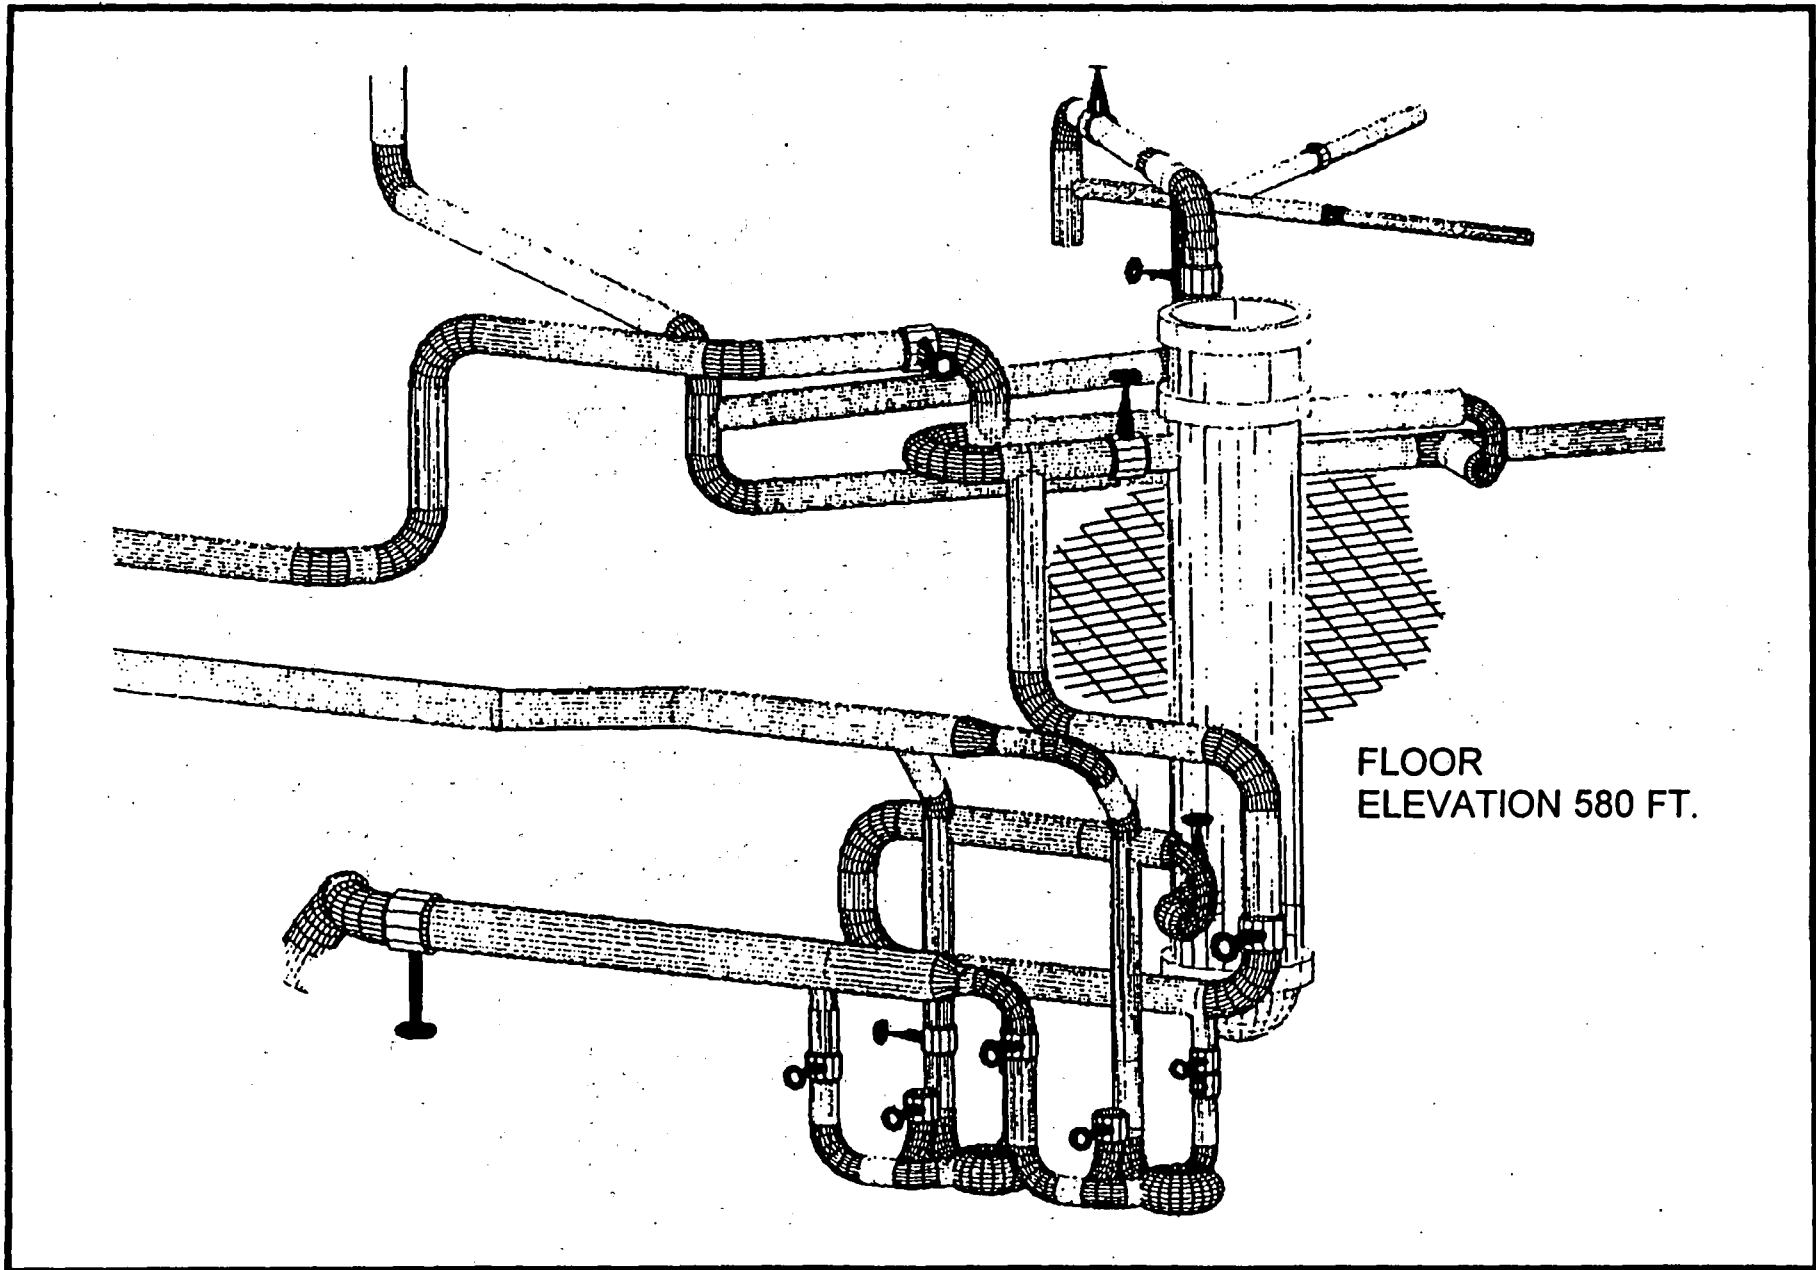
QUAD CITIES: RHR HEAT EXCHANGER & PIPING

- **Functional Design Bases**
  - Dresden LPCI  $H_x$  - Suppression Pool Cooling
  - Quad Cities LPCI/RHR  $H_x$  - Suppression Pool Cooling and Shutdown Cooling
- **Structural Design Bases**
  - Dead Load + Pipe Rupture + Operating Basis Earthquake (D+R+E) Using Normal Allowable AISC Code Stresses (“Elastic”)
  - Dead Load + Pipe Rupture + Safe Shutdown Earthquake (D+R+E’) Using AISC Code & “Plastic” Section Modulus
