**Commonwealth Edison**  
One First National Plaza, Chicago, Illinois  
Address Reply to: Post Office Box 767  
Chicago, Illinois 60690

Subject: Status Report on SSRT  
Open Issues  
NRC Docket No. 50-237

This letter satisfies the commitment in reference (b) to  
provide a status report for the open SSRT review items for  
Dresden Unit 2.

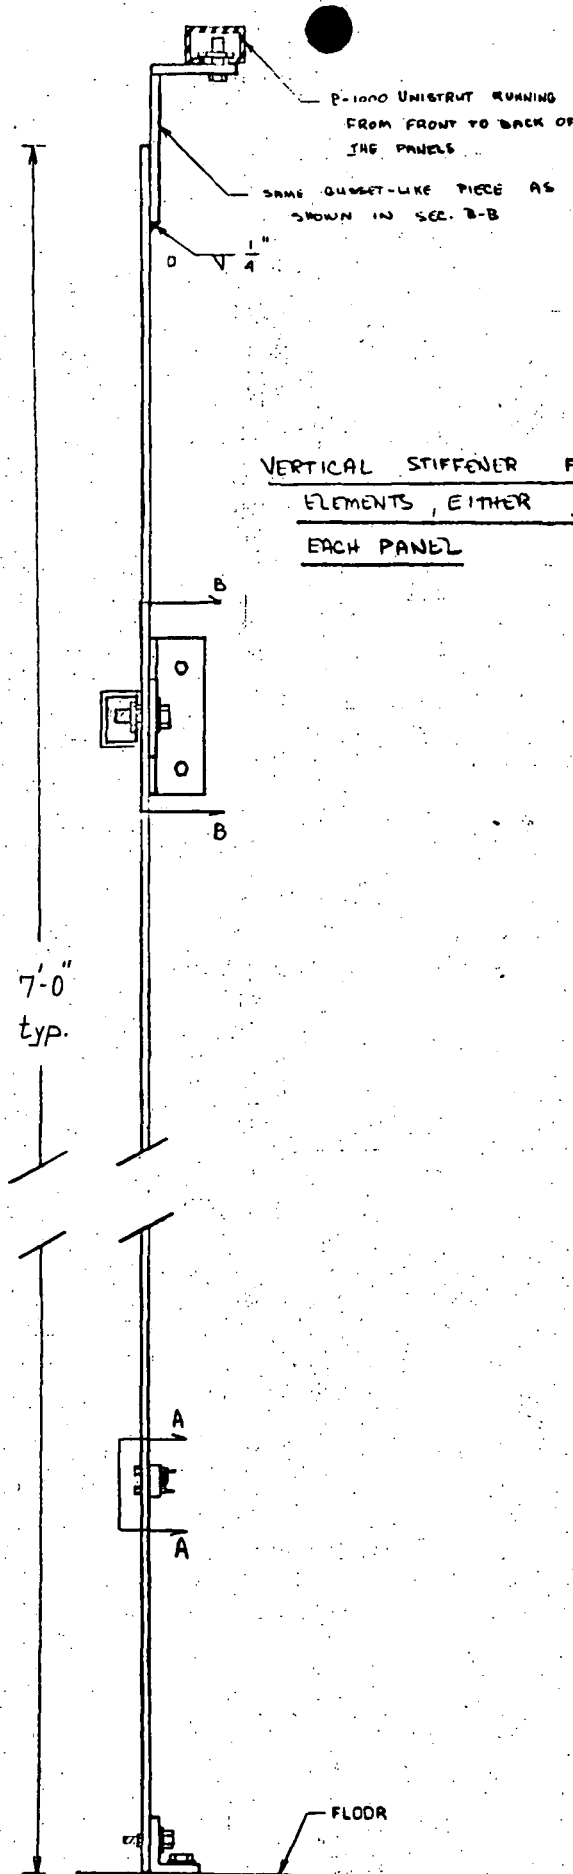
All local racks have bracing added to the panel as recommended in the General Electric report. The difference lies in the fact that the racks are located next to walls, therefore, the bracing is attached to the wall instead of the floor behind the racks.

FRONT & BACK END OF UNISTRUT WHICH RUNS ALONG THE PANEL DEPTH WHERE IT IS ATTACHED TO THE PANEL (SIDE VIEW)

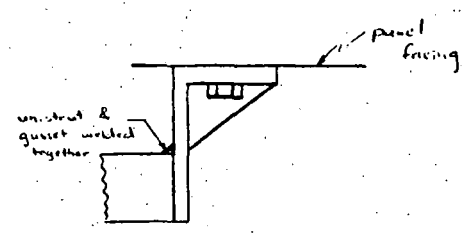
SEC. B-B

VERTICAL STIFFENER FIXED TO THE PANEL BY LATERAL ELEMENTS, EITHER ONE OF TWO TYPES SHOWN IS USED FOR EACH PANEL
