Subject: Response to NRC Bulletin No. 87-01
Dresden Station Units 2 & 3
Quad Cities Station Units 1 & 2
Zion Station Units 1 and 2
LaSalle County Station Units 1 & 2
Byron Station Units 1 & 2
Braidwood Station Units 1 & 2
NRC Docket Nos. 50-237/249, 50-254/265, 50-295/304,
50-373/374, 50-454/455 and 50-456/457

Reference: NRC Bulletin No. 87-01, dated July 9, 1987

DRESDEN STATION

Response to Items 1 - 5 of NRC Bulletin 87-01

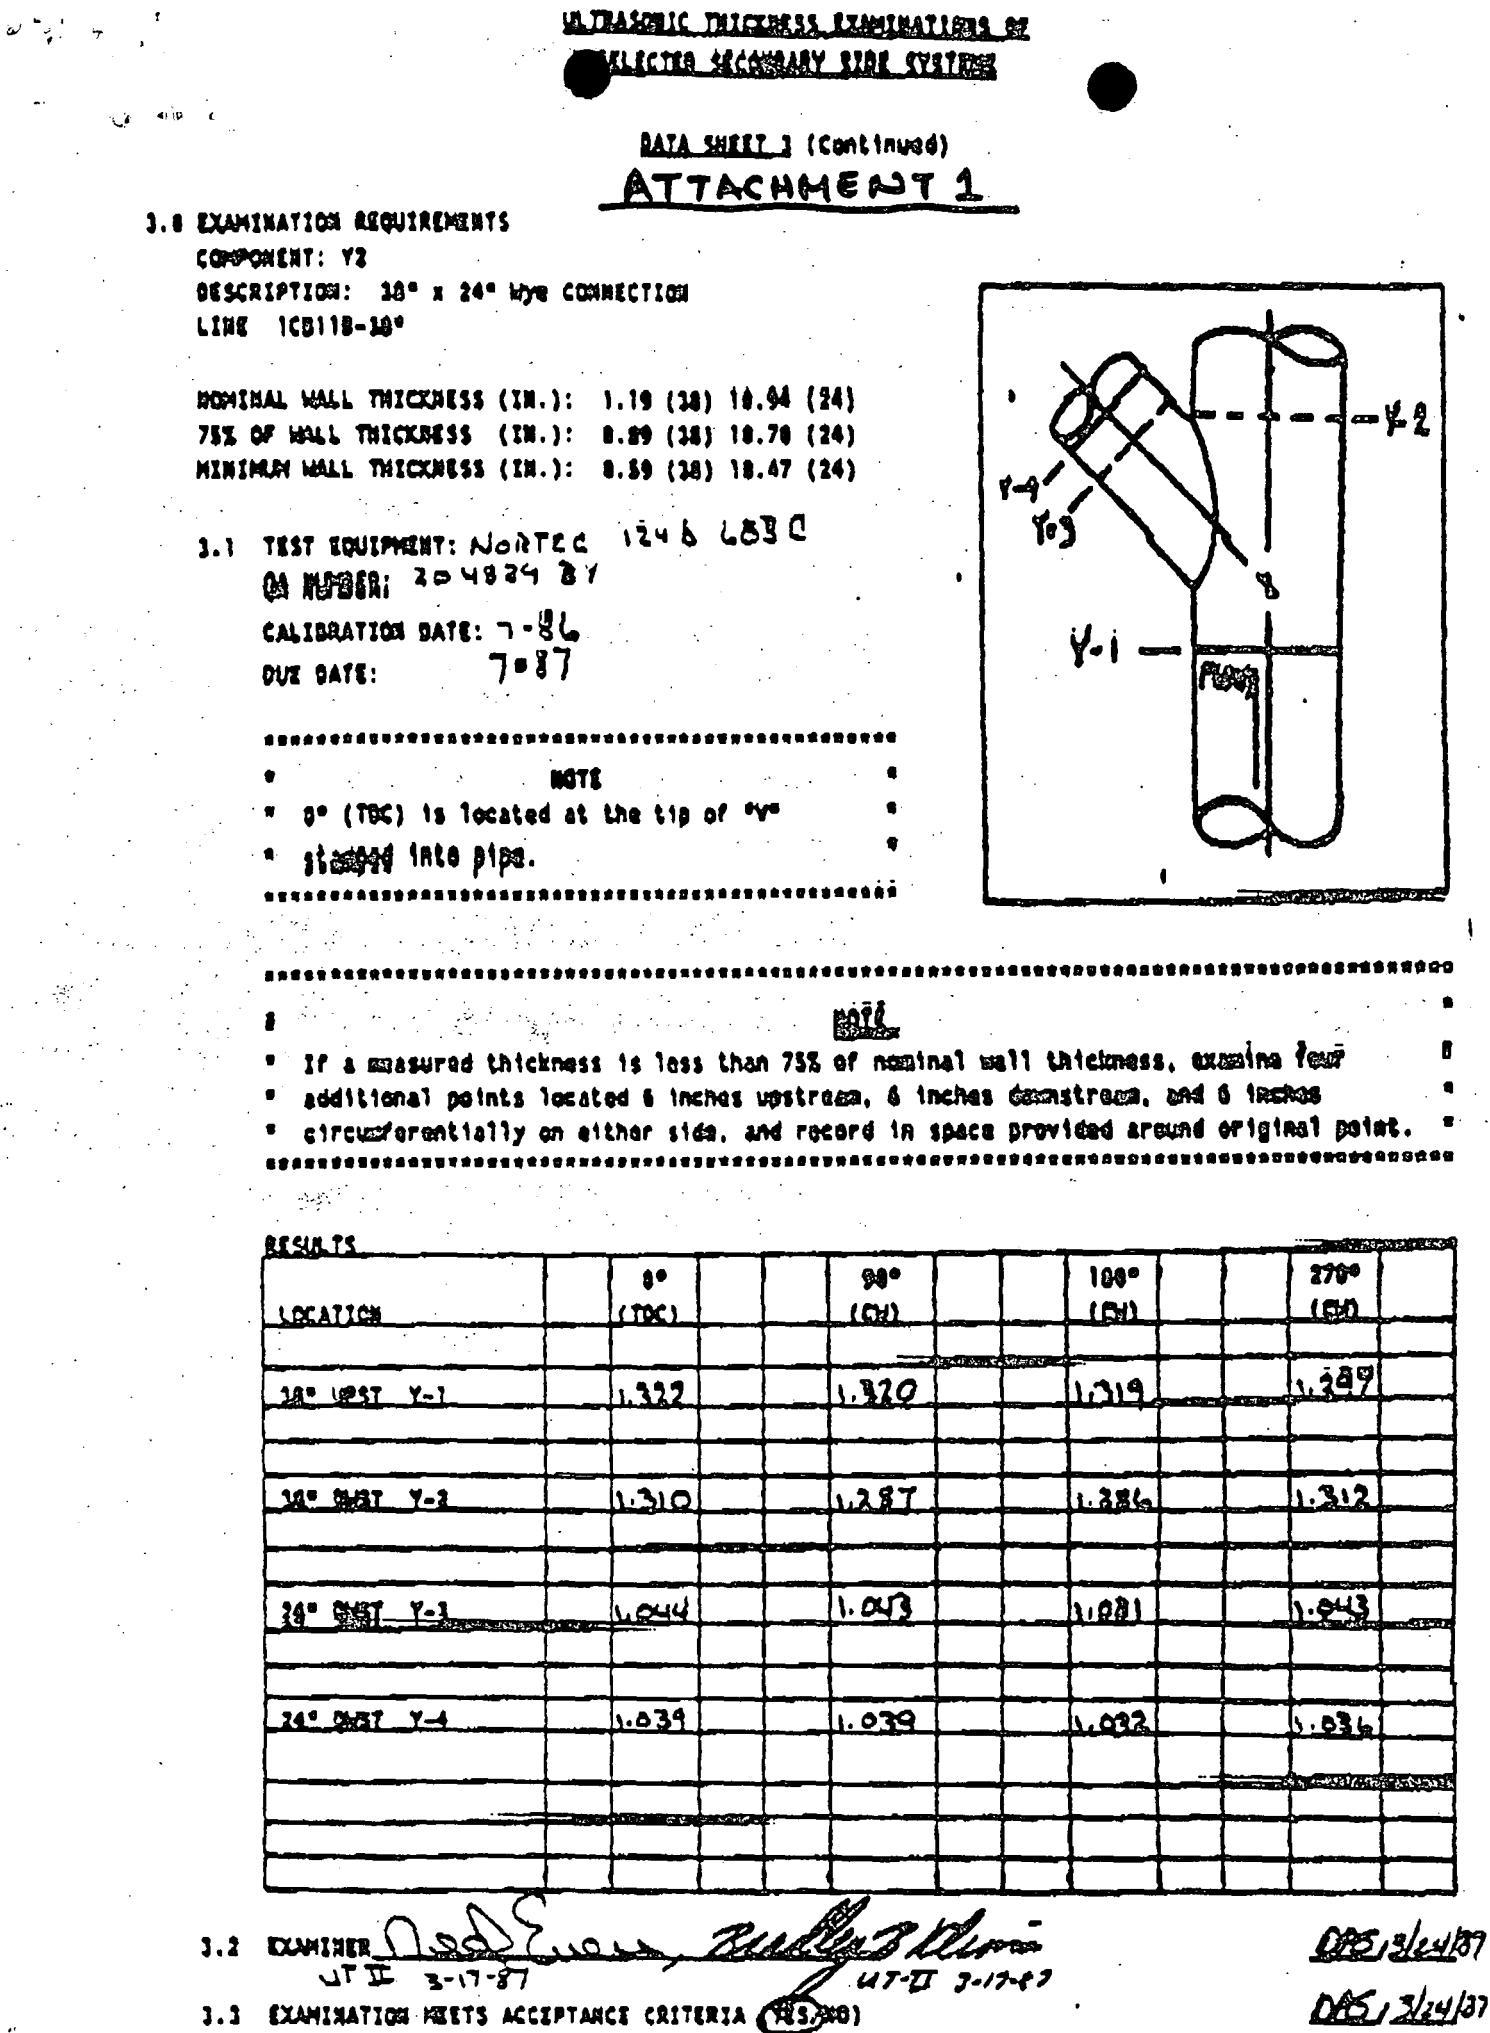
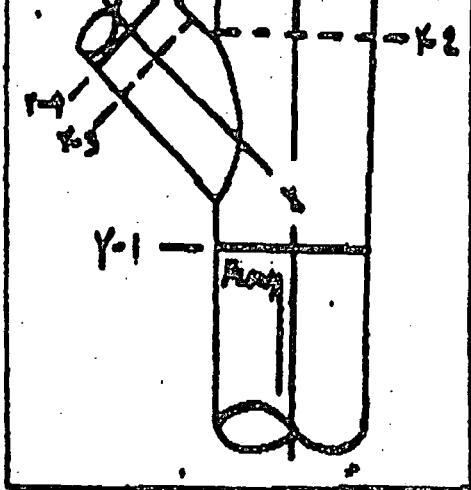
KOTE 0" (TDC) is located at the tip of "V" stamped into pipe. ----

If a measured thickness is loss than 78% of nominal wall thickness, exemine four additional points located 6 inches upstraza, 6 inches downstraca, and 6 inches circusterentially on either side, and record in space provided apound apiginal point.
