LICENSEE EVENT REPORT (LER)

Facility Name (1) Dresden Nuclear Power Station, Unit 2 Docket Number (2) 0 5 10 10 10 12 13 17 Page (3) 1 of 2 7

Title (4) Heat Damage to Upper Elevation Drywell Components Due to Closed Ventilation Hatches

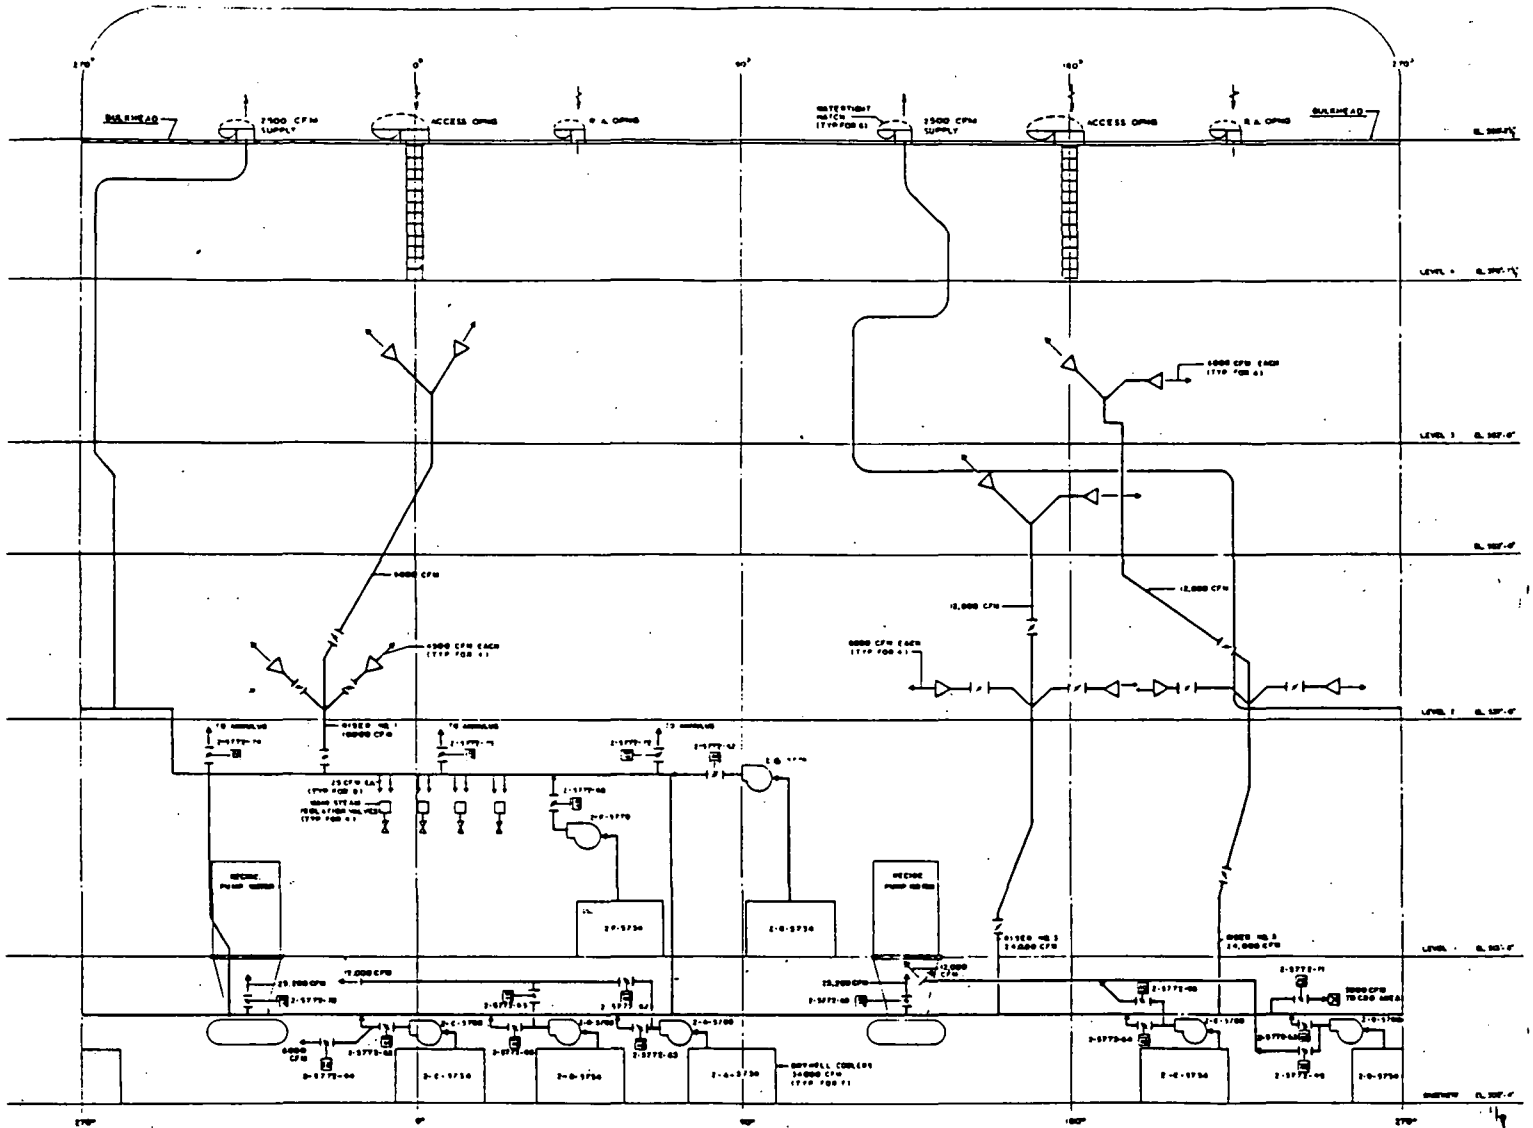
DIAGRAM OF DRESDEN UNIT 2
 DRYWELL COOLING SYSTEM
 FIGURE 4

As stated earlier, normal ventilation to the reactor head area is through the two supply hatches and then downward through the two return hatches and two manway hatches. This is illustrated in Figures 4 and 5. The restricted ventilation supply to the reactor head area is believed to have allowed local temperatures to approach that of the reactor vessel head. Heat would then be carried upward to the concrete shield plugs by a combination of thermal conduction through the drywell head, thermal radiation, and natural convection. Heat would similarly be carried downward to the fourth drywell elevation. The normal downward air flow from the reactor head area is a major air supply to the fourth drywell elevation. Hot air issuing upward from between the reactor vessel and the biological shield which ends at the fourth elevation is a second source of heat to the fourth drywell elevation. The restriction of normal air flow within the fourth drywell elevation is also believed to have contributed to excessive local temperatures.

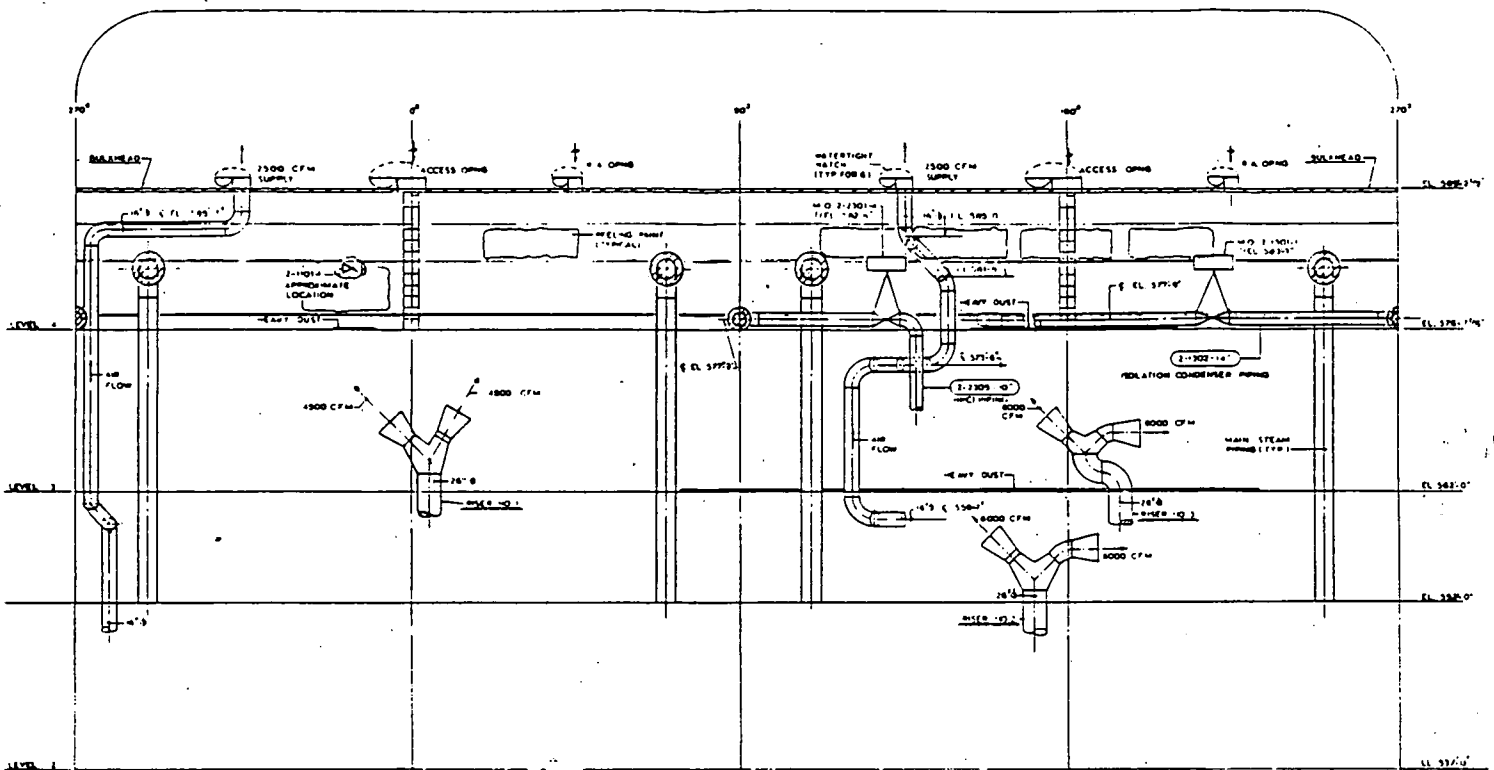
DIAGRAM OF DRESDEN UNIT 2
 DRYWELL COOLING SYSTEM
 UPPER ELEVATIONS
 FIGURE 5

The initial indication of the apparent cause of the heat damage to the paint was seen on October 31, 1988, when the drywell head [NH] was removed and the four ventilation hatches in the refueling bulkhead were found closed. It should be noted that the two manway hatches in the refueling bulkhead were found open. Figure 2 shows the location of six hatches in the refueling bulkhead (the ceiling of the fourth elevation). Normal ventilation to the reactor head area is through the two supply hatches and then downward through the two return hatches and two manway hatches. All six hatches should have been open. Figure 3 shows drywell cooling system temperature data from various thermocouples located in the drywell. Figures 4 and 5 show details of air flow to the fourth drywell elevation and to the fifth drywell elevation (reactor head area).
