Dresden Nuclear Power Station

Licensee Event Report #89-001-1, Docket #050249 is being submitted as required by Technical Specification 6.6, NUREG 1022 and 10 CFR 50.73(a)(2)(iv). This revised report is provided to correct an error concerning nomenclature of the Motor Control Center (MCC) 38-7/39-7 Reserve Feed Breakers and provide an updated status of corrective actions in progress.

Title (4) Turbine Trip and Reactor Scram on Stop Valve Closure Due to Slow

Transfer of House Loads During Loss of Offsite Power

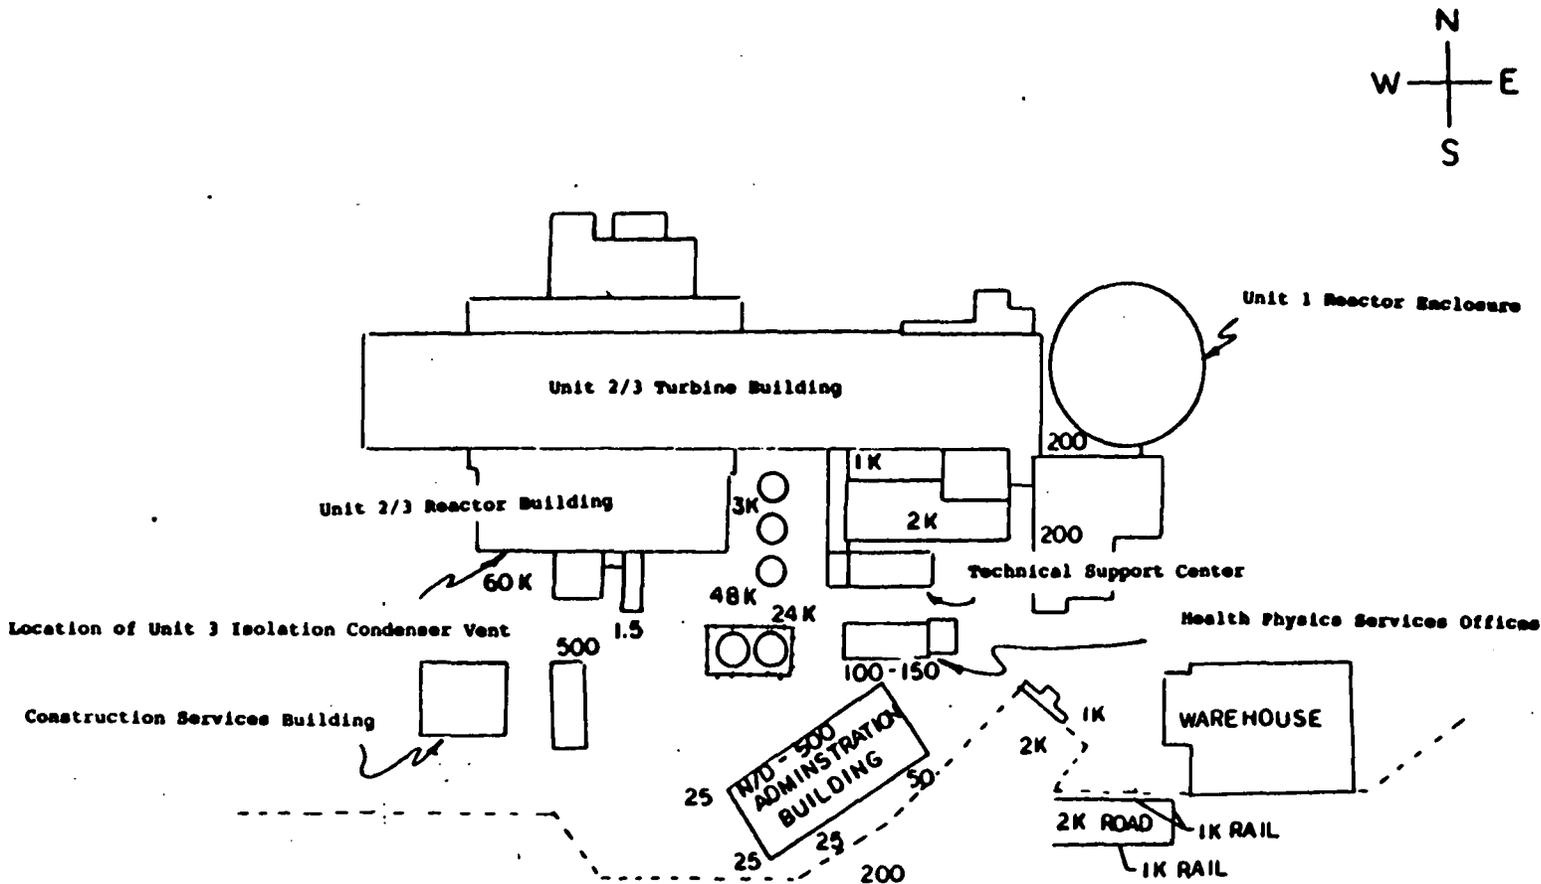
Figure 8. Diagram of Plant Grounds Affected by Isolation Condenser Vent

The event resulted in approximately 250,000 square feet of contamination to grounds and building roofs below and adjacent to the Unit 3 Isolation Condenser vent, which penetrates the south wall of the Unit 3 reactor building. Levels of contamination ranged from 25 disintegrations per minute (dpm)/100 square centimeters south and east of the Station Administration Building to 60,000 dpm/100 square centimeters just below the Isolation Condenser exhaust (see Figure 8). All contaminated areas were controlled and posted as contaminated to reduce the chance of personnel contamination events and the spread of contamination to non-contaminated areas; as a result, there were no external or internal personnel contaminations from the event.

Note: Initial contamination levels observed on March 25, 1989 following operation of the Isolation Condenser are listed in Units of Disintegrations Per Minute (DPM)/ 100 square centimeters.
