Exelon Insights and Actions

NRC Public Meeting - June 29 2017

LaSalle Unit 2 HPCS Injection Valve - Event Description

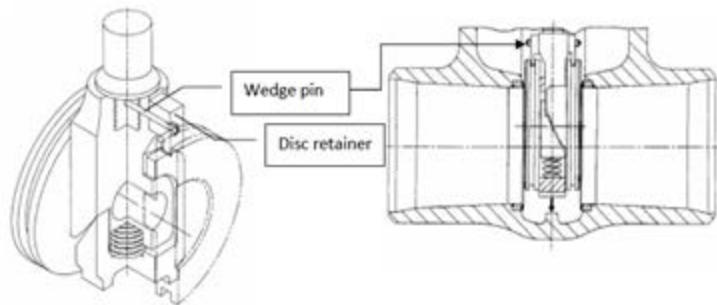
Figure 1: Typical Stem – Disc Assembly

- February 2017, LAS U2 High Pressure Core Spray Injection valve (2E22-F004) failed to open
- Failure of the wedge pin and wedge threads – stem/disc separation
- BWROG and Fleet governance were followed prior to the failure
- An anomaly in a prior diagnostic test was reasonably attributed to other conditions in the valve
- Stem Rotation checks were reported to be at end of acceptable range ($\sim 10^\circ$)
