**CEN-326 (F)**

**FINAL CORE SUPPORT BARREL  
INSPECTION REPORT  
POST CYCLE SIX  
ST. LUCIE UNIT ONE**

**MARCH 1986**

# St. Lucie Unit 1 Final Core Support Barrel Inspection Report

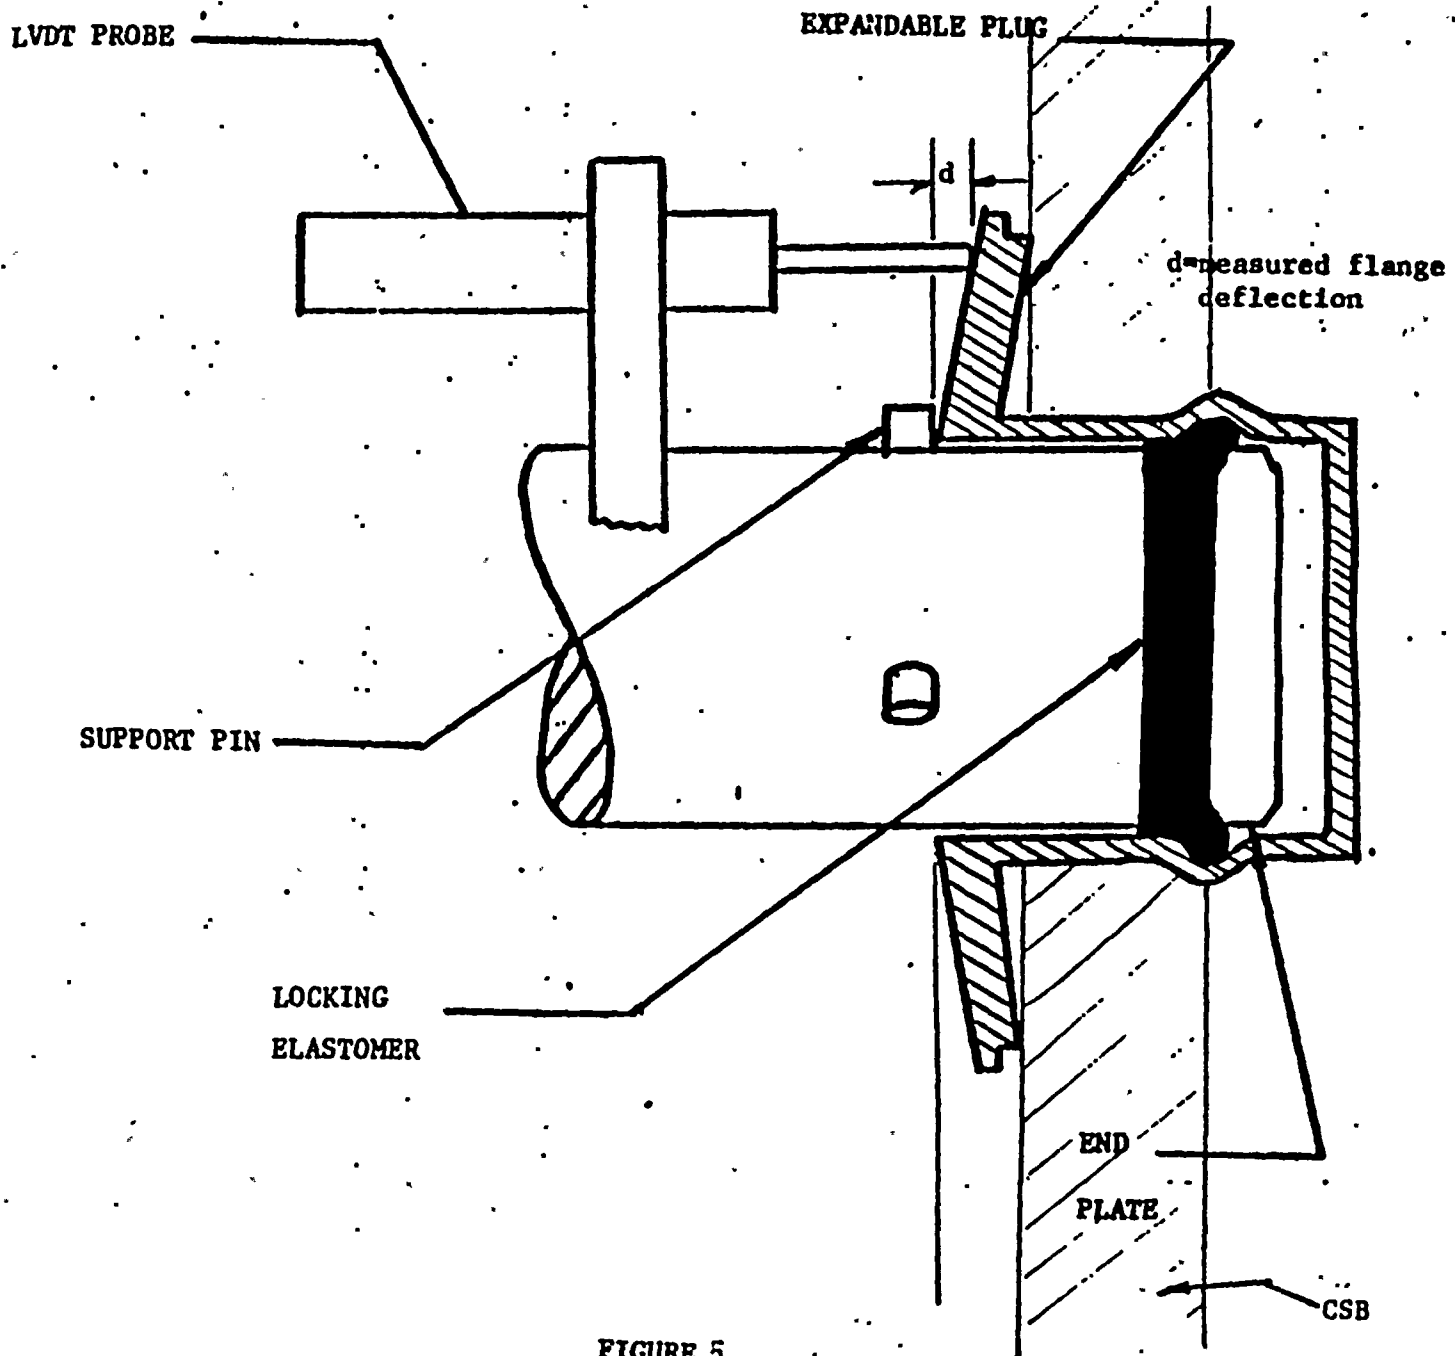
FIGURE 4

Figure 4 shows a cross sectional view of an installed plug. Once the bulge is formed and seated into the back chamfer of the hole in the CSB, the flange is released by the installation tool collet. Some spring-back of the flange occurs, but the bulge contact maintains the plug flange in a deflected configuration, thus preloading the plug into the CSB.

Installed Condition of  
EXPANDABLE PLUG
