Recommendations to Resolve Flowserve 10CFR Part 21 Notification Affecting Anchor Darling Double Disc Gate Valve Wedge Pin Failures (Revision 4)

BWROG Valve Technical Resolution Group

IE19

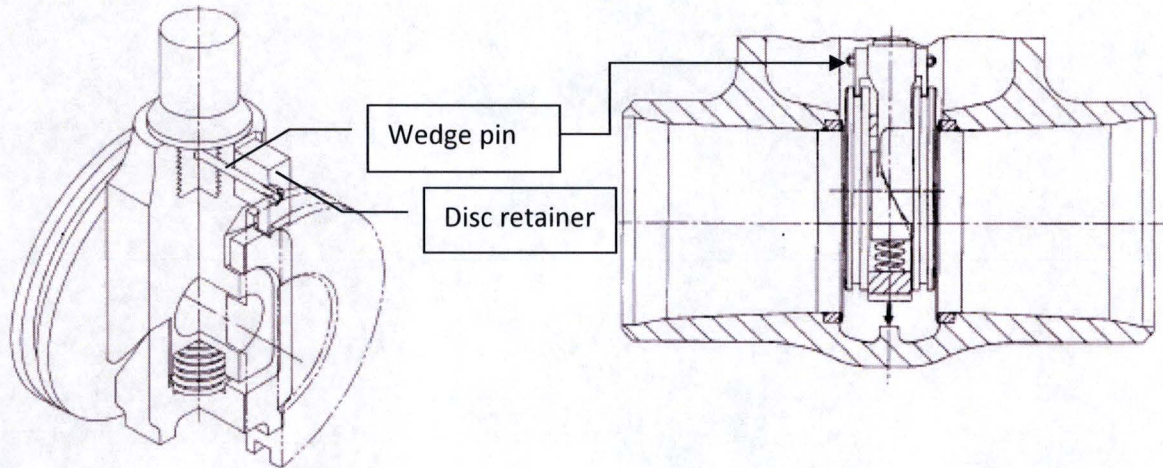
Cutaway pictures of a typical anchor darling double disc valve with threaded upper wedge stem connection with wedge pin and disc retaining clips

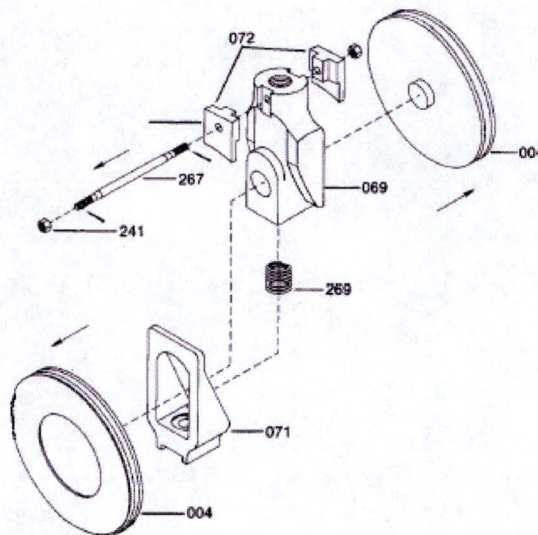
Exploding picture of the disc assembly

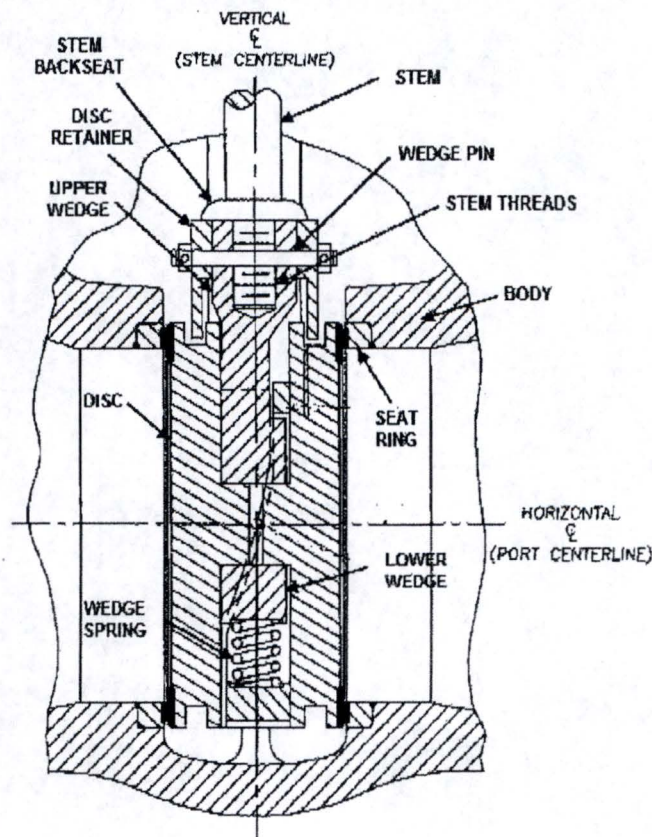
Figure 1
Typical Double-Disc Gate Valve Trim

The stems on most double-disc (DD) gate valves larger than size 2" are attached to the upper wedge using UN threads. A pin is installed through the hub of the upper wedge and stem threaded section to prevent the stem from loosening and eventually unscrewing from the wedge. In addition, the disc retainers on some DD gate valves are attached using the wedge pin. See Figure 1. The output torque of the actuator is transmitted to the stem/wedge joint through the stem and is resisted by the disc wedge pack, therefore the stem to wedge connection is loaded by the stem torque and thrust. The wedge pin is not designed to withstand the full actuator output torque. The actuator torque direction tends to tighten the stem into the wedge during closing and tends to loosen the stem during opening.

Failure of the wedge pin can cause loosening of the stem in the upper wedge and eventually separation of the stem leaving the valve inoperable. For certain designs pin failure could allow the retainers and miscellaneous attachment parts to fall out of position and become loose parts in the valve and piping system.

Anchor Darling double-disc gate valves have been supplied to the commercial nuclear industry for critical service since the early 1970's. In April 1996, a specific stem preload torque value was established based on valve size and pressure class. This recommended standard stem preload torque is based on a calculated, required stem thrust to close the valve which is considered great enough to envelope most applications. Attachment 1 details the recommended torque by valve size and pressure class.

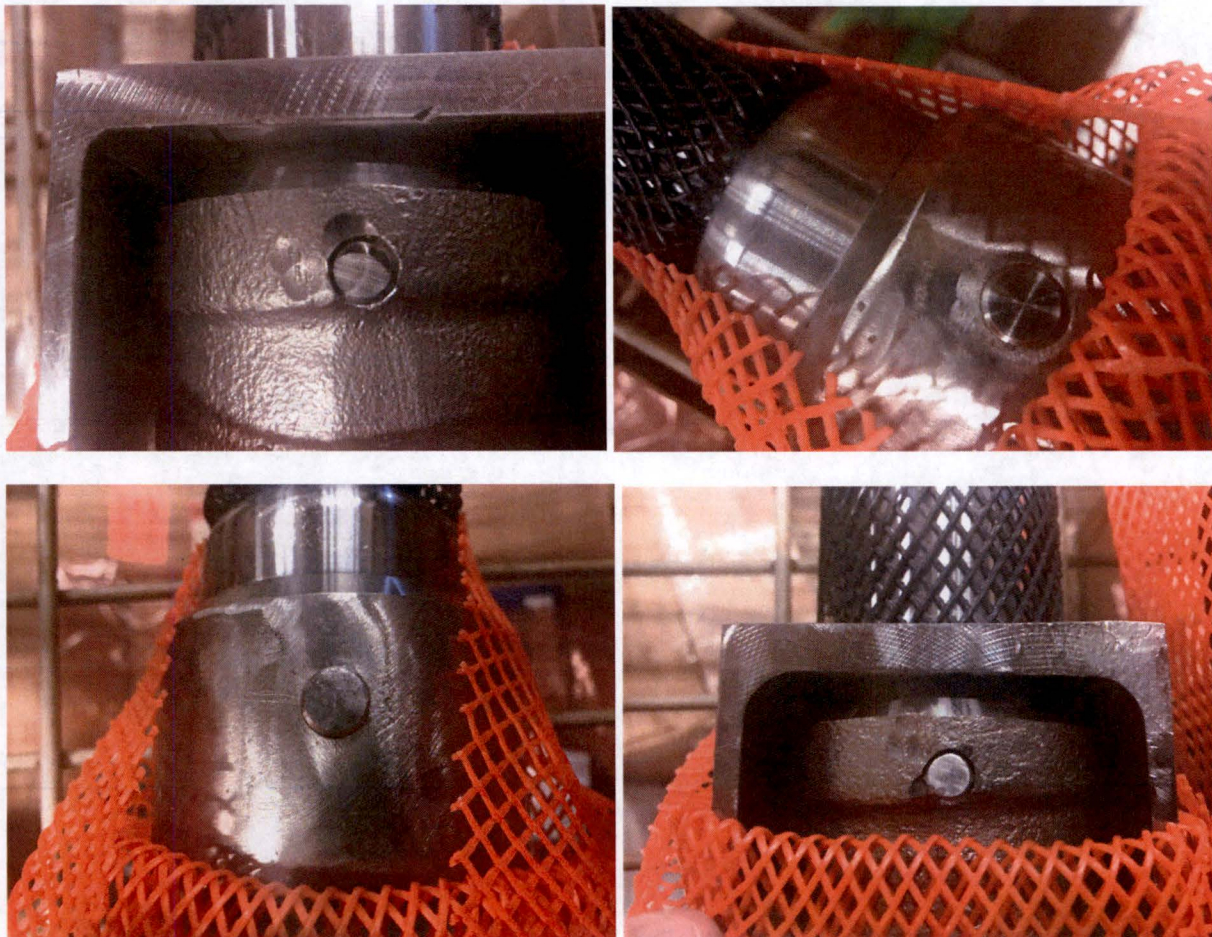
Photos of the properly staked stem / wedge assemblies with wedge pins staked or pinned are shown below.

Note: Pin staking guidance only applies to pins that do not act as disc retainers/keepers which have nuts

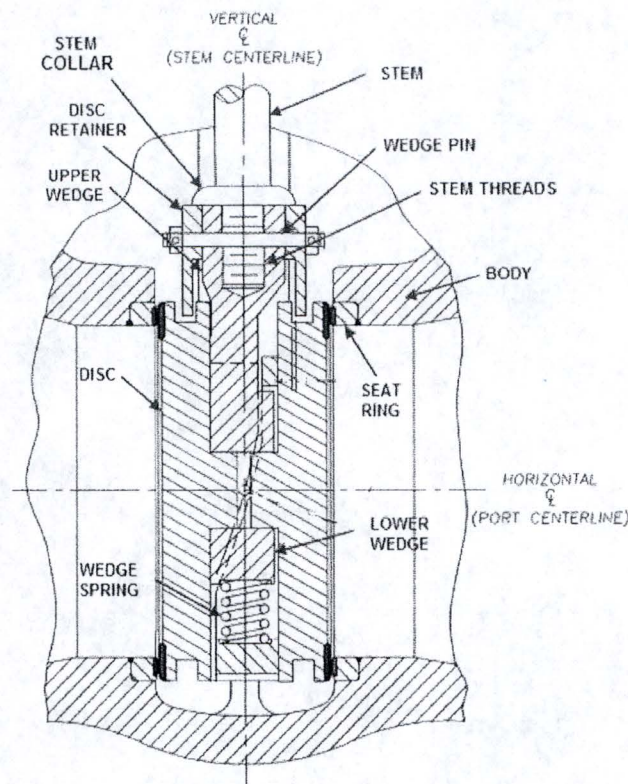
Figure 1
Typical Double-Disc Gate Valve Trim

Flowserve has been working with Exelon and nuclear industry groups to investigate and evaluate the stem-wedge separation in a size 12 class 900 Anchor/Darling motor-operated double disc (DD) gate valve. The valve stem was completely separated from the upper wedge, the wedge pin was sheared, the wedge threads stripped away and the pressed-on stem collar was pushed up leaving the valve inoperable. The valve operating thrust and torque is transmitted through the stem-wedge assembly, therefore separation of the stem and wedge will prevent the valve from opening and can adversely affect closing. See Figure 1 for a sketch of the stem-wedge joint.

A loose connection is the result of inadequate stem thread preload whether not applied initially during assembly or not maintained during operation. The initial stem preload can be reduced if the stem closing thrust in service is high enough to cause local yielding of the joint. Stems with integral collars typically have allowable thrusts which do not govern the thrust limit of the valve however a stem with a pressed-on collar, supplied with many of the originally supplied valves, has a thrust limit which is less than the typical maximum allowed thrust values previously determined by weak-link or maximum thrust analyses.

Valve evaluations and actions resulting from the previous notification are applicable and still apply. This notification includes additional information for maintaining the stem preload that was not addressed previously. The actuator thrust as well as the torque must be reviewed to insure the preload is maintained.

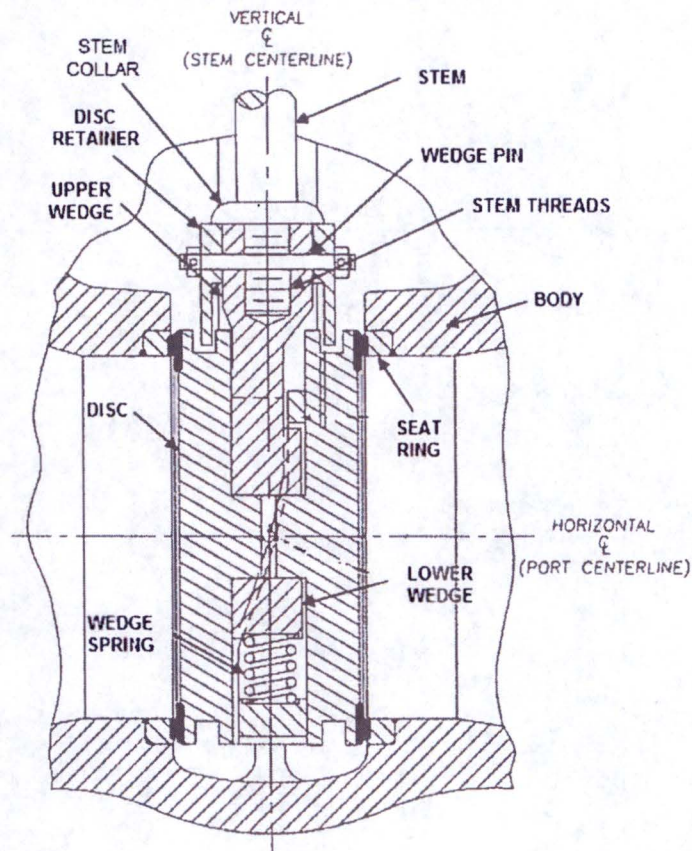
Figure 1
 Typical Double Disc Gate Valve Trim

DESCRIPTION: Exelon – LaSalle Unit 2 reported separation of the stem and upper wedge on valve 2E22-F004 during refueling outage L2R16 (February 2017). The stem was completely removed from the wedge with the wedge pin sheared and wedge threads completely stripped. The valve operating thrust and torque is transmitted through the stem-wedge assembly. Separation of the stem and wedge will prevent the valve from opening and can adversely affect closing. See Figure 1 for a sketch of the stem-wedge joint.

- 1) Preload the joint by torquing the stem into the upper wedge during assembly to a value greater than the actuator output torque before installing the wedge pin. This is the same recommendation as provided under the previous notification. It is further recommended to torque the stem to the maximum capability of the joint to provide additional margin and account for the stem thrust.
- 2) If stems are replaced use stems with integral collars. Consider stem replacement using stems with integral collars if the valves are disassembled.
- 3) If wedge pins are replaced use high strength material such as hardened martensitic / 17-4PH stainless or inconel. Consider pin replacement if the valves are disassembled.
