# **DRAFT COMPLETION REVIEW REPORT**

Hecla Mining Company Durita Facility Montrose County, Colorado Colorado Radioactive Materials License No. 317-02

March 30, 2015

The Colorado Department of Public Health and Environment Radiation Program

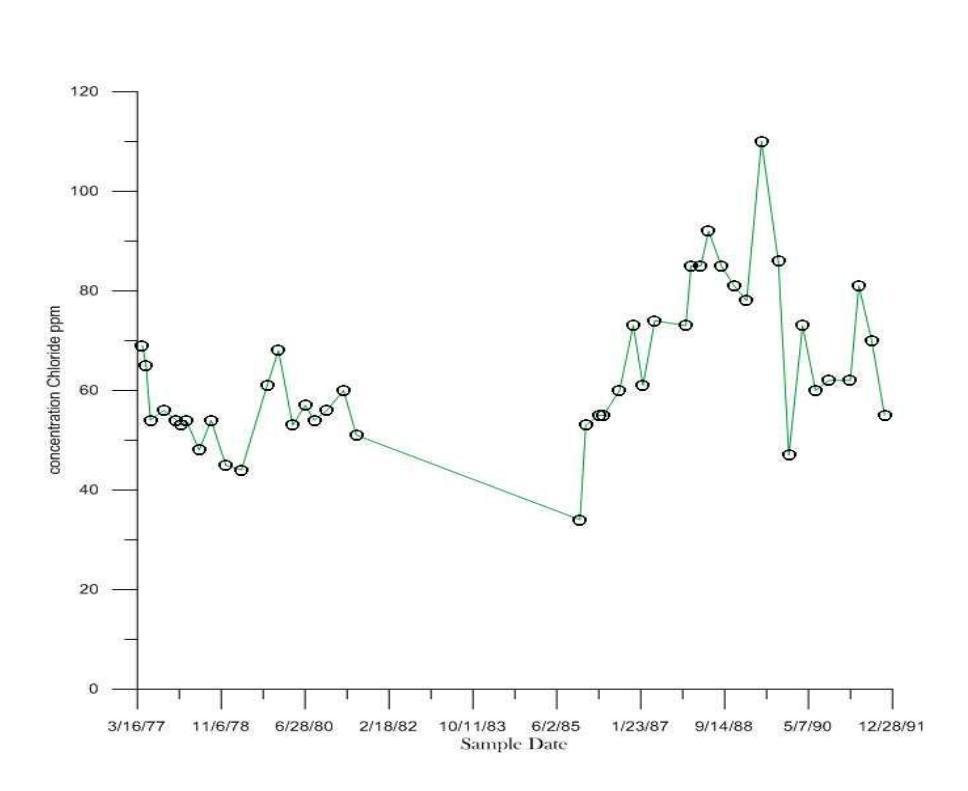
Monitor Well MW-4 chloride content over time

An evaluation of the flow data using a gradient of 0.033 and an apparent water velocity of 120 feet per year using the equation velocity = hydraulic conductivity time gradient divided by porosity (v= (k/n)(dh/dl)) yields an apparent hydraulic conductivity between 7 x  $10^{-4}$  cm/sec and 1 x  $10^{-3}$  cm/sec. This is the range of conductivities for a clayey silty sand found as is found in this part of the site (Freeze & Cherry, 1979). The gradient is taken from the general site gradient and from the slope of the shallow aquitard between MW-3 and MW-4 shown on Figure 7.4. Porosity is varied between 0.2 and 0.3 The sandy gravels found beneath the area of LT-202 will have a hydraulic conductivity greater than 1 x  $10^{-1}$  cm/sec. based on the same source. Using this analysis, the eastern area of LT-202 is within the sampling envelop of MW-4 during the monitoring period.

Plot of chloride content in well MW-4 over time 1977 to 1991.

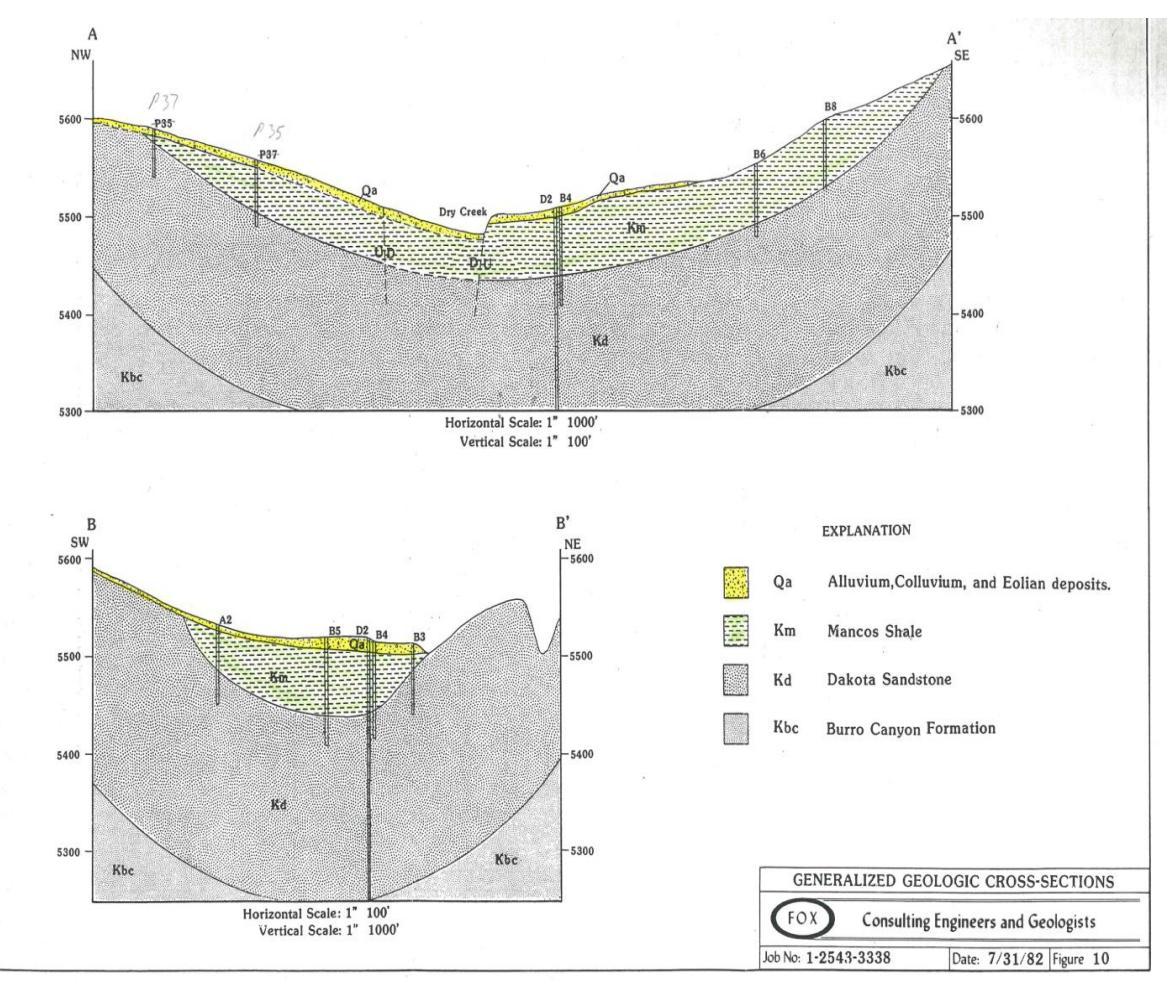
Conceptually, the Durita site sits on one side of a structural syncline, or shallow bowl. The surface of the bowl is made of the Mancos Shale formation. See Figure 7.1 for a general cross-section of the syncline. Wind and water surface sediment deposits occur across the site. Weathered Mancos Shale occurs in places at the surface of the southern half of the site. The upper sedimentary layers at the site are a triad of an upper weathered zone of alluvium, colluvium, and oxidized Mancos Shale; a middle zone of very low permeability, very dense, Mancos Shale rock in a chemically reducing state; and a lower water-saturated interval associated with the Mancos Shale – Dakota Sandstone conformable contact. Figure 7.6 shows this relationship in cross section form.

Generalized cross section across the Coke Oven Syncline. From Fox 1982

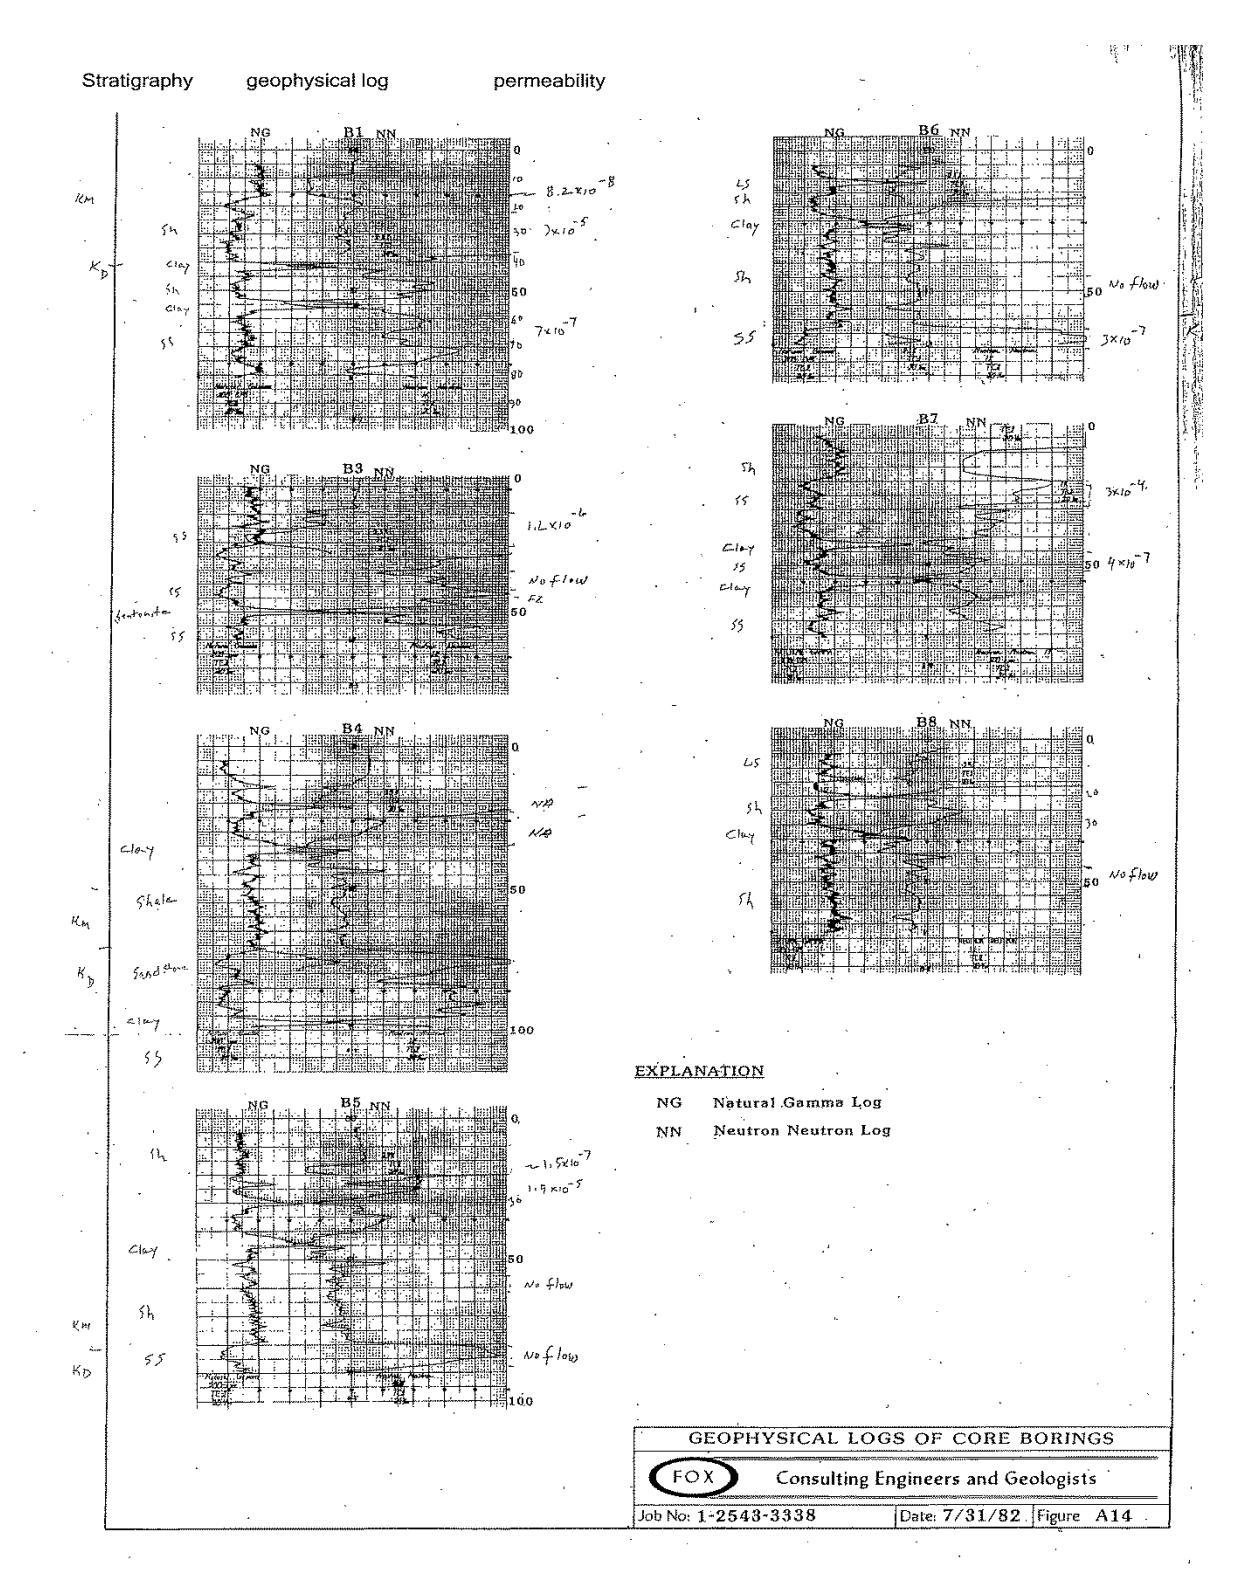
### Figure 7.2

The bore hole descriptions, permeability measurements, and geophysical logging reported by F. M. Fox (1982) (Figure 7.2) on and near the Durita site show a consistent pattern of very low hydraulic conductivity in the shale above the Mancos/Dakota contact. Several of the measured conductivities were below measurable flow. This zone acts to physically and chemically isolate water flowing in the upper Dakota and basal Mancos formations from surface waters at the Durita site. There is a clay layer directly above this lower shale consistent in the geophysical measurements that are described as bentonite in the lithologic description for borehole B3.

The drilling logs for monitor well MW-8 through MW-14 show the un-weathered Mancos Shale to be dry between units A and C. The geophysical logs, Figure 7.2, reported by F. M. Fox (1982) show a distinct basal Mancos Shale signature above the Dakota Sandstone. This basal shale feature is topped with a bentonite clay layer about three to four feet thick. Three in-hole conductivity tests were performed in this basal shale. No measurable conductivity was reported for the measurements conducted in boreholes B-5, B-6, and B-8. These are boreholes on or close to the Durita site.

Stratigraphy and measured permeability plotted against the natural gamma and neutronneutron geophysical measurements. From Fox 1982.

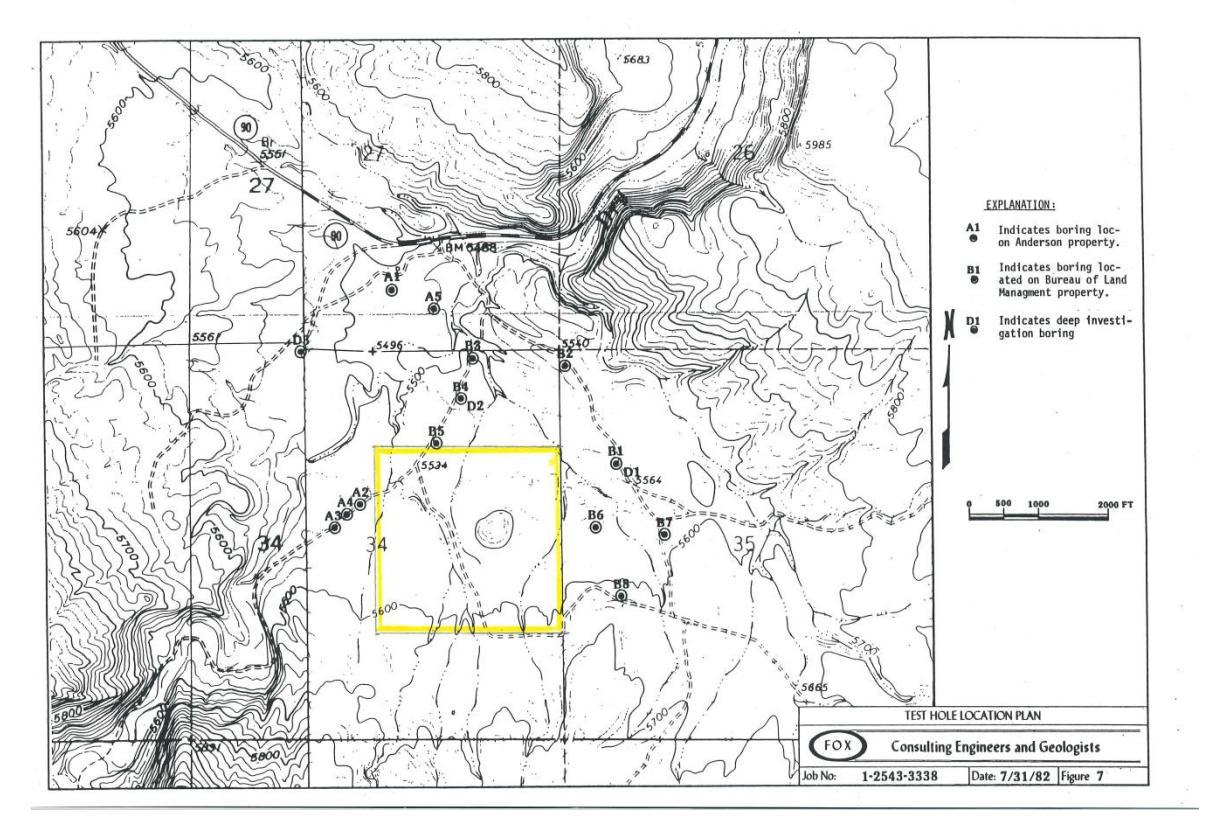
depth than the other measured boreholes. Borehole locations are shown in Figure 7.4.

Figure 7.4 Test hole location map from Fox 1982. The Durita site is outlined in yellow.

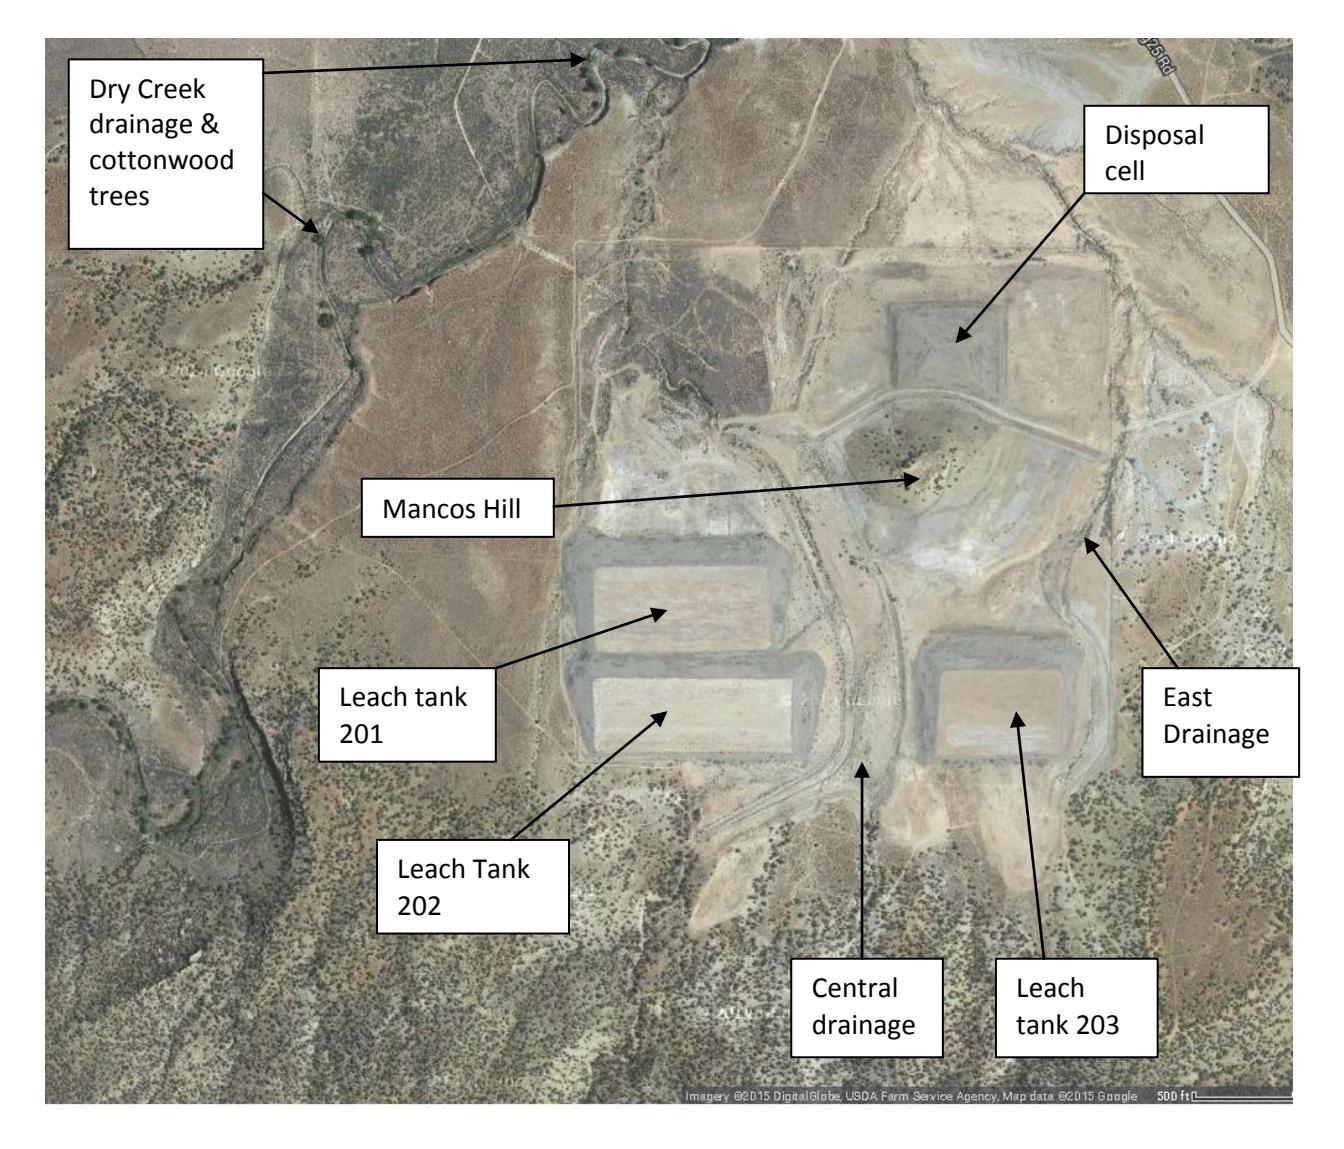
There is no perennial surface water at the site. Ephemeral water flow is associated with precipitation and drains to the north. Natural drainages on the site have been modified to protect the disposal areas. Some areas of Dry Creek west of the Durita site show evidence of continuous near-surface water saturation by the presence of phreatophytes. Figure 7.5 shows the drainage and the location of some cottonwood trees.

Ground water at the site occurs continuously at, or near, the base of the Mancos Shale and into the Dakota Sandstone. The source of the water is infiltration of precipitation and runoff into the surface exposures south of the Durita site and on the slopes of Naturita Ridge. The exposed re-charge area is on the southern limb of the Coke Oven Syncline. Water in the Dakota Sandstone moves north, and down dip, under the site. It is covered by the aquitard/aquiclude of the Unit B Mancos Shale and thus becomes a confined aquifer under the Durita site. Figure 7.1 shows a cross-section across the site. Figure 7.2 shows the geophysical logs and permeability measurements made during this investigation. Figure 7.3 shows the shallow aquitard contours; Figure 7.4 shows the test hole location map where soil borings were installed by F. M. Fox (1982) Figure 7.5 shows a satellite photograph of the Durita site with major features labeled.

Figure 7.5 Satellite image of the Durita site area with major features identified.
