FINAL COMPLETION REVIEW REPORT

**For the Hecla Mining Company Durita Facility
Montrose County, Colorado**

Colorado Radioactive Materials License No. 317-02

March 2, 2016

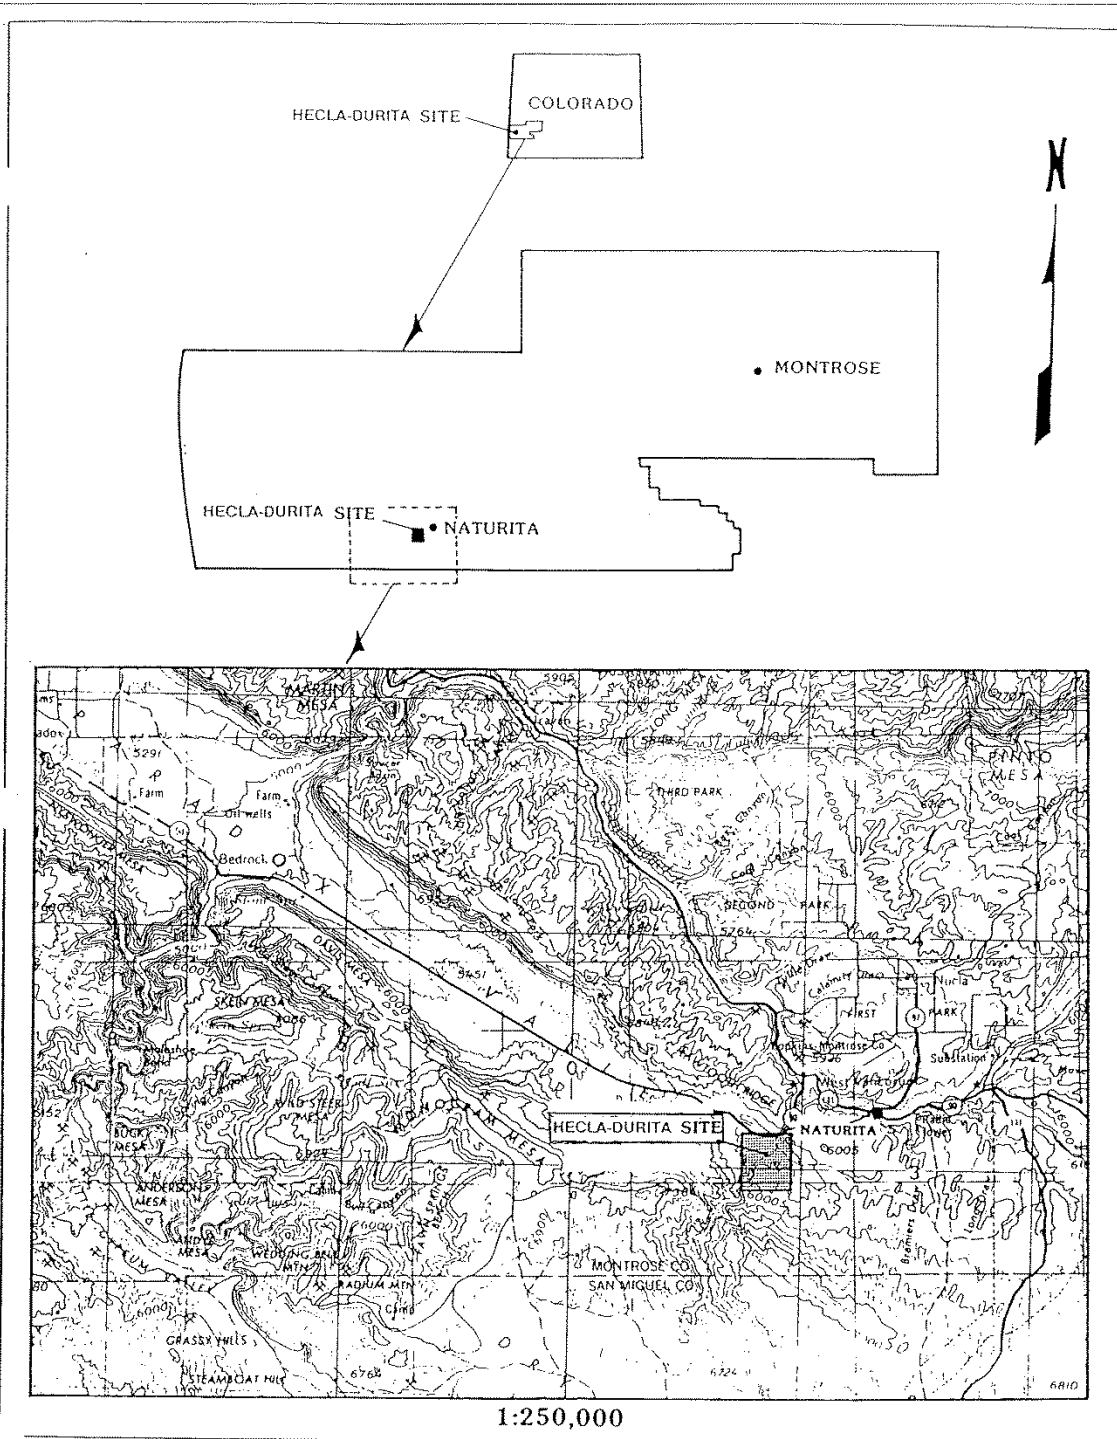
FIGURE 1
SITE LOCATION MAP DURITA SITE

The site encompasses 160 acres and is located on gently north-sloping terrain at the southeast end of the Paradox Valley in western Montrose County, approximately 100 miles south of Grand Junction and 2.5 miles west of the town of Naturita, Colo. (Figure 1).

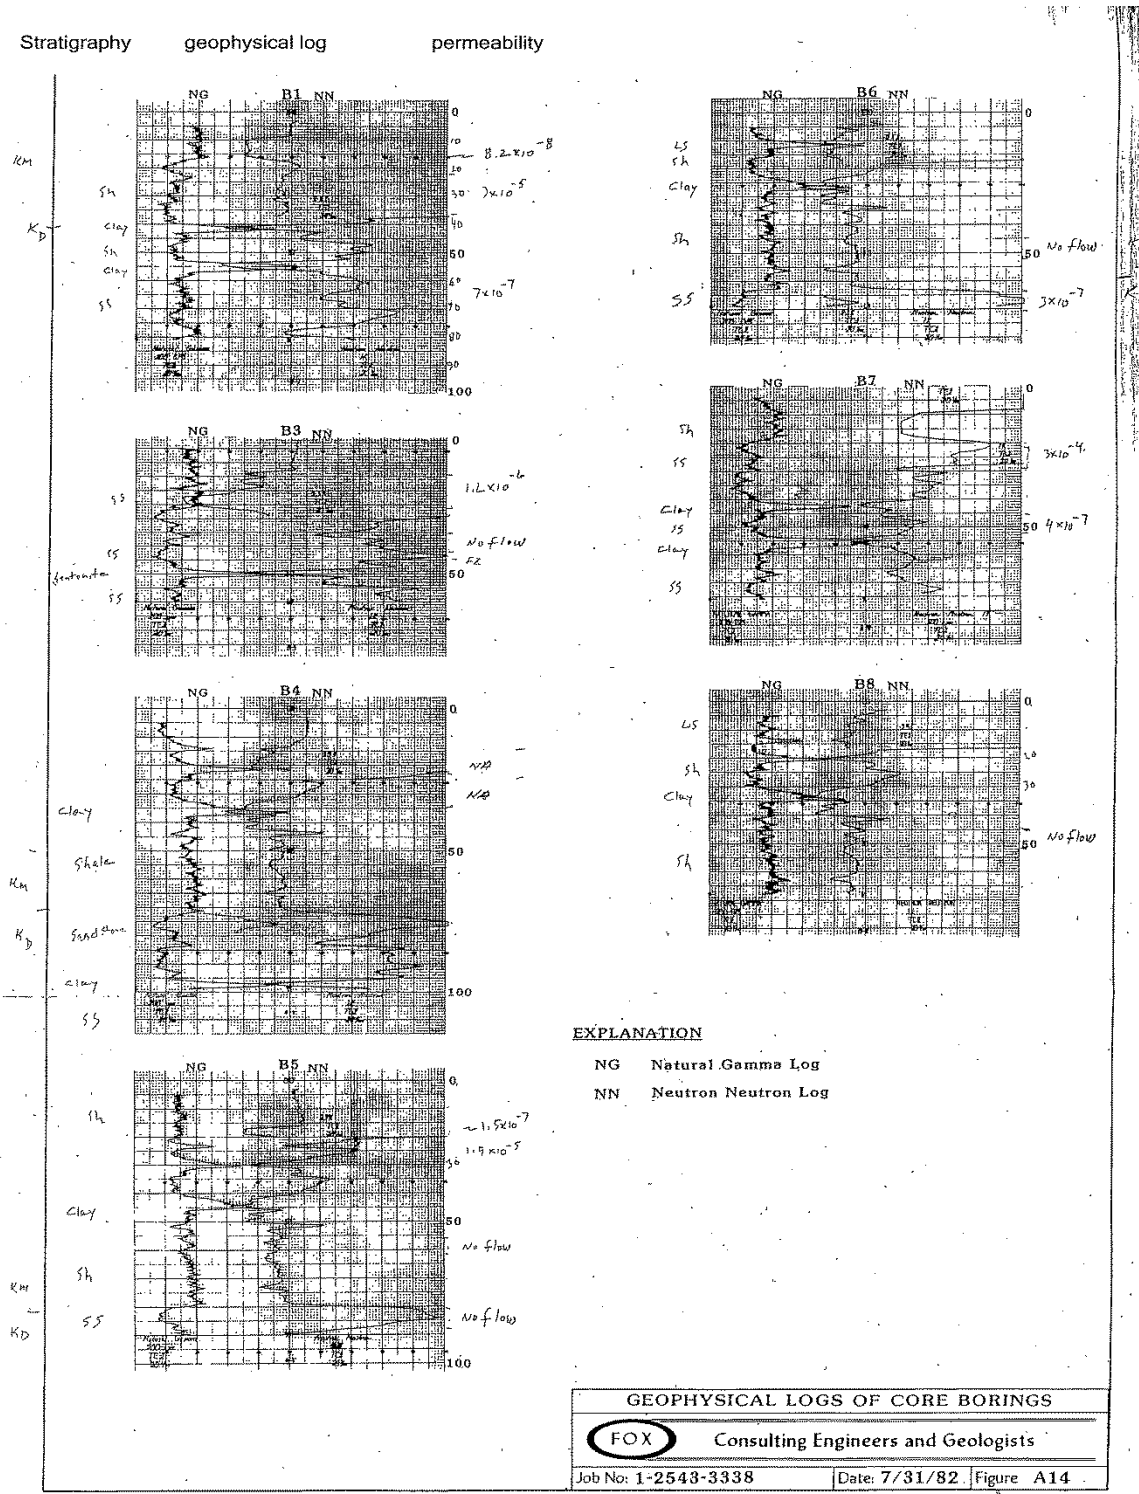
Figure 7.2
 Stratigraphy and measured permeability plotted against the natural gamma and neutron-neutron geophysical measurements. From Fox 1982.

The drilling logs for monitor well MW-8 through MW-14 show the un-weathered Mancos Shale to be dry between units A and C. The geophysical logs, Figure 7.2, reported by F. M. Fox (1982) show a distinct basal Mancos Shale signature above the Dakota Sandstone. This basal shale feature is topped with a bentonite clay layer about 3 feet to 4 feet thick. Three in-hole conductivity tests were performed in this basal shale. No measurable conductivity was reported for the measurements conducted in boreholes B-5, B-6, and B-8. These are boreholes on or close to the Durita site.

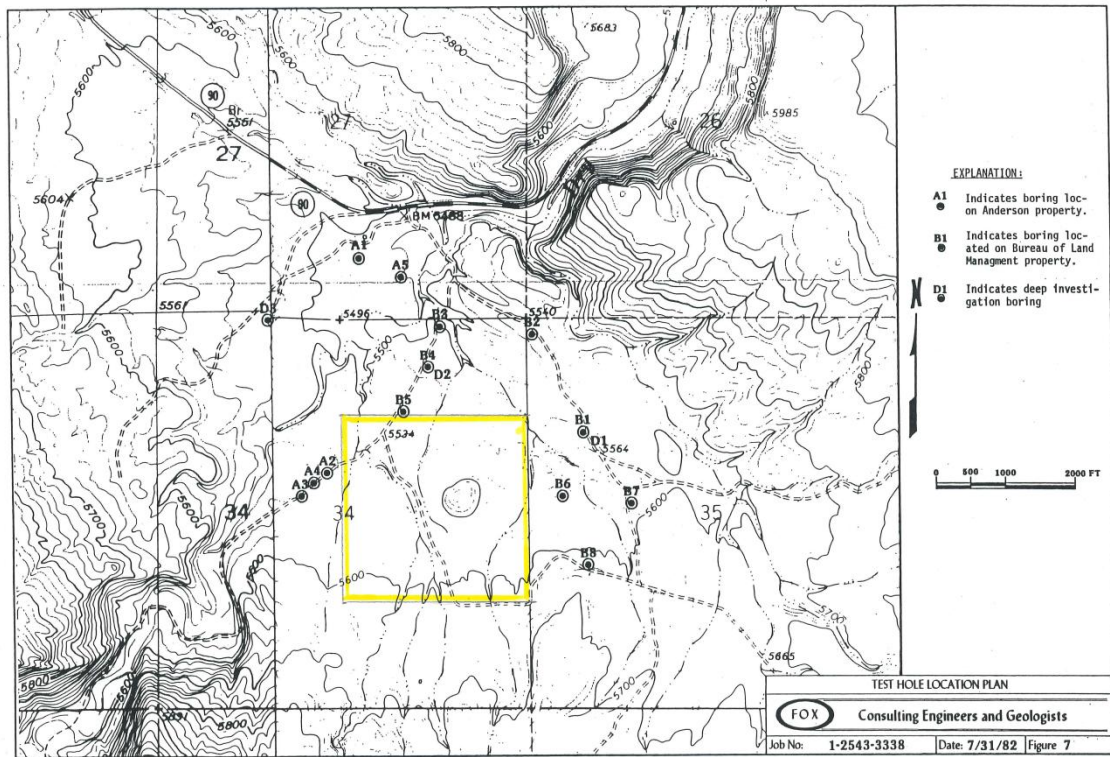
Figure 7.4 Test hole location map from Fox 1982. The Durita site is outlined in yellow.

Two hydraulic conductivity measurements were performed in the basal shale in borehole B-1 with values of 8.2×10^{-8} cm/sec and 3×10^{-5} cm/sec. The drilling log of B-1 indicates that the conductivities were done in an oxidized zone. The basal Mancos Shale is at a shallower depth than the other measured boreholes. Borehole locations are shown in Figure 7.4.

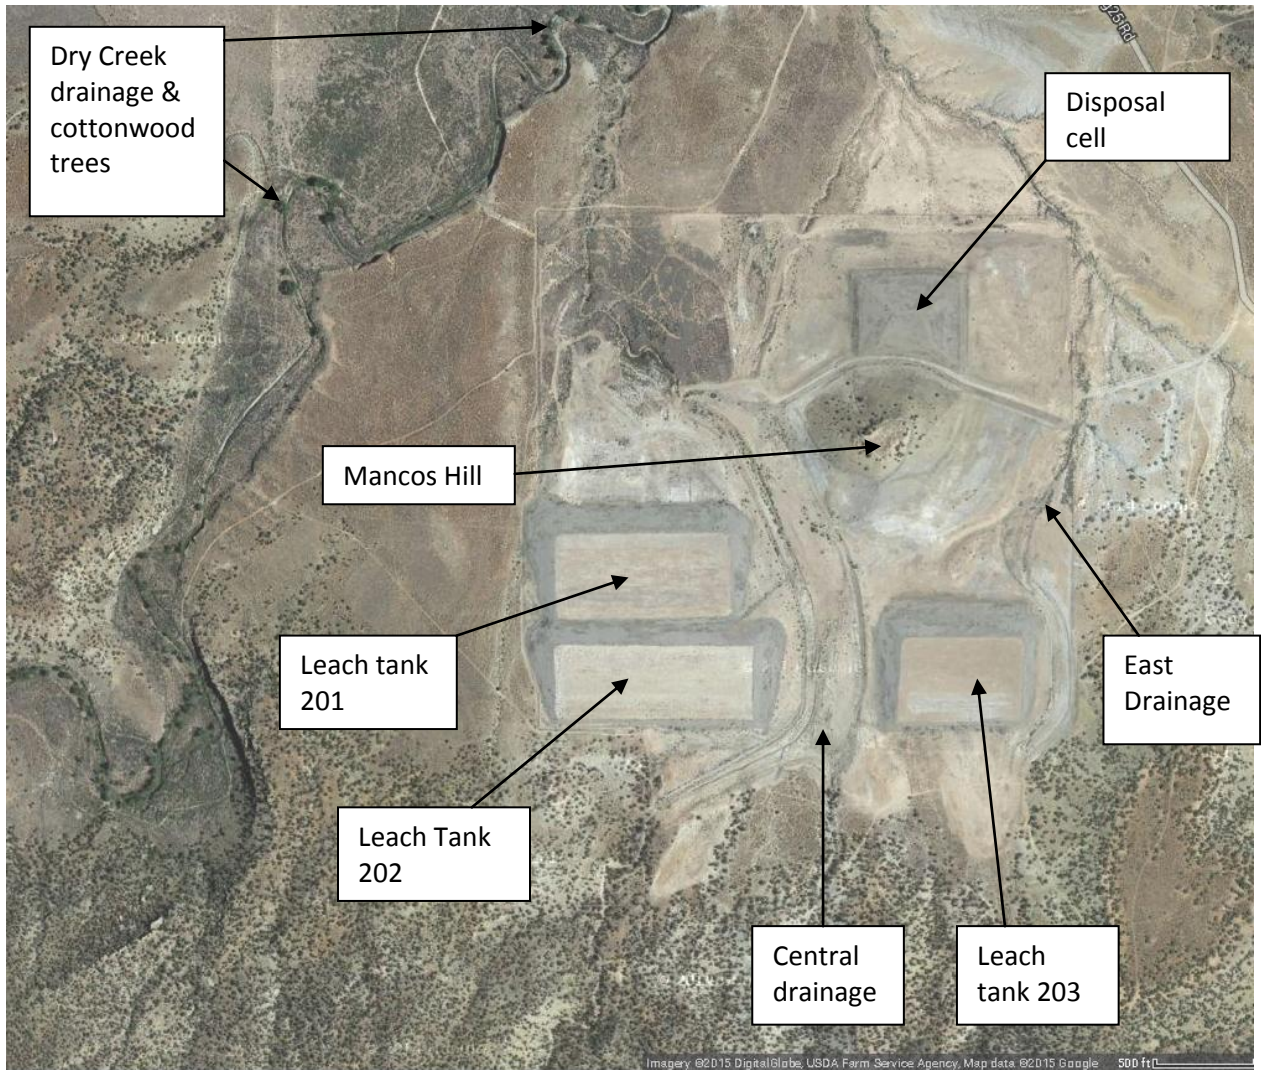
Figure 7.5 Satellite image of the Durita site area with major features identified.

Groundwater at the site occurs continuously at, or near, the base of the Mancos Shale and into the Dakota Sandstone. The source of the water is infiltration of precipitation and runoff into the surface exposures south of the Durita site and on the slopes of Naturita Ridge. The exposed re-charge area is on the southern limb of the Coke Oven Syncline. Water in the Dakota Sandstone moves north, and down dip, under the site. It is covered by the aquitard/aquiclude of the Unit B Mancos Shale and thus becomes a confined aquifer under the Durita site. Figure 7.1 shows a cross-section across the site. Figure 7.2 shows the geophysical logs and permeability measurements made during this investigation. Figure 7.3 shows the shallow aquitard contours; Figure 7.4 shows the test hole location map where soil borings were installed by F. M. Fox (1982) Figure 7.5 shows a satellite photograph of the Durita site with major features labeled.

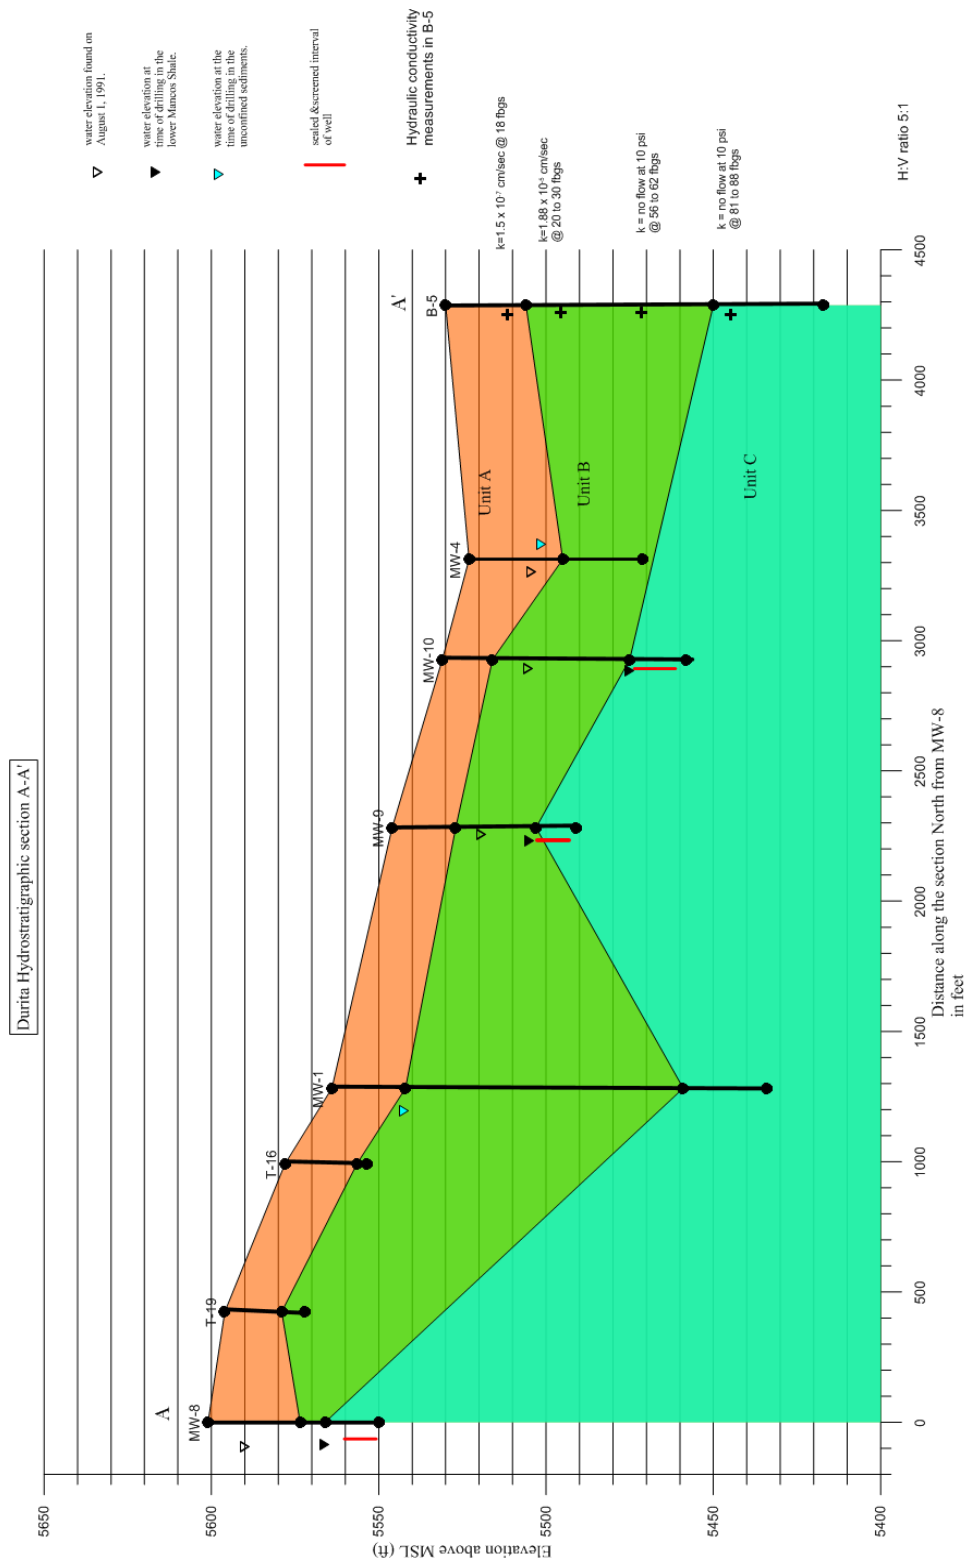
Soil boring descriptions and geophysical logs for boreholes B-1, B-5, and B-6, show a sandstone interval in the upper Dakota Sandstone. There are three measured hydraulic conductivities measured in this section ranging from 3 x 10⁻⁷ cm/sec to no measurable conductivity. Figure 7.6 and Figure 7.7 show the hydrostratigraphic section from south to north across the Durita site showing well screen intervals and

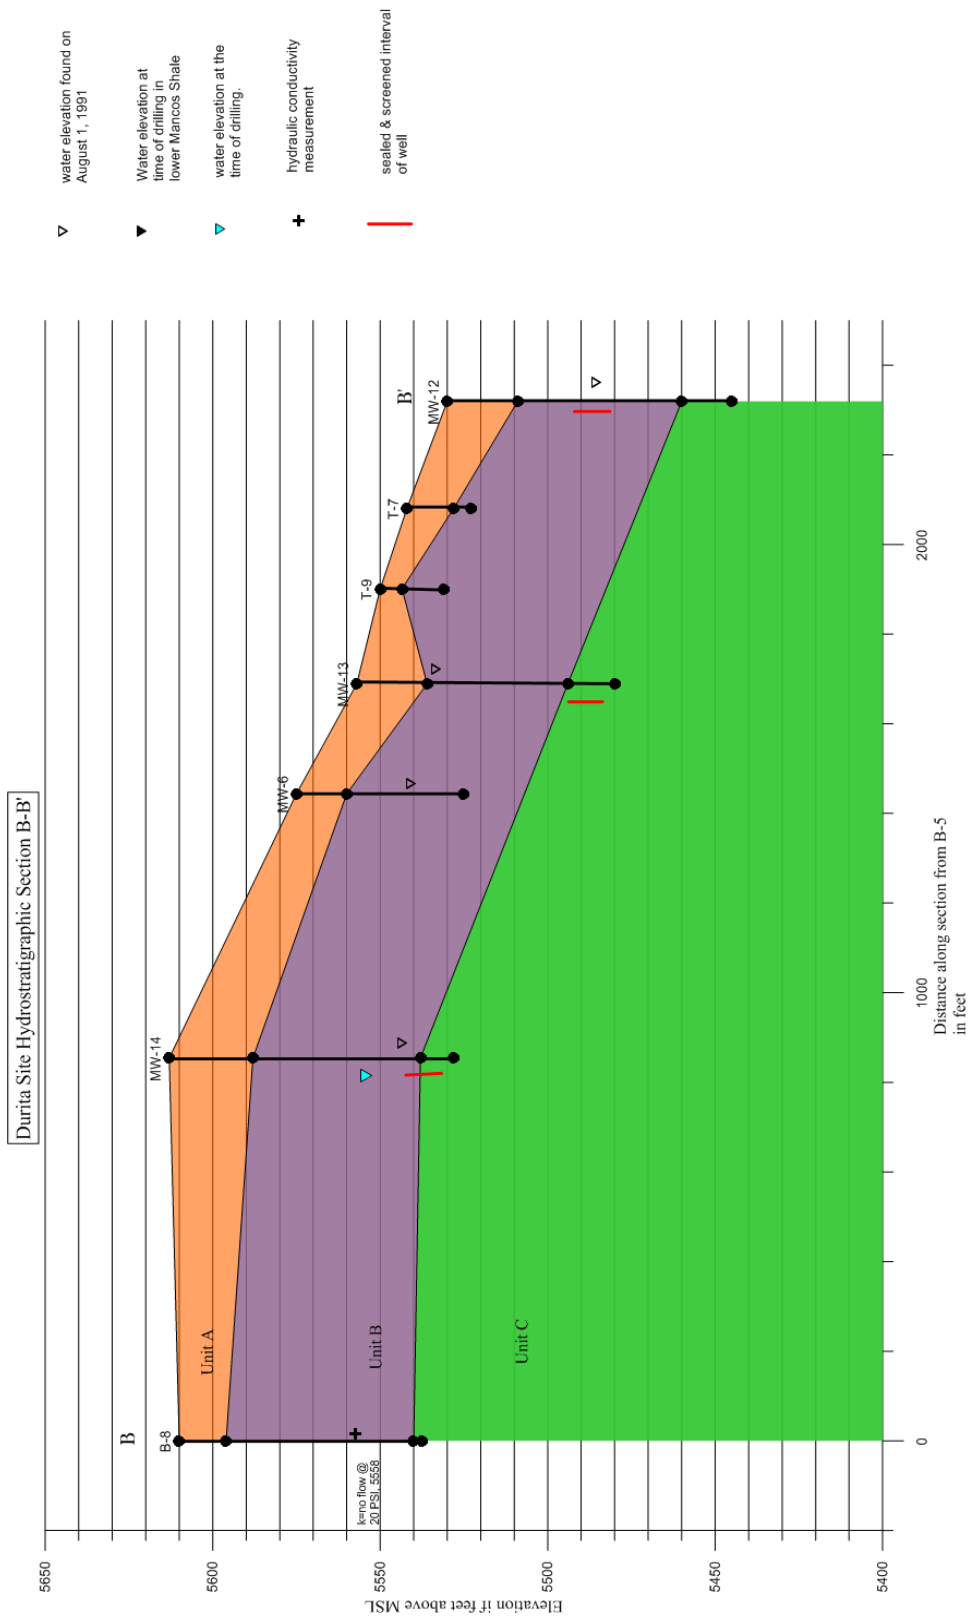
Most wells drilled into the lower saturated interval show a groundwater potential higher than the elevation of the saturated section. MW-12 shows that the first saturated interval it penetrates has a free-air potential and is not confined. The first saturated interval in MW-12 is a 1-foot thick sand within the Mancos Shale at 20 feet below ground surface (bgs). The drilling log does not indicate that any separate lower saturated interval was encountered. Groundwater elevations taken between 1991 and 1998 in MW-12 appear to show a seasonal rise in water elevation in the second quarter of the year. It happened in four of six years when measurements were made. This seasonal rise may indicate evidence from MW-12 of a connection between a saturated sandstone interval and the surface. This connection, if it exists, appears related to the unnamed drainage along the east side of the site. However, the chemical analyses of water from MW-12 shows high levels of total dissolved solids (TDS) and dissolved sulfate consistent with the monitor wells known to be confined. It is also consistent within the range of natural sulfate and TDS found in the Mancos Shale as per DOE, (2011). The concentrations are among the highest on the site. This is inconsistent with recharge of fresh water from the surface. Please refer to Figure 7.7 for a hydrostratigraphic section along the east side of the Durita site.

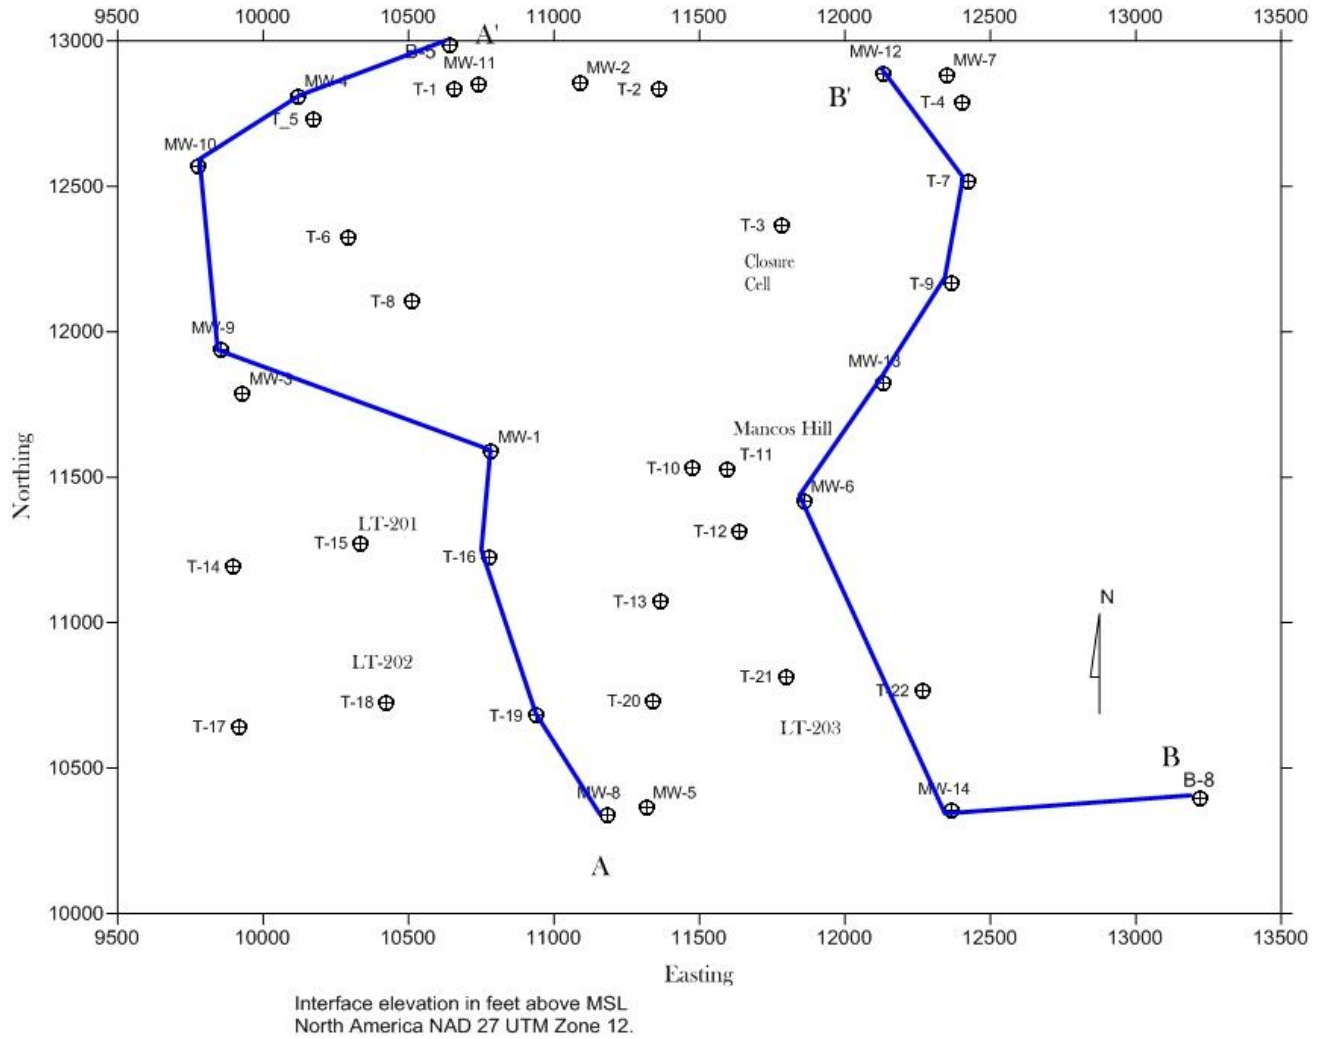
static water heads. Figure 7.8 shows the locations of the wells and boring shown in Figures 7.6 and 7.7.
