WCAP-9663

METALLURGICAL INVESTIGATION OF CRACKS
IN THE PRESSURIZER NOZZLE-TO-SAFE-END
WELD OF THE ROBERT EMMETT GINNA
NUCLEAR POWER GENERATING STATION

February 1980

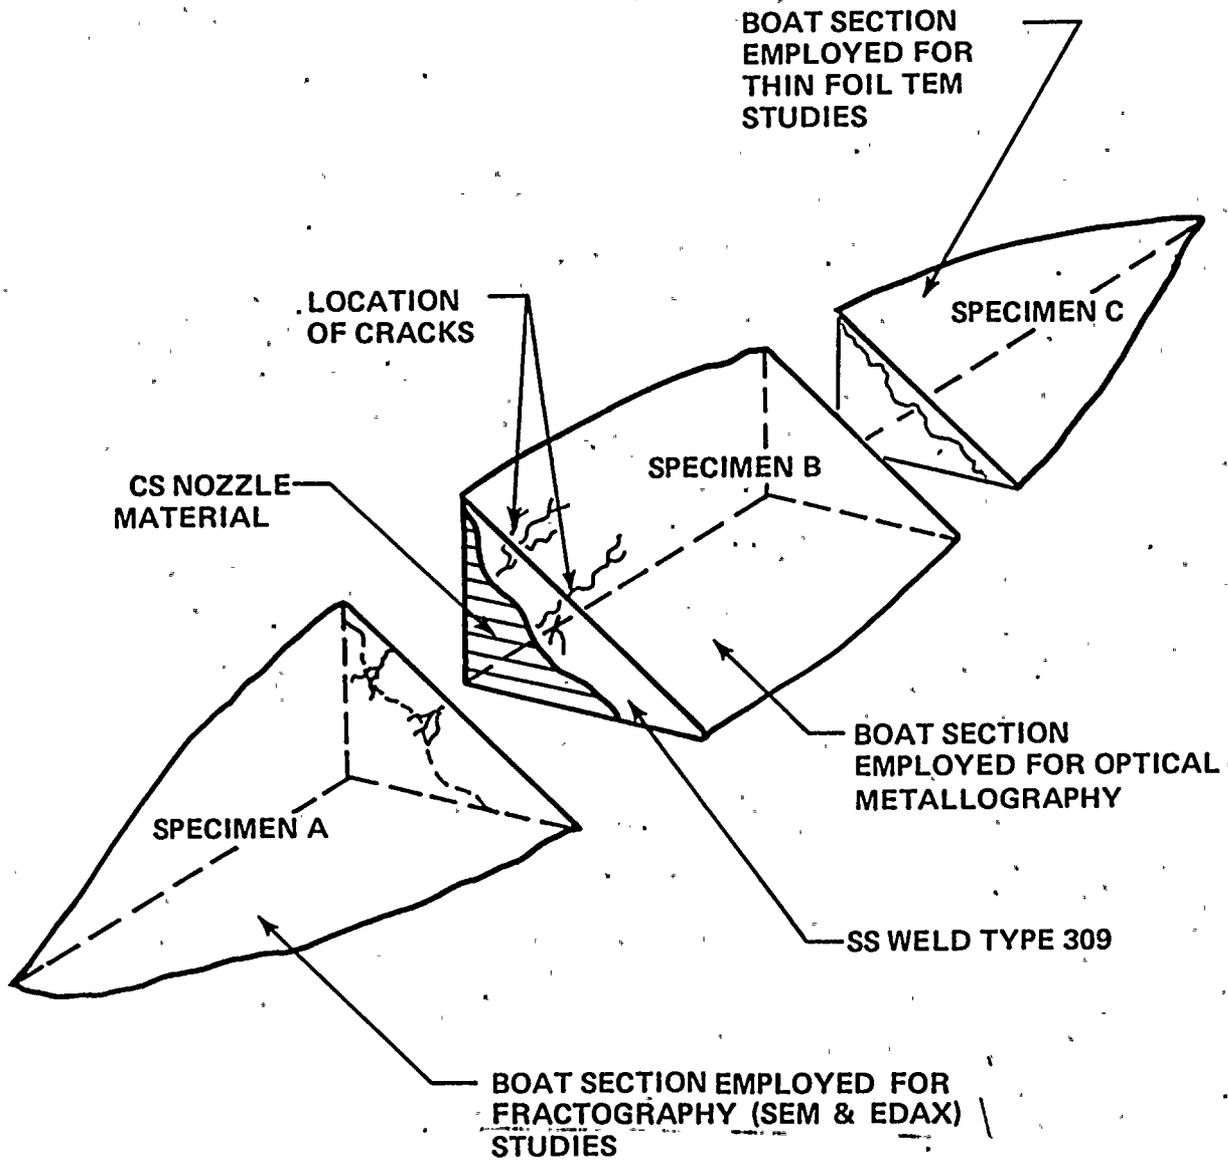
The boat sample was first surface polished and carefully examined by light microscopy prior to its sectioning in order to establish the location and distribution of cracks. The boat was then sectioned at two selected locations to produce three specimens designated as A, B, and C which were employed for various aspects of metallurgical investigation as illustrated in figure 2-1. The first cut was taken through the region containing the largest population of surface cracks so that an accurate assessment of morphology and distribution of cracks could be made from the resulting sections. The corresponding specimens A and B were employed respectively for fractographic and optical metallographic studies of the cracks. The specimen C, resulting from a second cut of the boat sample, contained essentially no cracks and was employed exclusively for the preparation of thin foil specimens of the weld metal for fine structure studies by transmission electron microscopy.

Figure 2-1. Schematic of Sectioned Boat Sample Employed for Various Aspects of Metallurgical Investigation
