Rochester Gas & Electric Corporation
R. E. Ginna Nuclear Power Plant

GINNA STATION

ENFORCEMENT CONFERENCE

Inspection Report 93-08

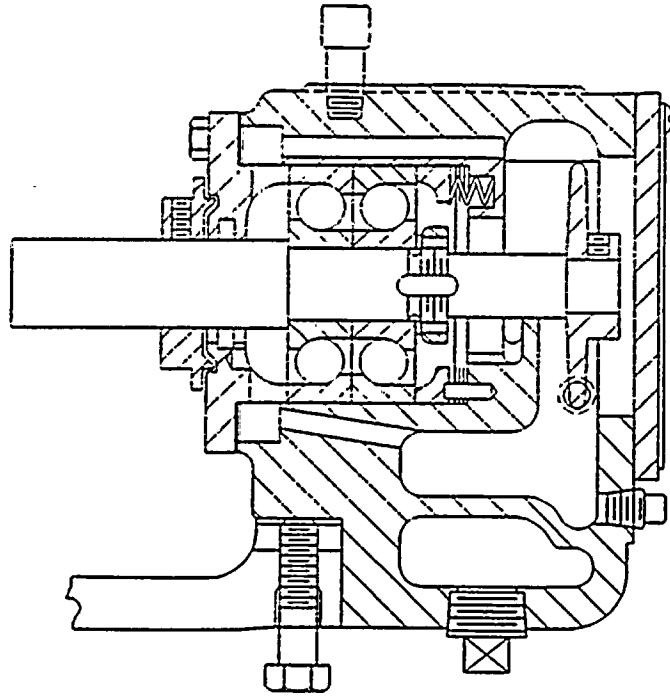
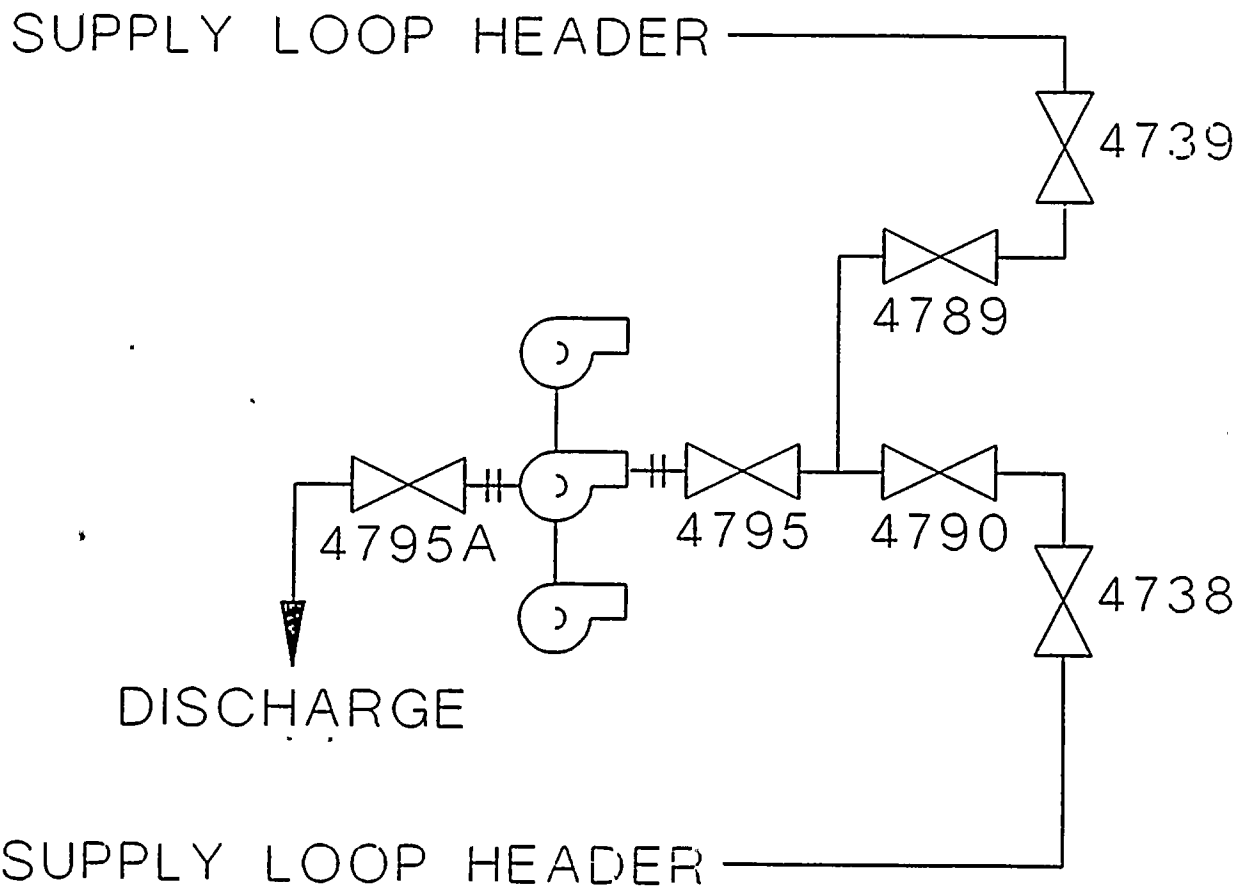
SAFETY INJECTION PUMP THRUST BEARING COOLING

- All SIP Bearings Clean
 - Flow Present
-
- Evaluation Remained Valid
 - No Change in Program Direction
