DESIGN ENGINEERING REPORT

WNP-2 FEEDWATER PIPING THERMAL DEFLECTION EVENTS

Washington Public Power Supply System Nuclear Plant No. 2

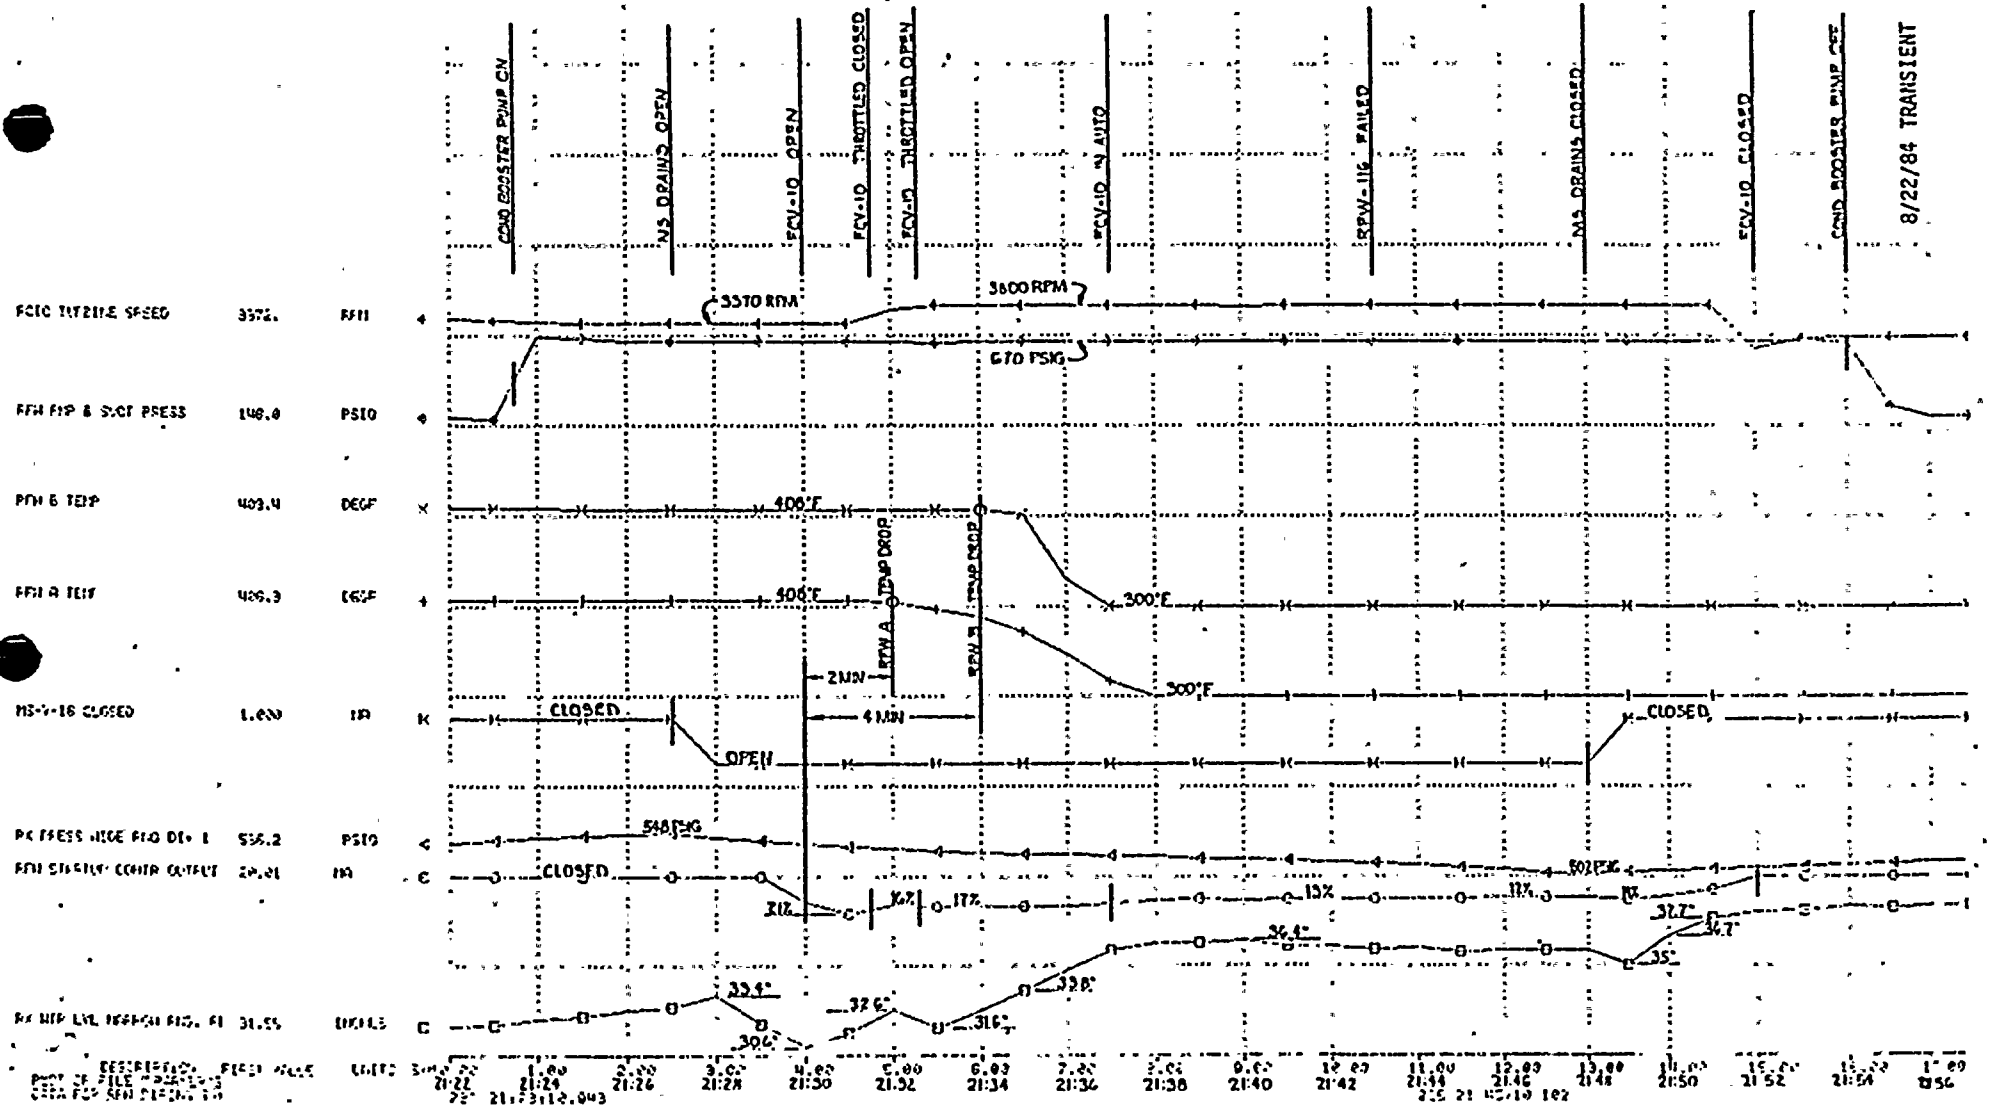
FIGURE 4

The following summarizes significant events leading up to and following the failure of several feedwater piping supports on Wednesday, August 22, 1984. The plant had previously been operating at about 60% power and was shutdown during testing. Attempts to restart were delayed pending resolution of high conductivity in the condensate system. For approximately five days the reactor was held in hot standby (approximately 1% power) with RWCU being returned to the vessel via the RFW piping. The condensate and RFW systems were completely shutdown. Refer to Figure 4 for graphic representation of pertinent data.

21:45*	Hanger RFW-116 pulled from the ceiling, hanger RFW-114 attachment welds failed, and hanger RFW-112 was observed buckled.
	21:48*	Flanges on the flow straightening sections began leaking. (3 of 4 sets)
