SUBJECT: Forwards Rev 0 to "Rept on Steam Generator Tube Leak at Unit 1," per 870220 request. Rept provides requested info for Units 1 & 2 & discussion of alternatives considered for Unit 3.

Subject: Palo Verde Nuclear Generating Station (PVNGS)
Units 1, 2 and 3
Docket Numbers: STN 50-528 (License No. NPF-41)
STN 50-529 (License No. NPF-51)
STN 50-530
Report on the PVNGS Steam Generators
File: 87-E-056-026; 87-F-056-026

TUBE LEAK AT PVNGS UNIT 1

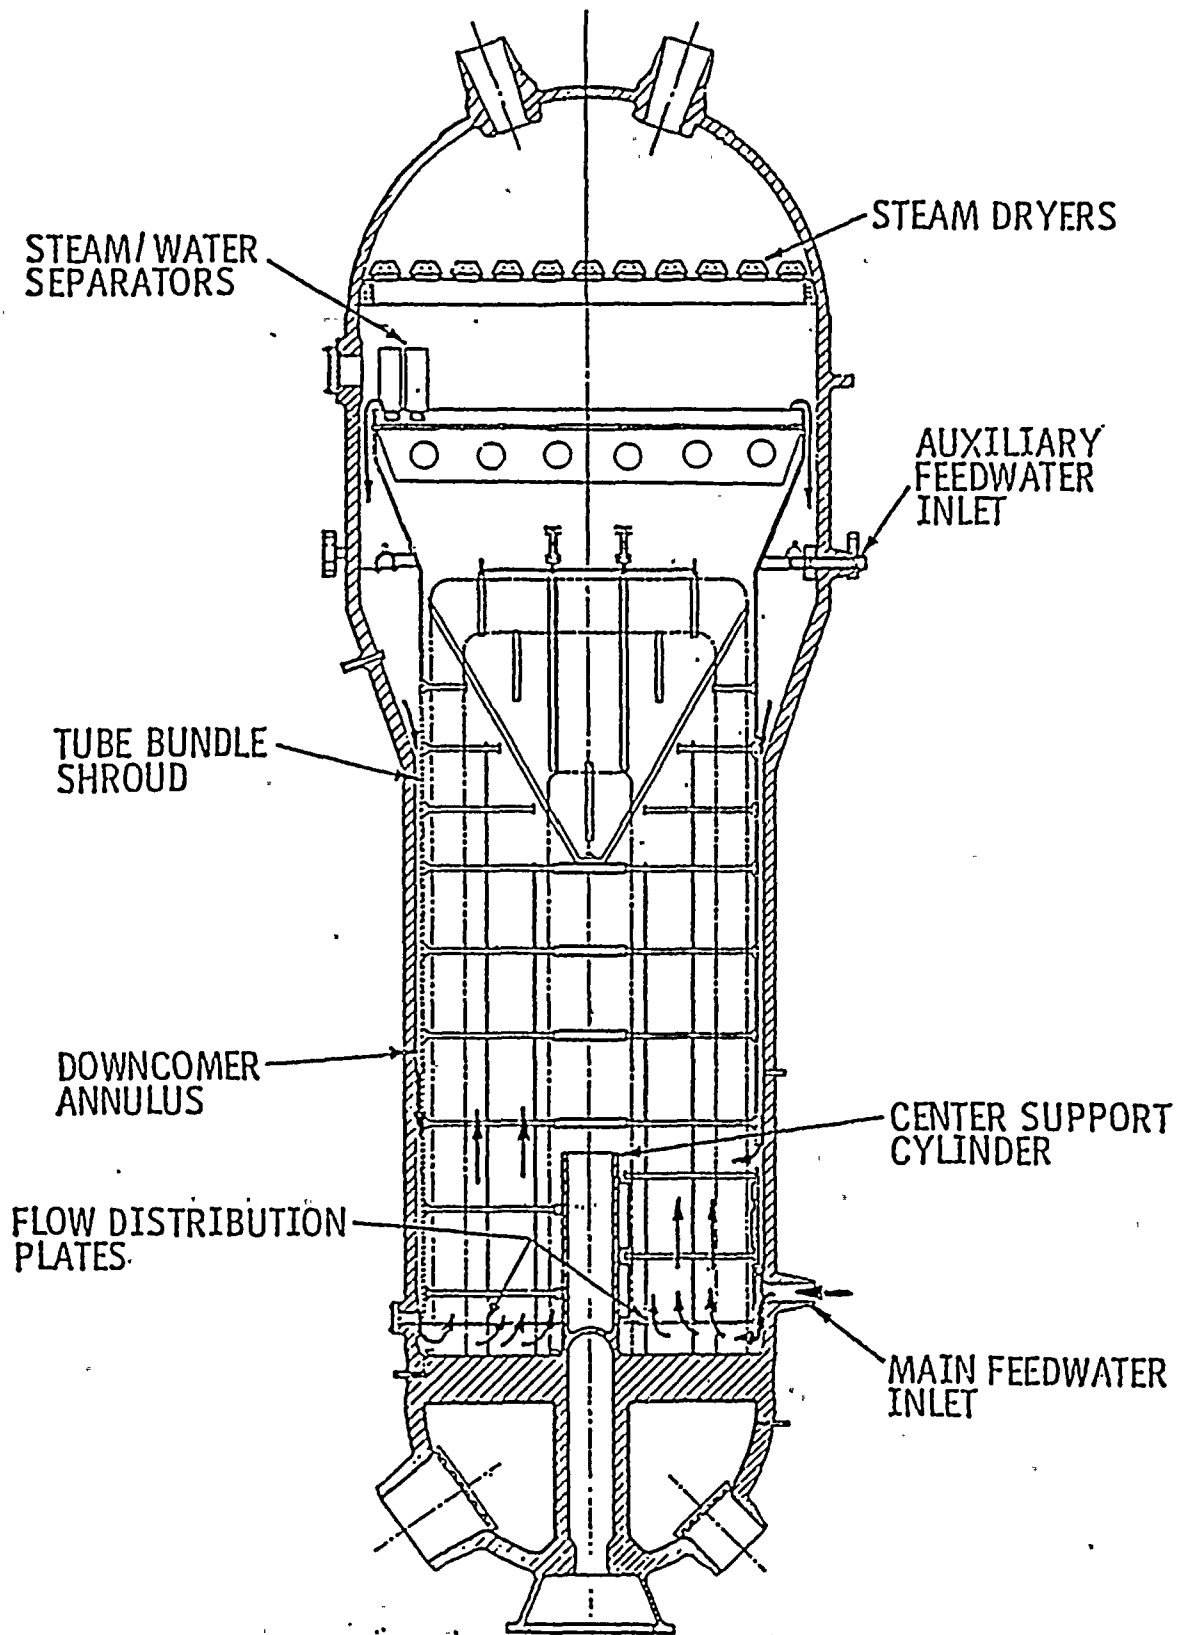
Figure 1

The System 80 steam generators (Figure 1) are of the recirculating U-tube design. The tube supports employ the CE eggcrate design which provides maximum open flow area. The major difference between the System 80 steam generators and earlier CE steam generators is the incorporation of an integral economizer (Figure 2). The economizer uses the lower portion of the cold leg half of the tube bundle to preheat incoming feedwater to saturation conditions, resulting in a more efficient heat transfer process.

INTEGRAL ECONOMIZER STEAM GENERATOR

AXIAL FLOW

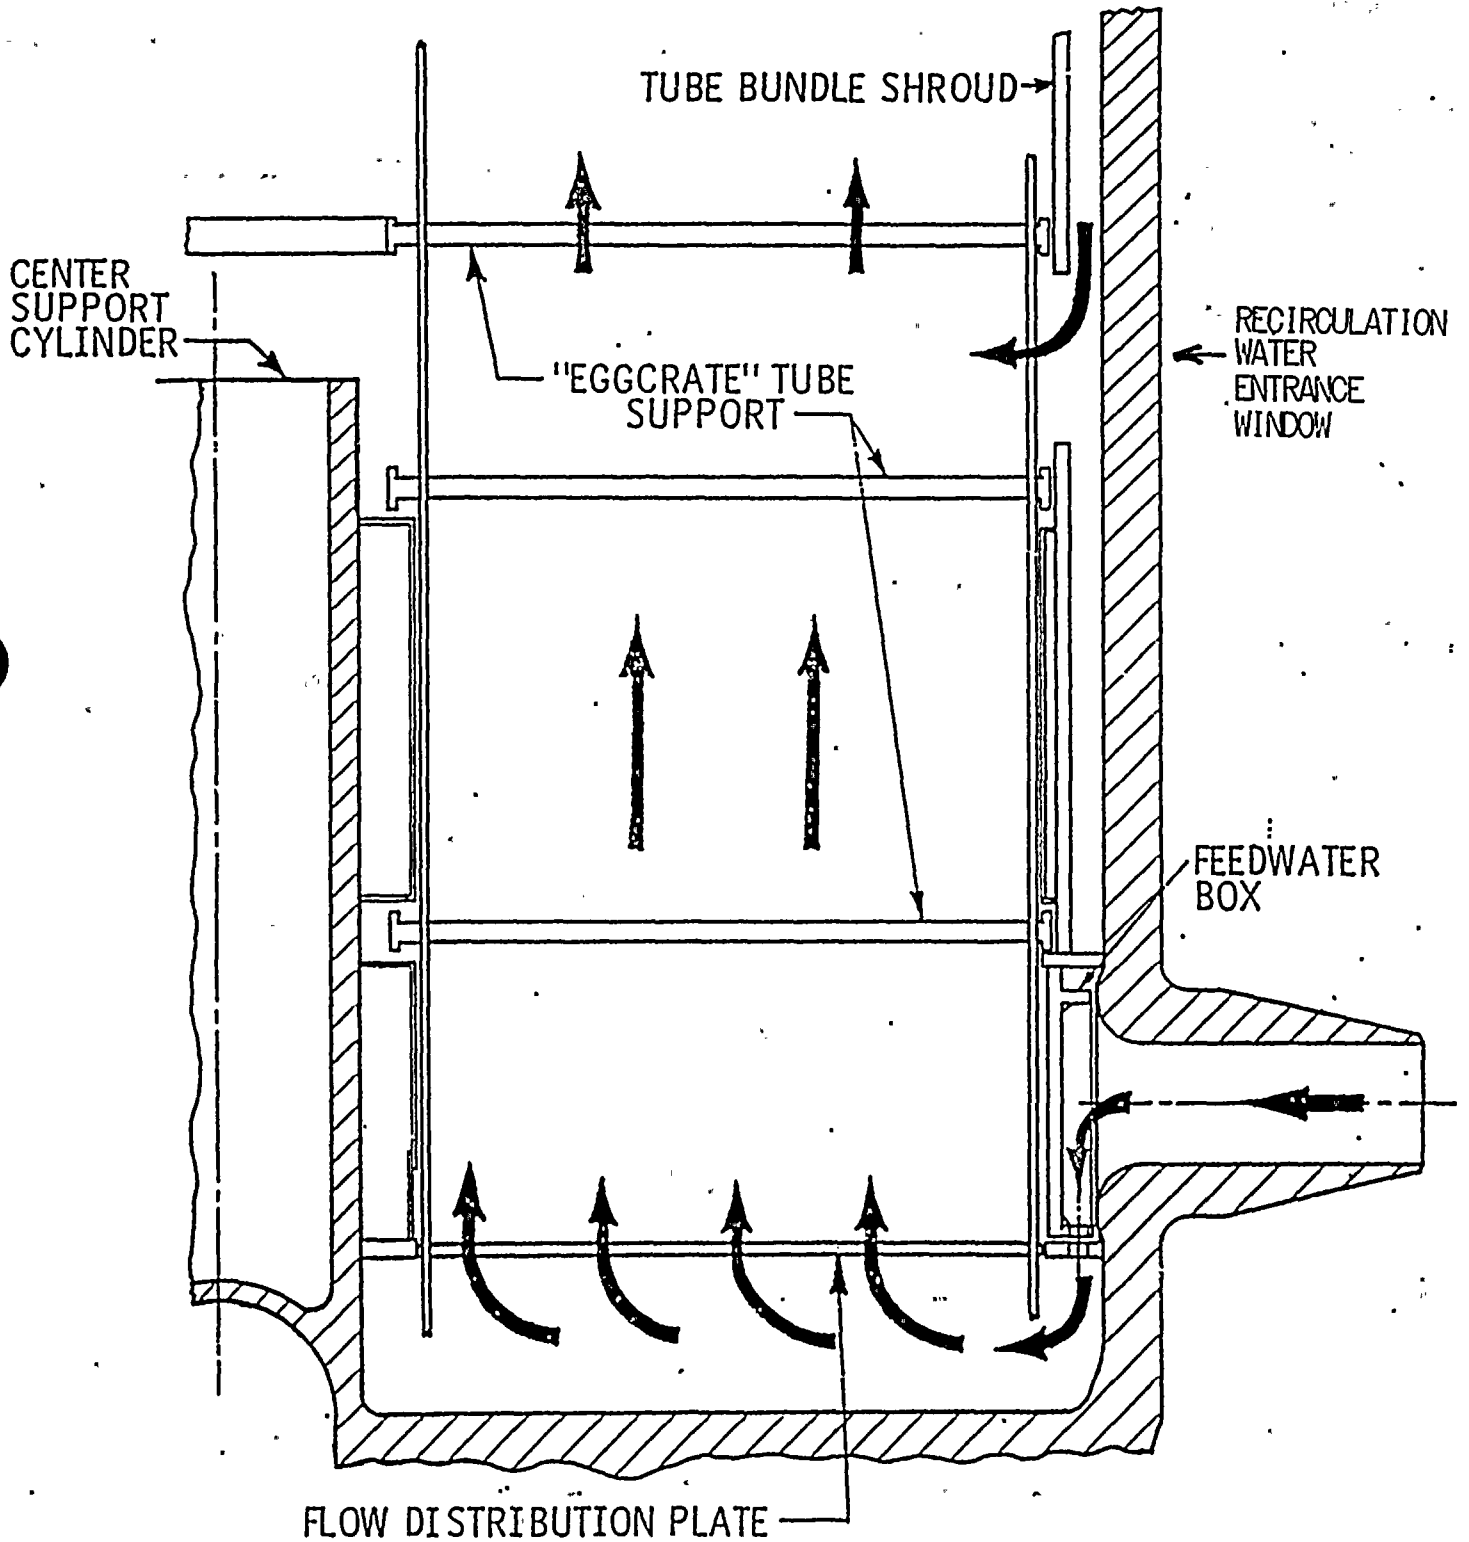
Figure 2

At the top of the economizer section (economizer section extends to the top of the divider plate as shown in Figure 4), the saturated feedwater from the economizer section mixes with recirculating water introduced through a 16-inch entrance window extending 180° around the cold leg side half-circumference (Figure 2).

ECONOMIZER ELEVATION VIEW

In the CE System 80 steam generators (Figure 1), the downcomer recirculating flow enters the cold leg side tube bundle above the integral economizer between the second and third tube supports (Figure 2). At the intersection of the recirculating water entrance window and the tube lane, a unique condition exists wherein the downcomer recirculating water can preferentially seek the low flow resistance open tube lane (Figure 17). This results in high local radial cross flow velocities. These velocities are believed to be of sufficient magnitude to cause tubes along the tube lane near the recirculating water entrance window to vibrate within the eggcrate supports, resulting in the observed tube wear.

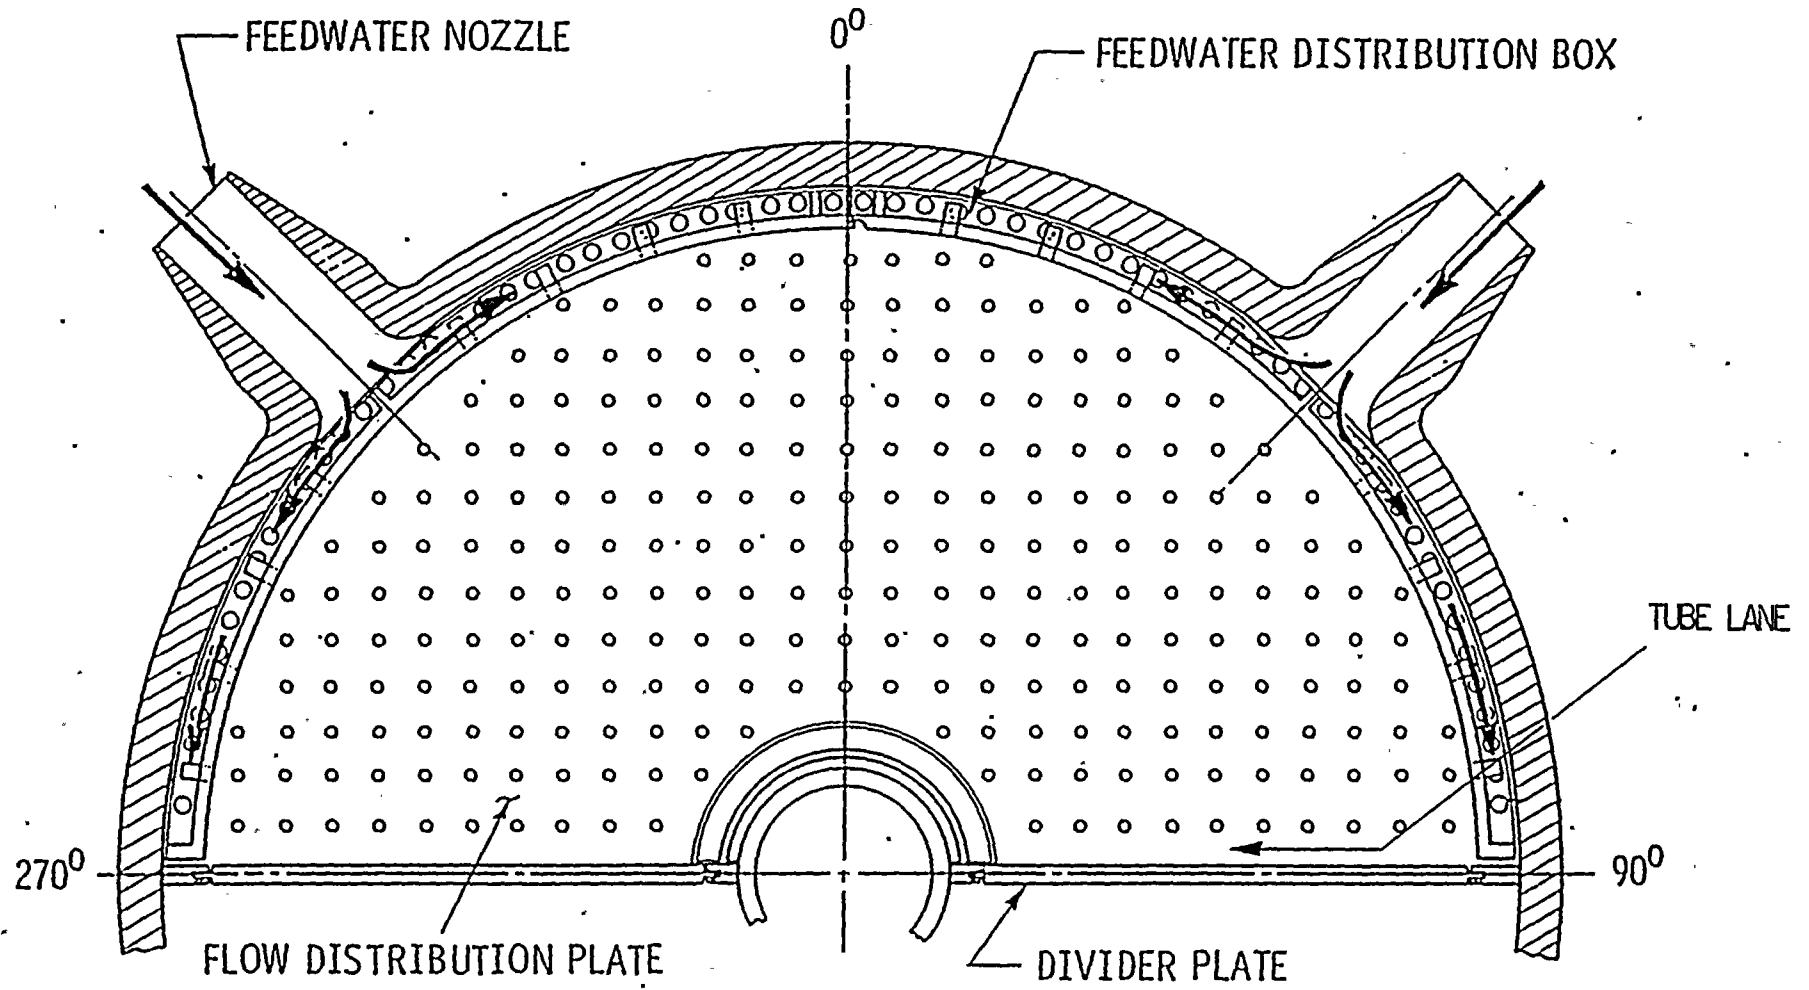
Figure 3.

The integral economizer is an axial flow design. Feedwater is introduced into a water box (Figure 3) that forms a half-ring around the cold leg side of the tube bundle. Discharging uniformly around the half-circumference through ports in the bottom of the water box, feedwater flows radially inward across the tube sheet beneath the flow distribution plate. The flow distribution plate is designed to achieve uniform axial mass velocity over the cross section of the economizer.

ECONOMIZER PLAN VIEW

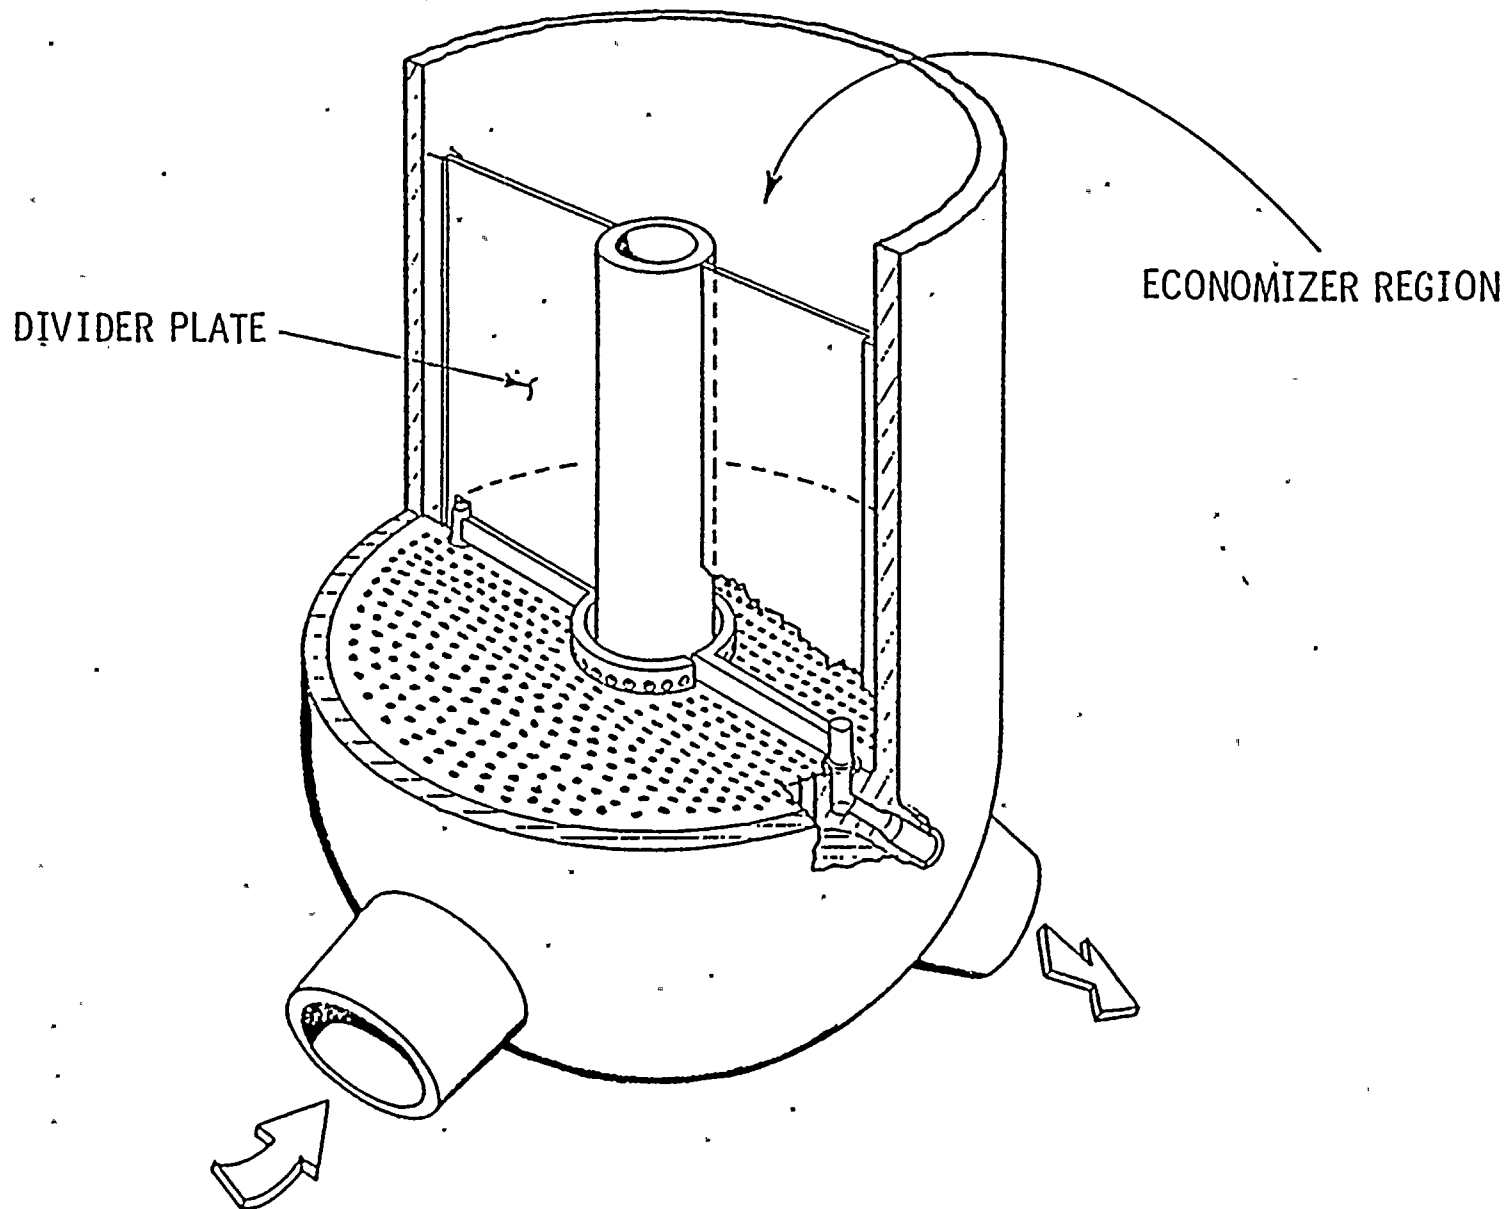
Figure 4

The economizer is formed by mounting a 2-5/8 inch thick divider plate in the tube lane (Figure 3) between the hot and cold leg sides of the tube bundle (Figure 4). The divider plate is attached to the steam generator shell and the center support cylinder and extends up past the third tube support. The divider plate completely isolates the cold and hot leg sides in the lower portion of the steam generator.

ECONOMIZER REGION

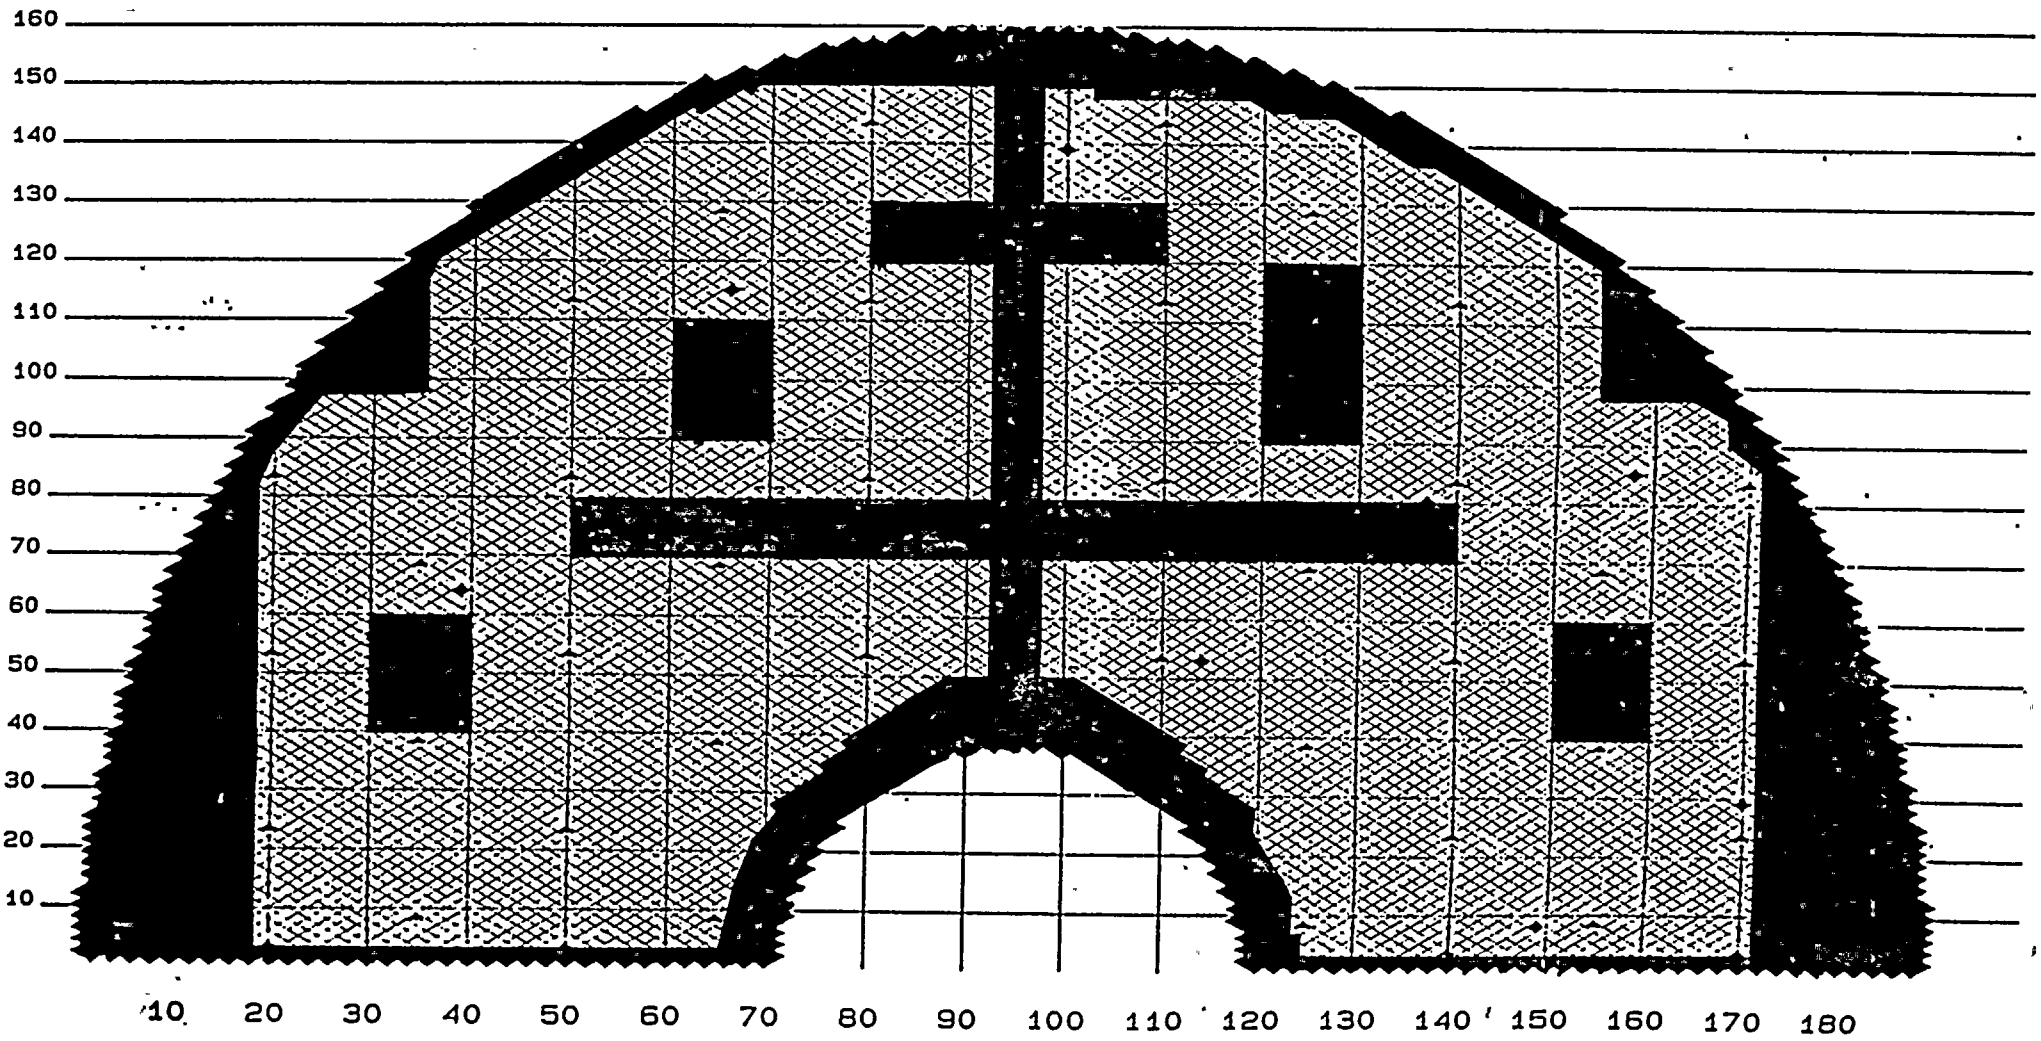
Figure 5

to increase the inspection scope to include additional tubes in the cold leg corner regions. The final Unit 1 inspection pattern is indicated by the shaded regions of Figure 5.

Steam Generator Inspection Pattern
For Unit 1 (Shaded Regions)

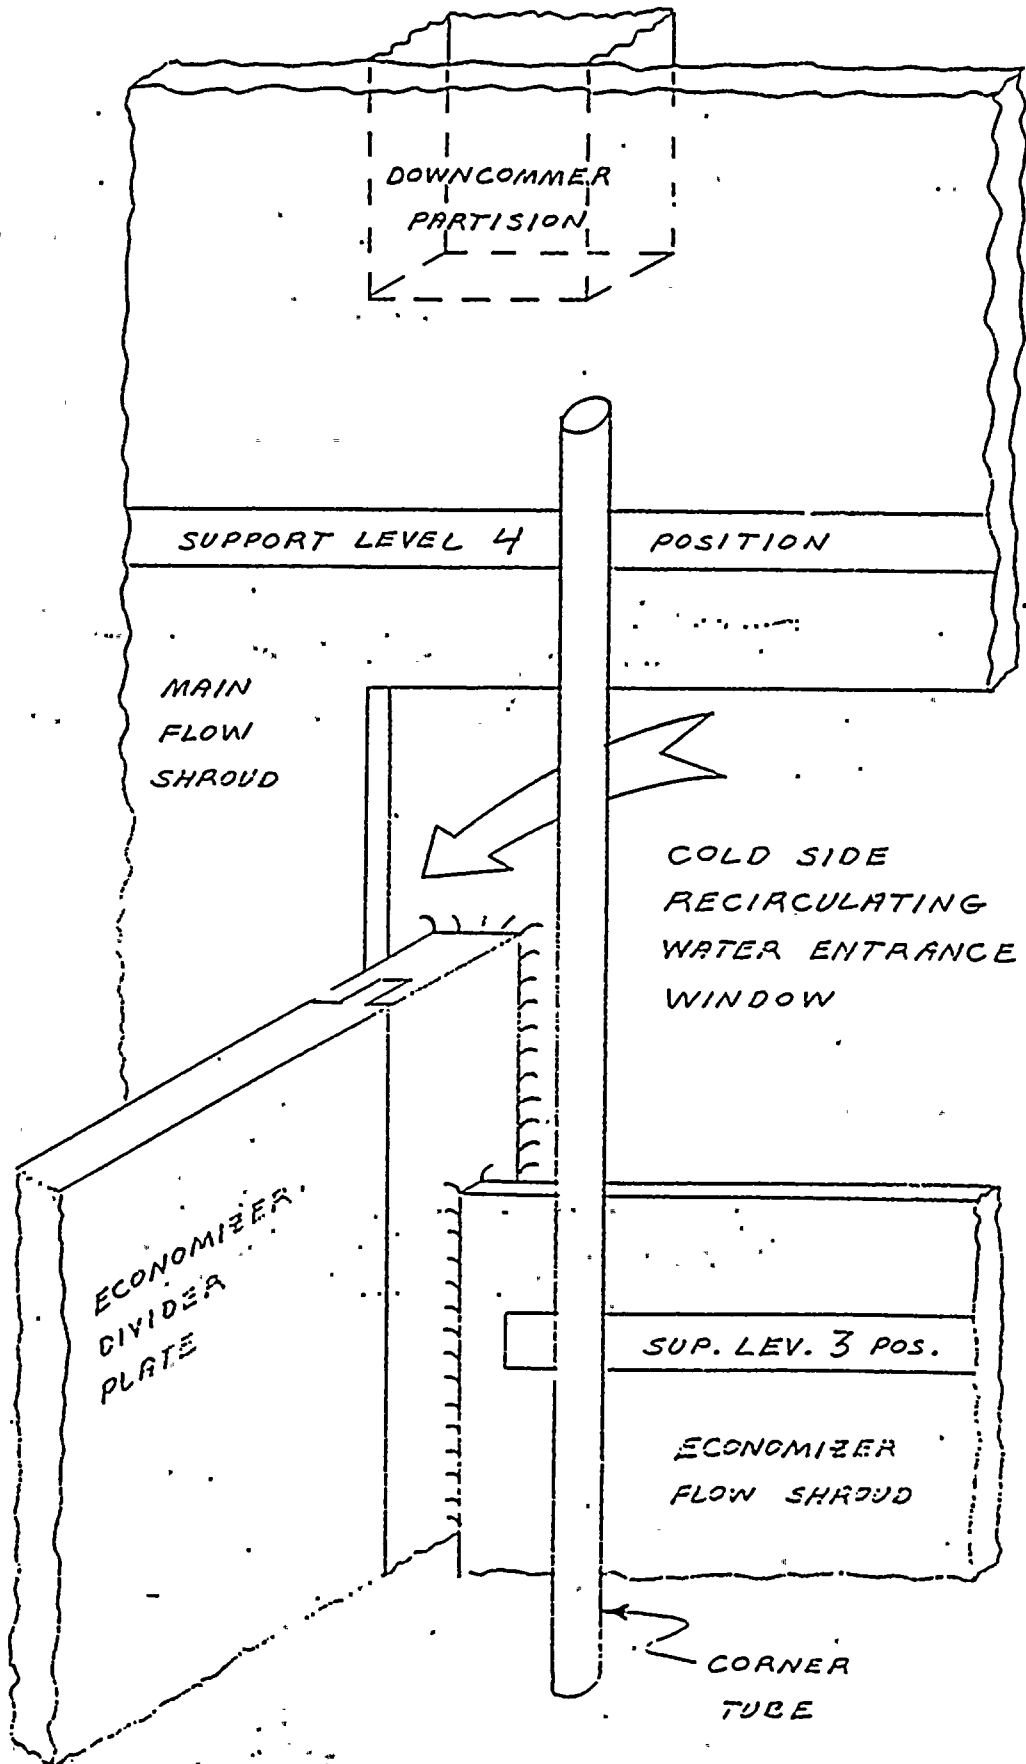
Figure 17

COLD SIDE TUBE BUNDLE ENTRANCE REGION
