SUBJECT: Forwards response to RJ Pate request for justification for continued operation of Unit 1 & inability of Control Element Assembly 56 to reliably drop during testing. Addl info solicited by C-E & followed.

Subject: Palo Verde Nuclear Generating Station (PVNGS)
Unit 1
Justification for Continued Operation - Inability
of CEA 56 to Drop
File: 88-A-056-026

ATTACHMENT A

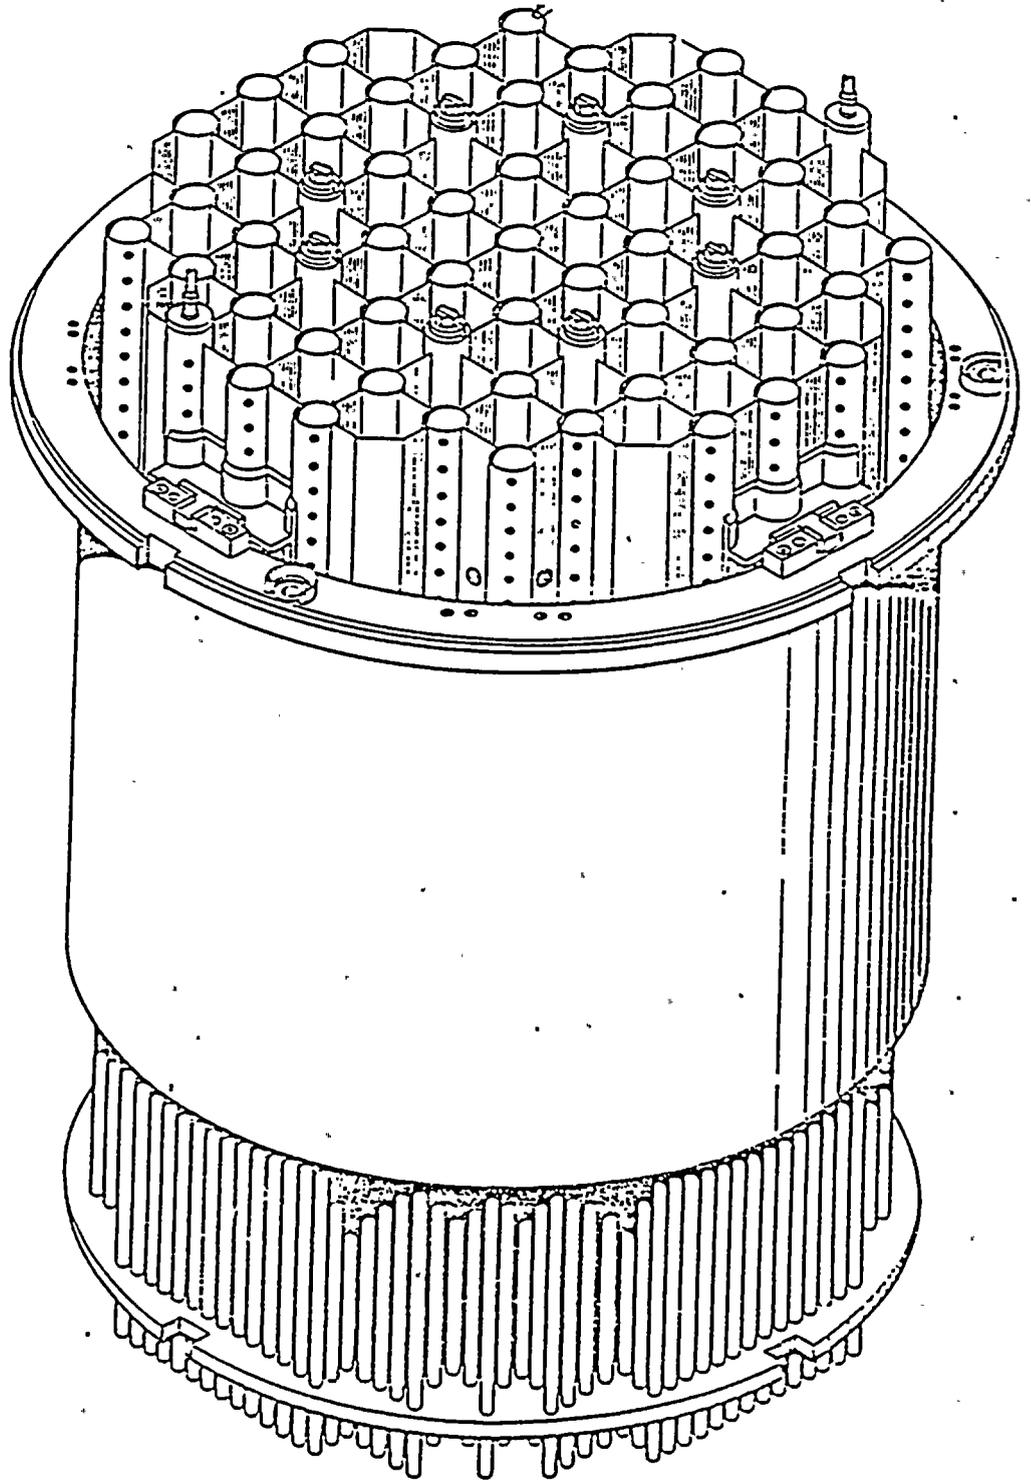
FIG. 3

- g. The UGS was reinstalled in the reactor vessel (Figs. 1&2).
- h. The reactor vessel head was reinstalled.
- i. During the course of heating up and running the RCPs, the ball bearing dropped between the UGS guide tube and the CEA finger (Figs. 3-12).

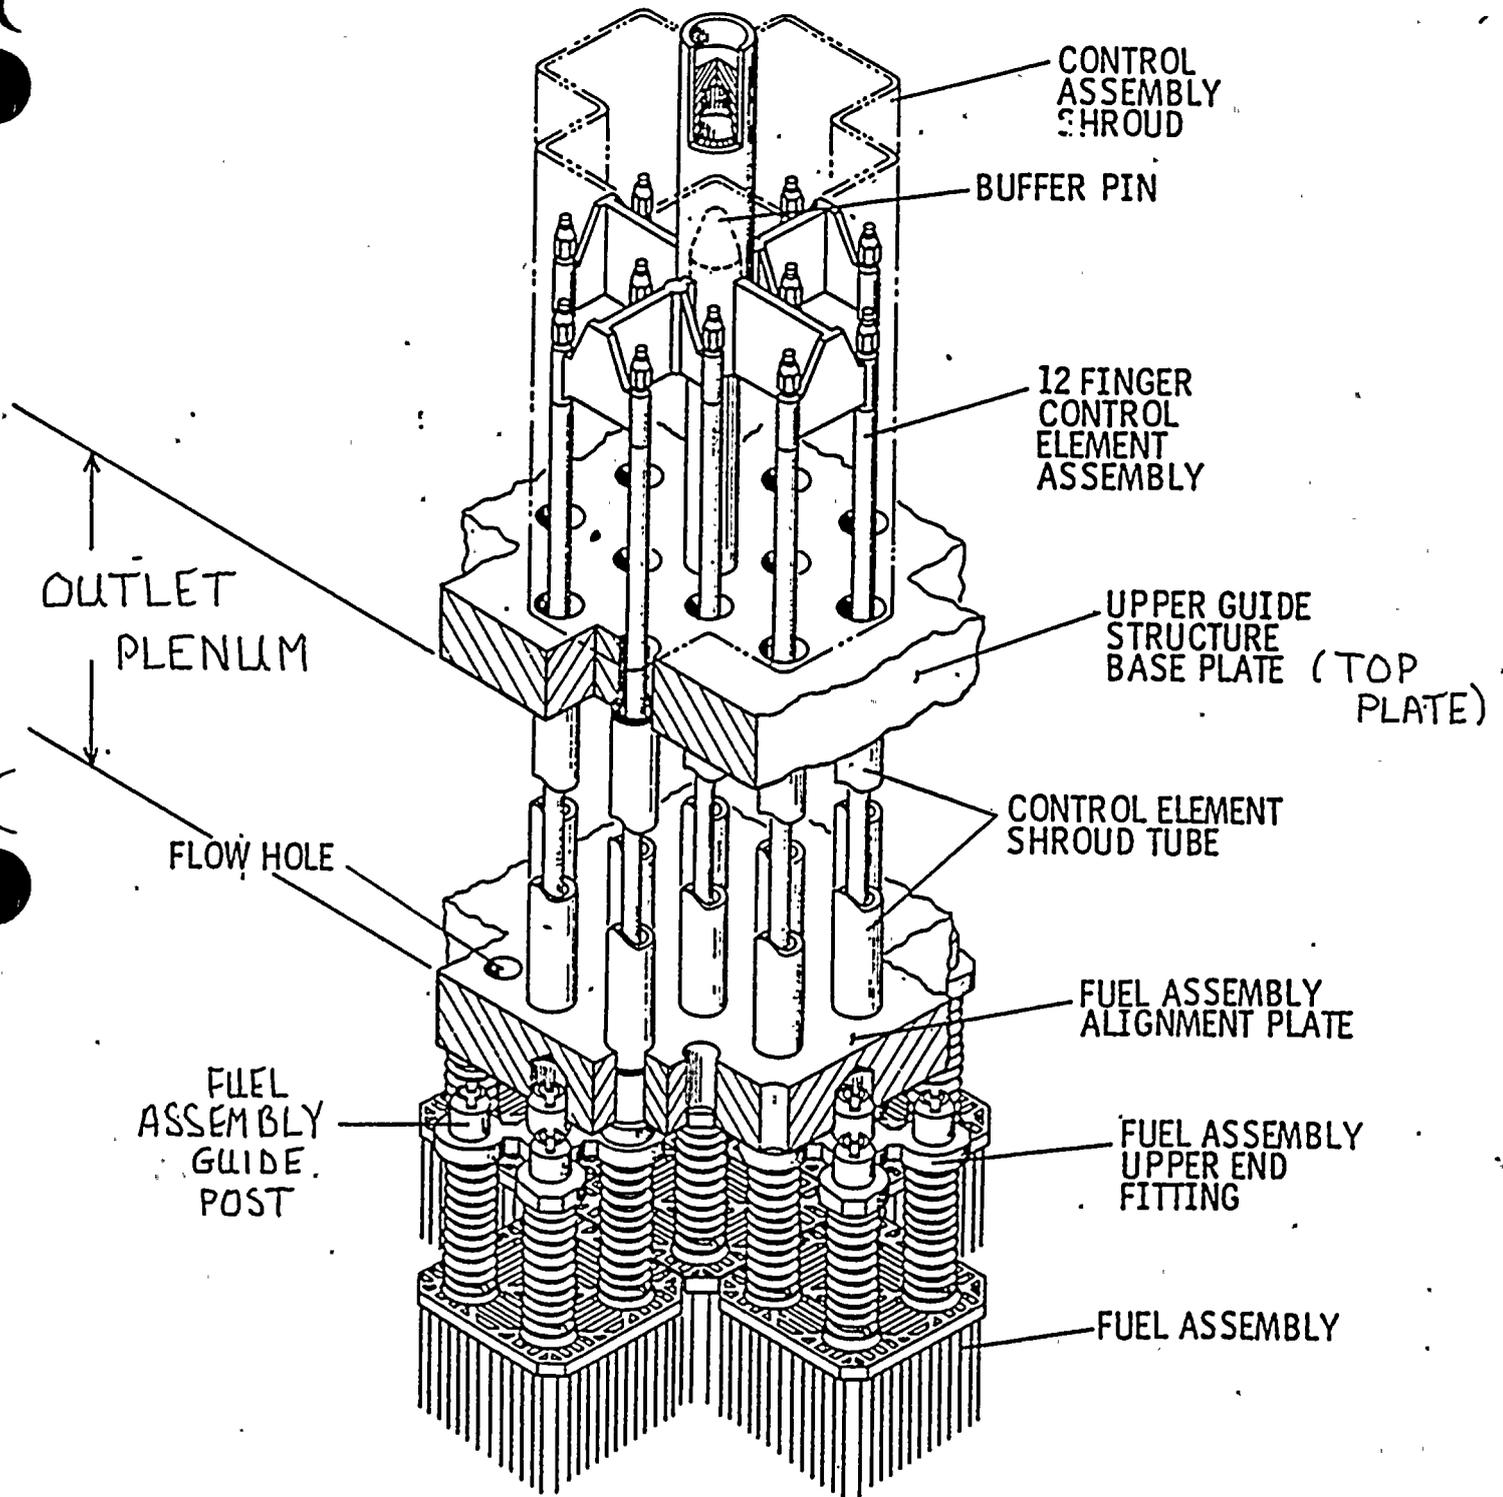
FIG. 10

There is only one credible pathway which the ball bearing can follow that can produce an interference of the type observed in this event. It would be necessary for the ball bearing to travel from its location in the core up into the upper plenum (Fig. 10), via flow holes in the UGS support plate and then down through the UGS guide tube, between the CEA finger and the UGS guide tube (Fig. 14). An evaluation (documented on an Engineering Evaluation Report) shows that there is less than a 0.5% probability that this event could occur when full RCS flow is established. The probability of the event is reduced even further during one - RCP and two - RCP combinations. This will contribute to a

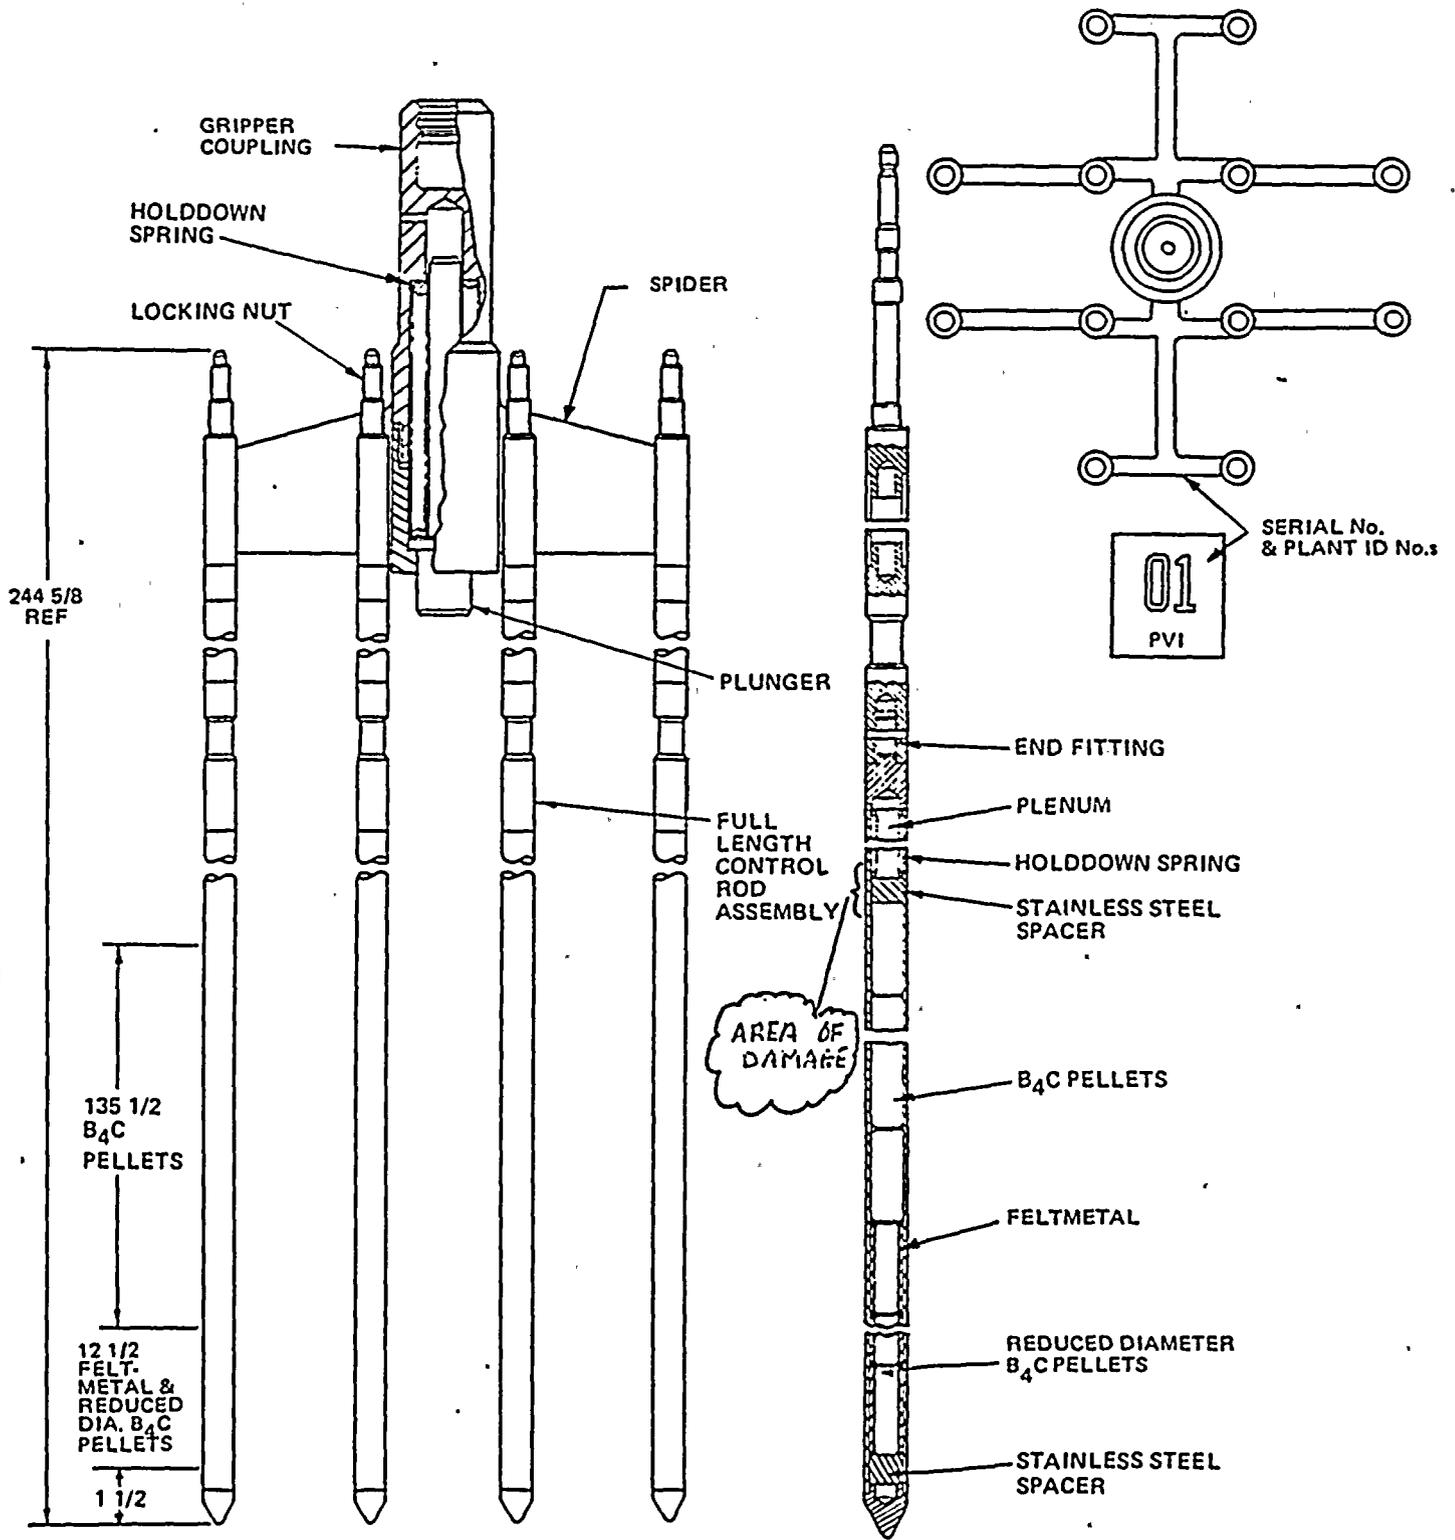
FIG. 21

excessive or requiring further examination. These marks were made either by normal contact with the guide tube during reactor trips or by contact with the guide tube/end fitting while the CEA was stuck. The CEA finger which did interact with the ball bearing was examined over its entire length. Evidence of scratches normally occurring due to metal-to-metal contact between CEAs and guide tubes were evident and evaluated as acceptable. Scratches and occasional indentations were observed at several elevations on the CEA finger and generally within a small area of the circumference of the finger. The most severe indication was located on the CEA approximately 147 inches from the bottom of the CEA. Thus, when the CEA is 30 inches withdrawn, the damaged area of the CEA would be adjacent to the damaged area of the fuel assembly guide post. It could be characterized as a depression approximately 1/8 inch wide at the surface of the CEA and approximately 3 inches long in the axial direction. This corresponds to the region of the top of the B₄C pellet stack in the upper portion of the CEA (Fig. 21). It was visually determined that the CEA cladding was not breached.

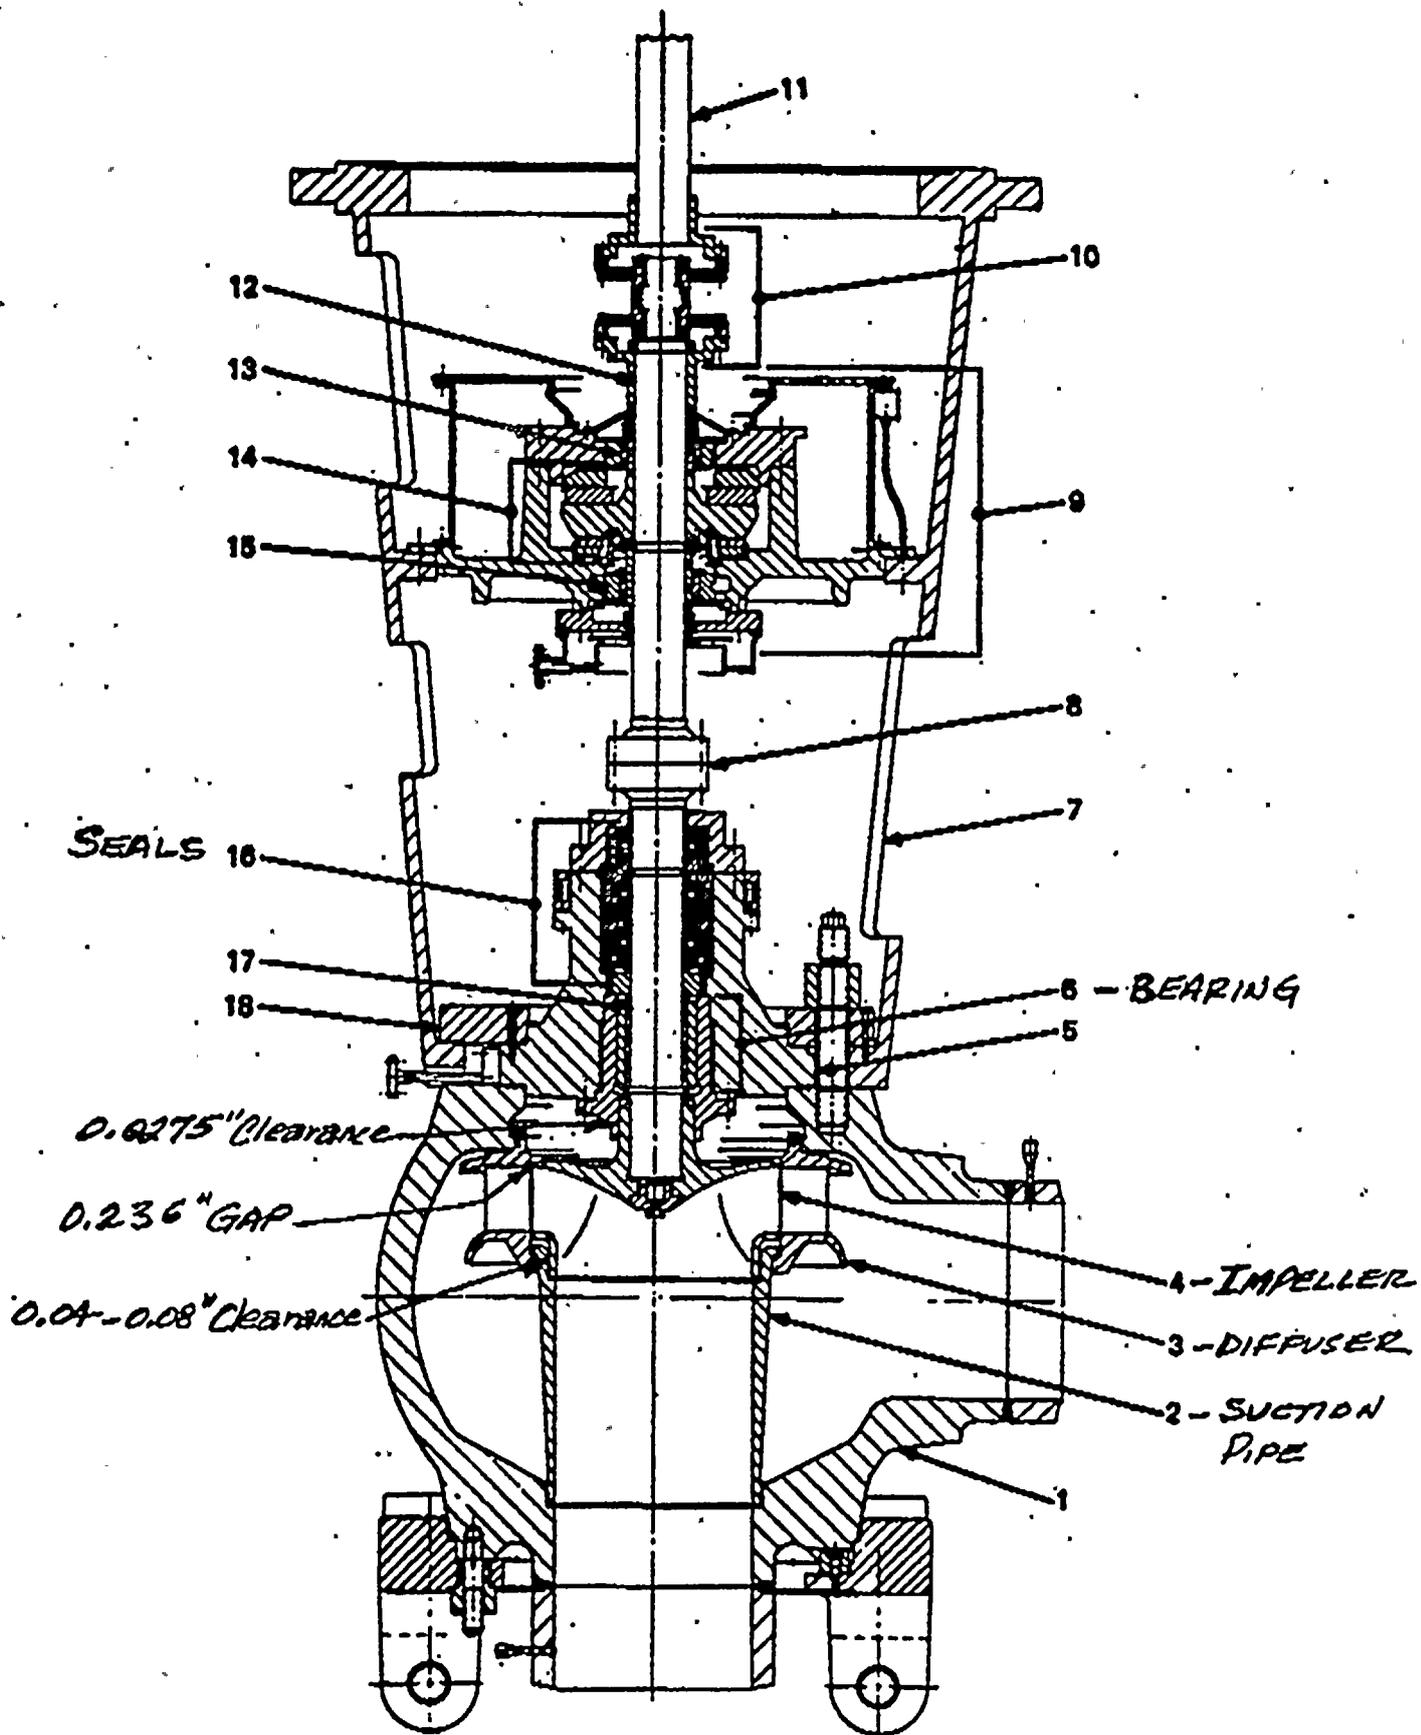
FIGURE-27

The radial clearance between the impeller O.D. and diffuser I.D. is 6 mm (0.236 inch) so it is possible that the ball bearing could pass through this gap and become lodged on the top of the impeller, particularly if there is reverse flow through the pumps as will occur with less than four pumps operating. The ball bearing would not pass further up into the bearing or shaft seal area because the radial clearance between the impeller hub and bearing sleeve bore is 0.0275 inch; (Fig. 27). If the ball bearing size is reduced through wear, it is still unlikely that it would enter the pump bearing because the downward flow of seal injection water would prevent this.

Reactor Coolant Pump Component Locations.
