ELECTRICAL DISTRIBUTION SYSTEM
DESIGN ASSESSMENT

May 22, 1989

ELECTRICAL DISTRIBUTION SYSTEM DESIGN ASSESSMENT

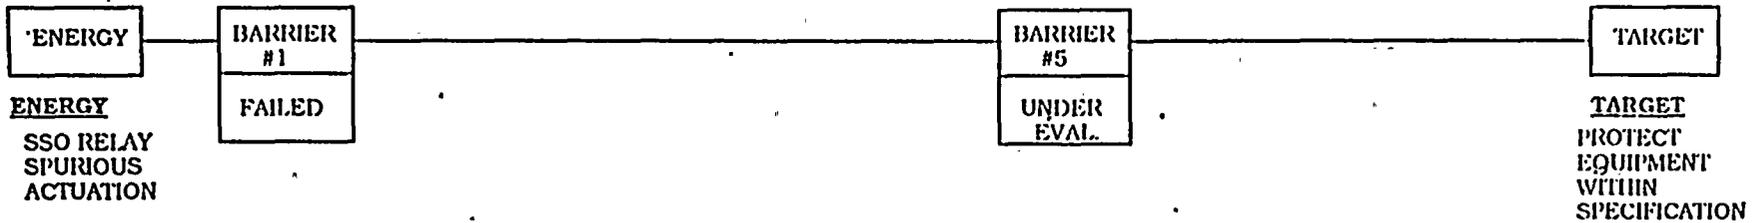
ENERGY-BARRIER-TARGET ANALYSIS FOR IIR 2-3-89-001

1. EQUIPMENT PERFORMANCE	<input type="checkbox"/>	<input checked="" type="checkbox"/>	<input type="checkbox"/>	<input type="checkbox"/>	<input type="checkbox"/>	<input type="checkbox"/>	SSO RELAY ACTUATION

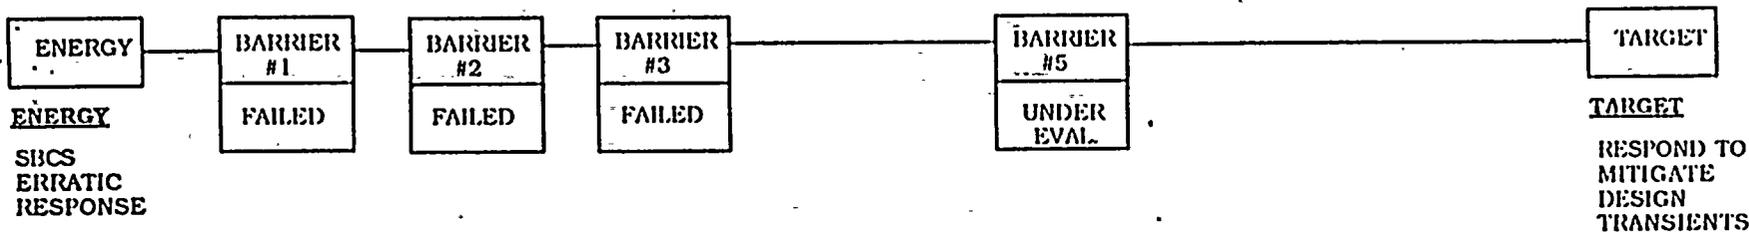
ENERGY-BARRIER-TARGET ANALYSIS FOR IIR 2-3-89-001

1. EQUIPMENT PERFORMANCE	<input type="checkbox"/>	<input checked="" type="checkbox"/>	<input type="checkbox"/>	<input checked="" type="checkbox"/>	<input type="checkbox"/>	<input type="checkbox"/>	-RELAY TIMER CARD MALFUNCTION

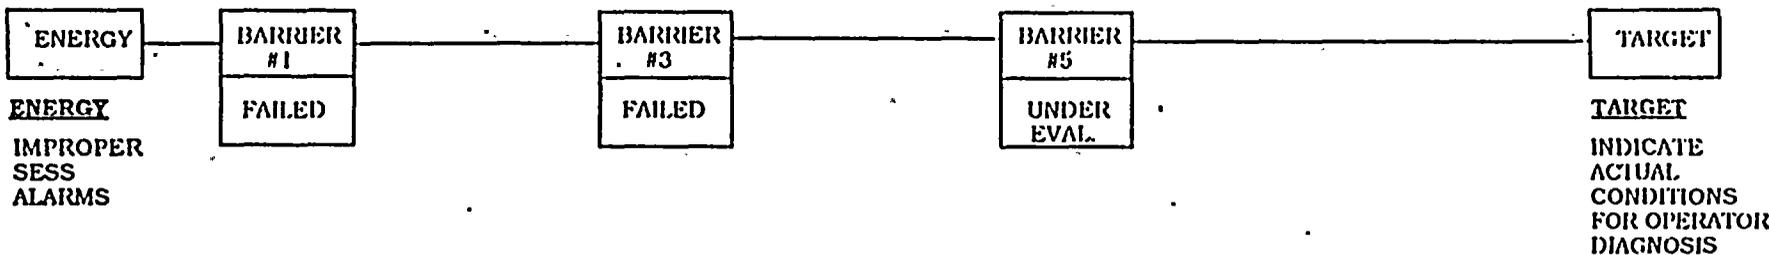
ENERGY-BARRIER-TARGET ANALYSIS FOR IIR 2-3-89-001

1. EQUIPMENT PERFORMANCE	<input type="checkbox"/>	<input checked="" type="checkbox"/>	<input type="checkbox"/>	<input type="checkbox"/>	<input type="checkbox"/>	<input type="checkbox"/>	DUAL INDICATIONS OR NON-ALARM

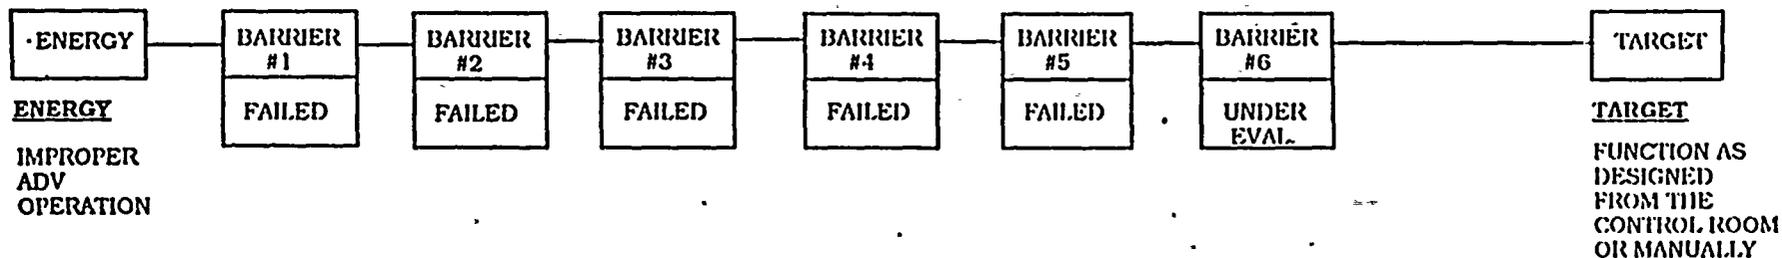
ENERGY-BARRIER-TARGET ANALYSIS FOR IIR 2-3-89-001

1. EQUIPMENT PERFORMANCE	<input type="checkbox"/>	<input checked="" type="checkbox"/>	<input type="checkbox"/>	<input checked="" type="checkbox"/>	<input type="checkbox"/>	<input type="checkbox"/>	- DID NOT RESPOND FROM C.R OR RSP - HANDWHEEL CLEVIS

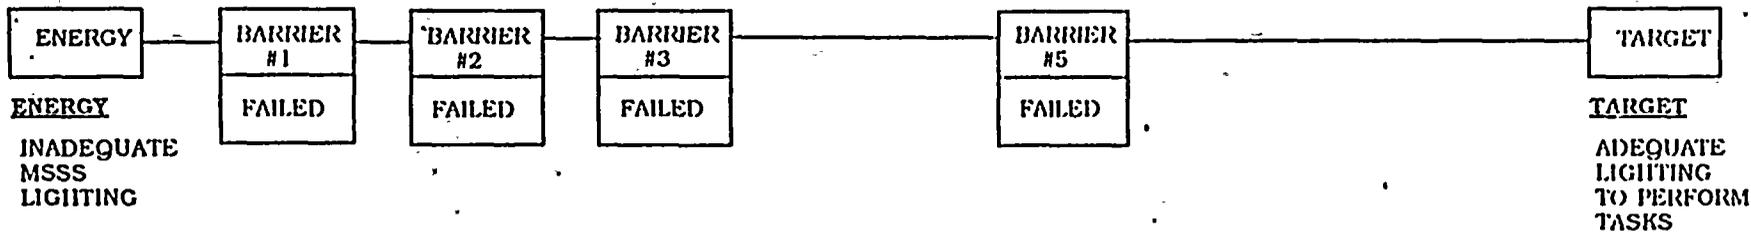
ENERGY-BARRIER-TARGET ANALYSIS FOR IIR 2-3-89-001

1. EQUIPMENT PERFORMANCE	<input type="checkbox"/>	<input checked="" type="checkbox"/>	<input type="checkbox"/>	<input checked="" type="checkbox"/>	<input type="checkbox"/>	<input type="checkbox"/>	ESSENTIAL LIGHTING EMERGENCY LIGHTING

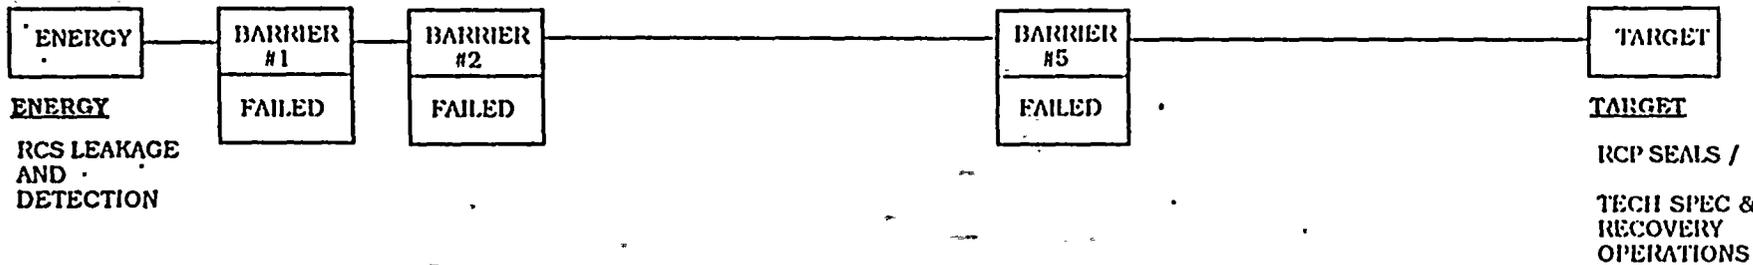
ENERGY-BARRIER-TARGET ANALYSIS FOR IIR 2-3-89-001

1. EQUIPMENT PERFORMANCE	<input type="checkbox"/>	<input checked="" type="checkbox"/>	<input checked="" type="checkbox"/>	<input type="checkbox"/>	<input type="checkbox"/>	<input type="checkbox"/>	<ul style="list-style-type: none"> • SEAL BLEEDOFF REESTABLISHED • SEAL FAILURE
