PALO VERDE NUCLEAR GENERATING STATION  
UNITS 1, 2, AND 3

JUSTIFICATION FOR CONTINUED OPERATION  
GEA DROP EVENTS

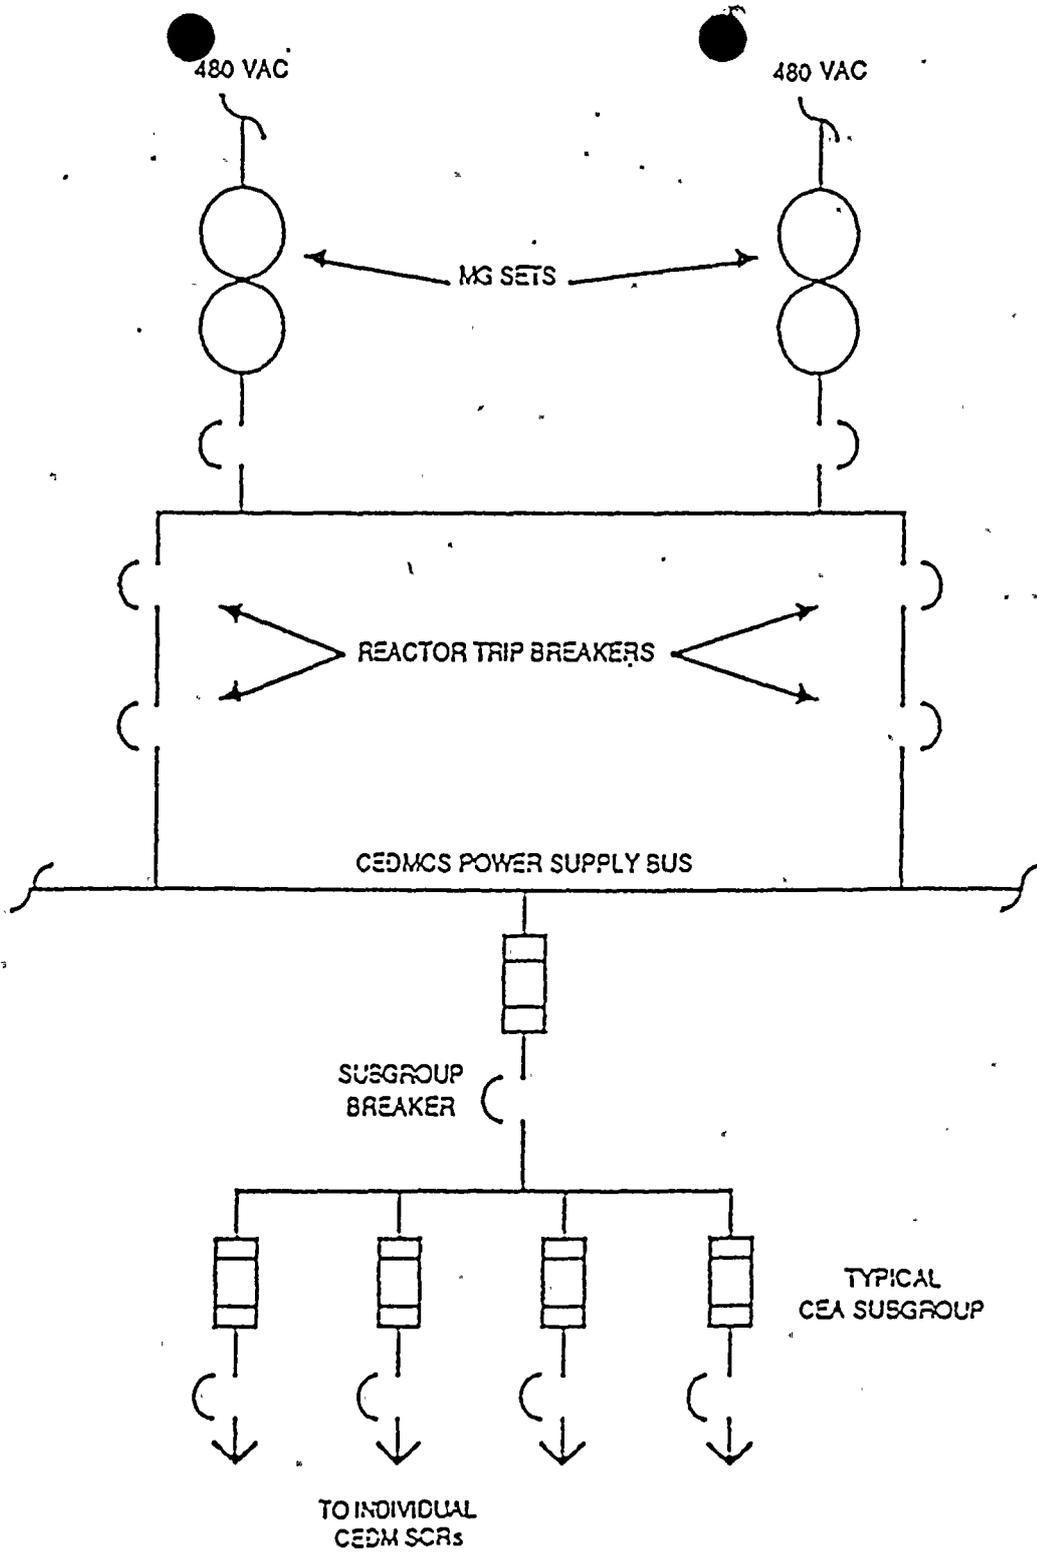
FIGURE 1 - CEDMCS POWER SUPPLY

The purpose of the CEDMCS is to provide the drive signals to the coils of the magnetic-jack Control Element Drive Mechanisms (CEDMs) which position and hold the individual Control Element Assemblies (CEAs). The CEDMCS controls the direction, rate, and duration of CEA motion in response to automatic or manual demands. The CEDMCS is a non-safety related control system. The safety function of the CEAs is to drop into the core when power is removed from the CEDMs. Power is removed from the CEDMs when the reactor trip breakers open in response to valid reactor protection signals. Refer to Appendix A, Figure 1 for a schematic of the power supply arrangement to the PVNGS CEDMCS.
