PALO VERDE  
NUCLEAR GENERATING STATION

ATMOSPHERIC DUMP VALVE  
ENGINEERING ANALYSIS

March/April, 1989

REVISION 2

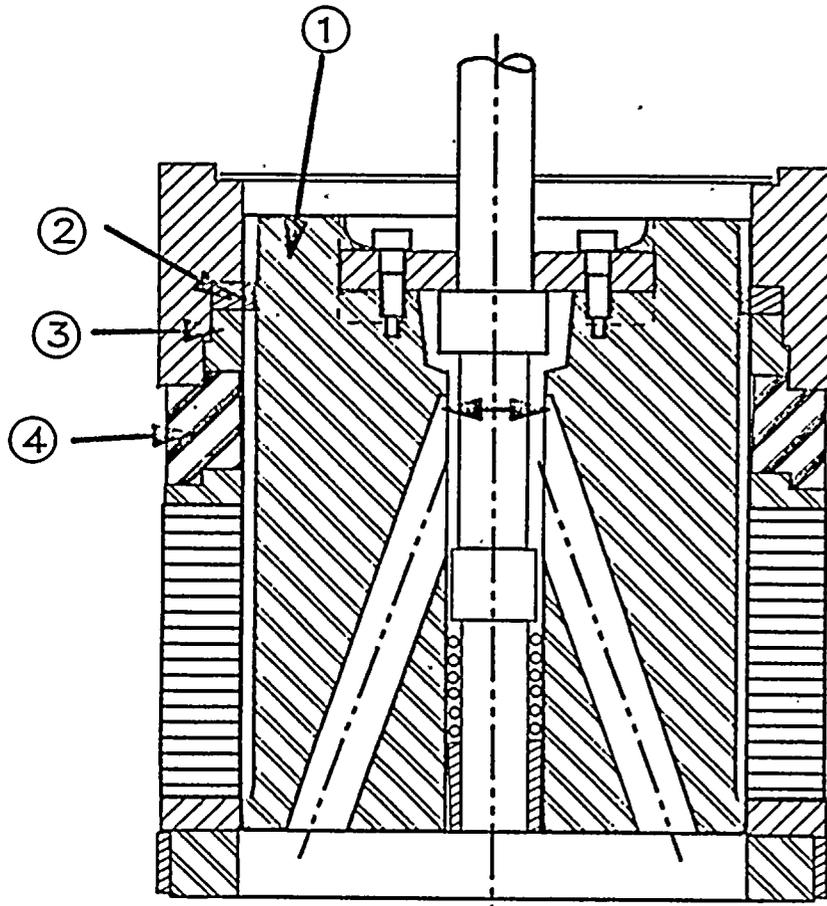
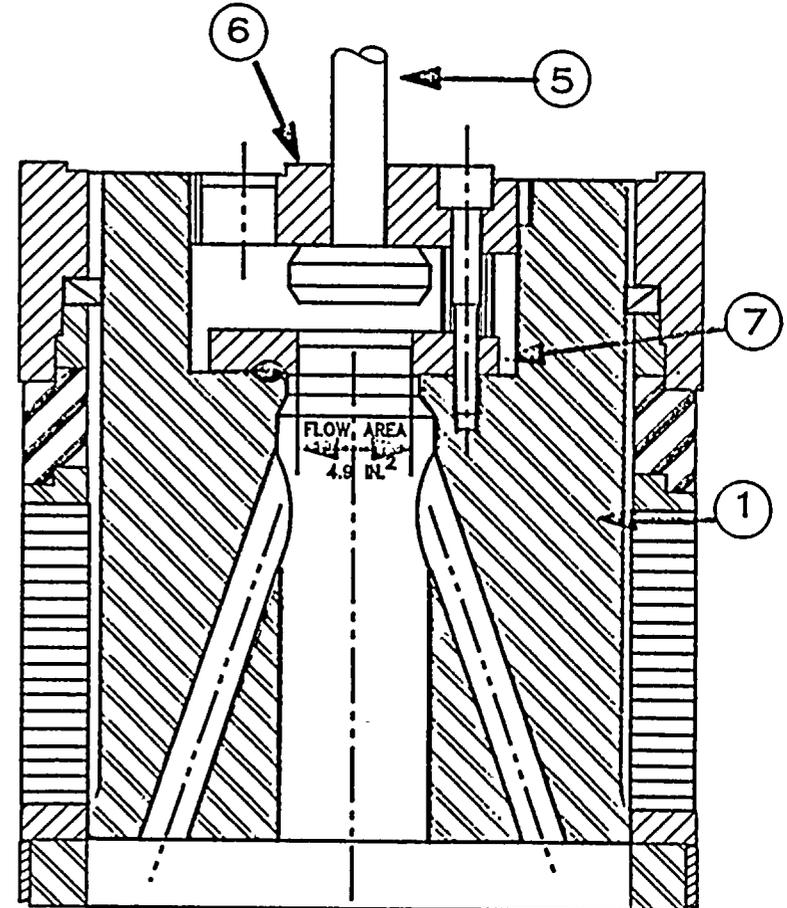
· FIGURE IX-2

FLOW AREA = 2.5 INCHES<sup>2</sup>

- ① MAIN VALVE PLUG (REWORKED)
- ⑤ MAIN VALVE STEM (PILOT VALVE PLUG) (NEW)
- ⑥ RETAINING PLATE (NEW)
- ⑦ PILOT VALVE SEAT RING (NEW)
