U.S. NUCLEAR REGULATORY COMMISSION

AUGMENTED INSPECTION TEAM (AIT) REPORT

Facility Name: Palo Verde Nuclear Generating Station
Units 1, 2, and 3

Areas Inspected: Augmented Inspection Team (AIT) review of a partial loss of offsite power event at Unit 3 due to an unattended, ungrounded mobile crane boom striking one of two offsite 13.8 kV power transmission lines.

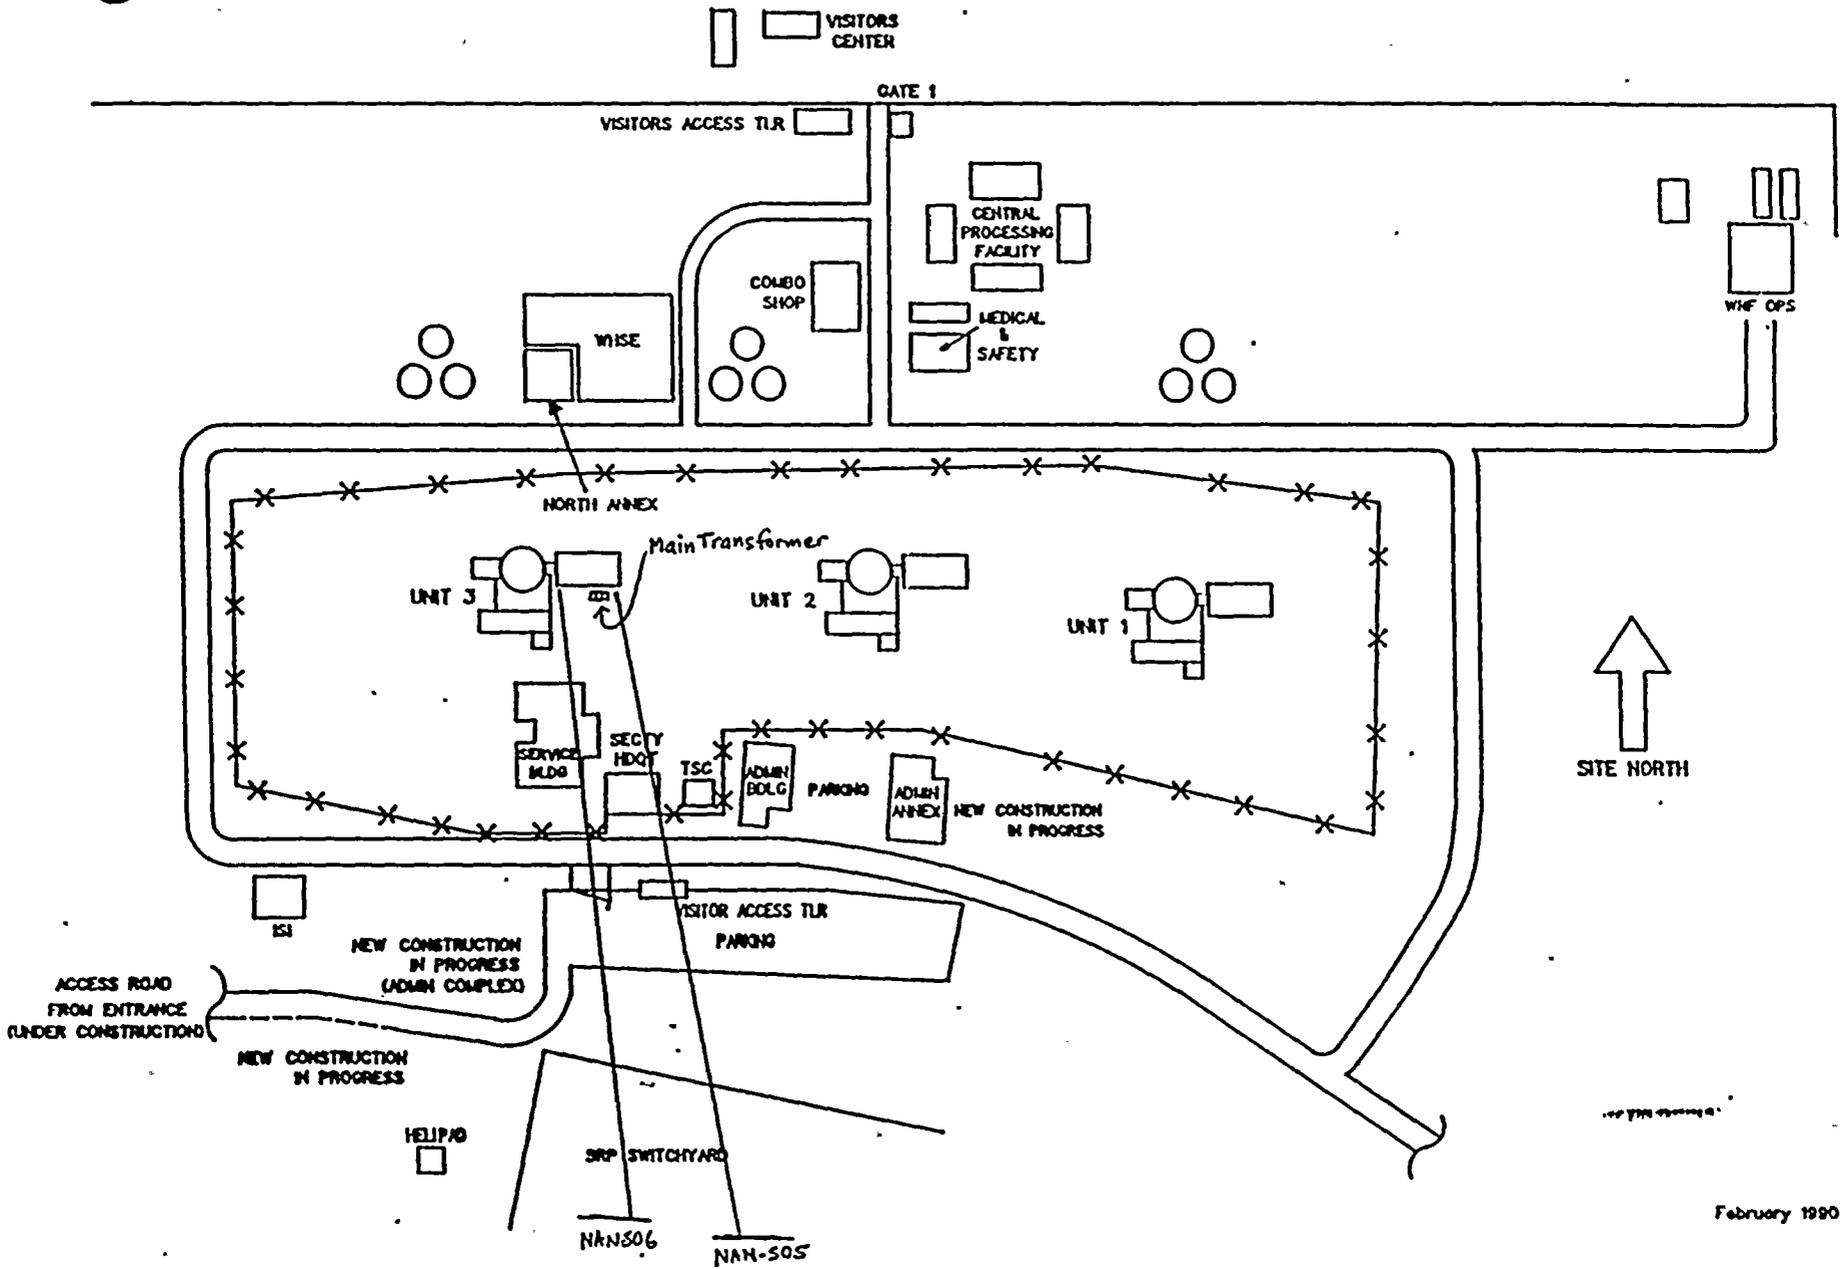
FIGURE 1

PLAN VIEW OF PALO VERDE NUCLEAR GENERATING STATION

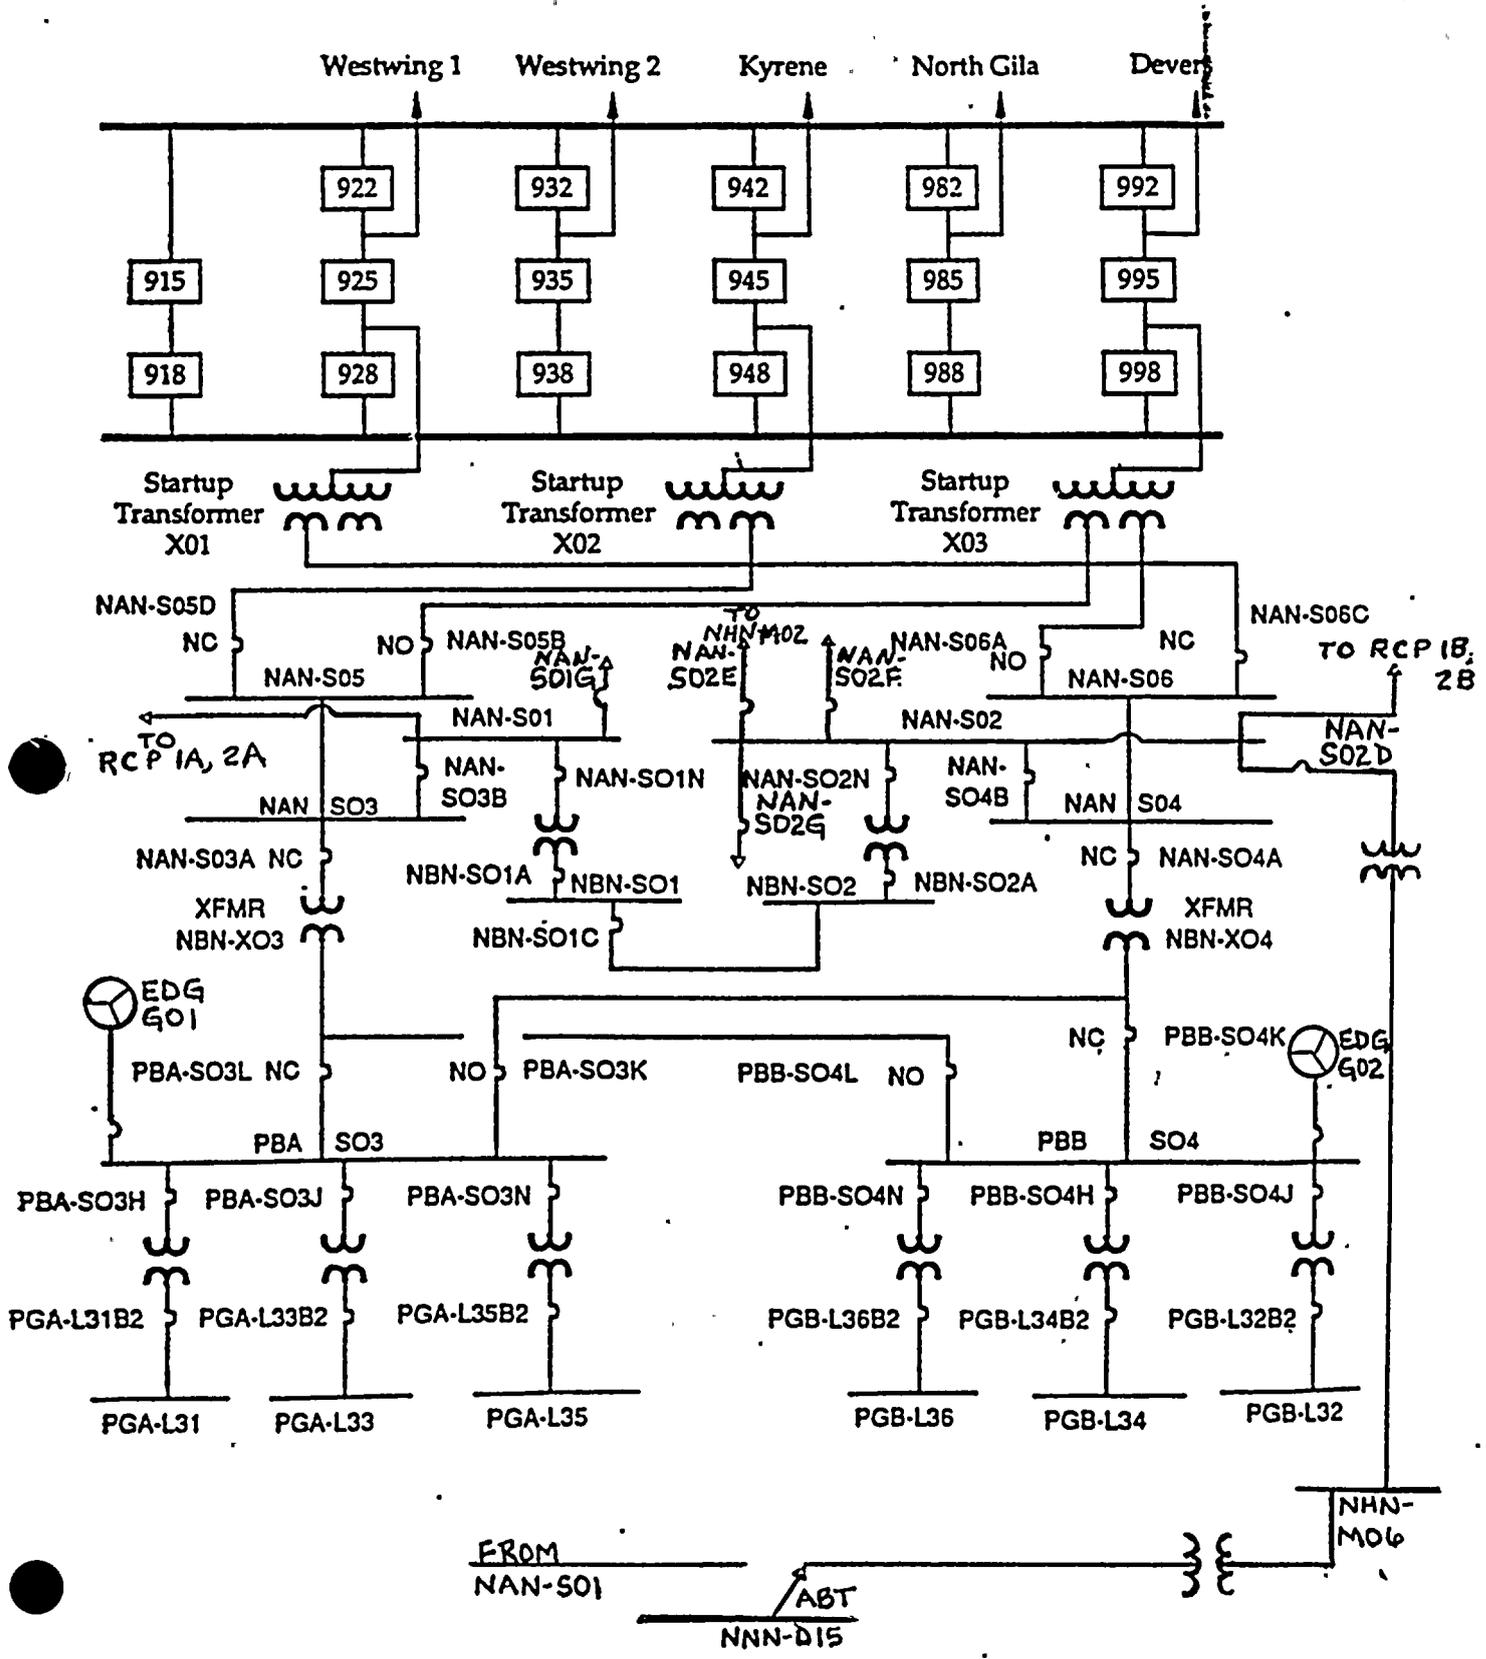
FIGURE 2
SIMPLIFIED ELECTRICAL SYSTEM SCHEMATIC

Electrical Distribution System Figure 2 depicts the plant electrical single line diagram. Offsite electrical power is supplied to each unit from the 525 kilovolt (kV) switchyard via two 13.8 kV startup transformers and buses NAN-S05 and NAN-S06 (located in the switchyard) through two sets of transmission lines (east and west, respectively), each comprised of two conductors for each of the three phases. These transmission lines supply power to 13.8 kV buses (NAN-S03 and NAN-S04, respectively), from which Class 1E 4160 volt Engineered Safety Features (ESF) buses (PBA-S03 and PBB-S04, respectively) are powered via two ESF Service Transformers. When shutdown, non-Class 1E loads, including RCPs, are also powered from buses NAN-S03 and NAN-S04. Each unit is provided with two 4160 volt Emergency Diesel Generators (EDGs) connected to their respective ESF buses.

The Control Room was notified at about 9:11 a.m. of a crane in the high voltage lines, but the communications were inaccurate, resulting in the Shift Supervisor directing that the wrong lines be deenergized. Operators deenergized NAN-S06, which removed power from two of four RCPs and from 4160 volt ESF bus PBB-S04 (see Figure 2). The B EDG started and provided power to Class 1E loads as designed.
