SUBJECT: LER 88-007-00:on 880908, ice build-up in ice condenser flow passages due to sublimation. ltr.

D. C. Cook Nuclear Plant - Unit 1					
Too Build-Up in Too Condenser Flow Passages Due to Sub	limation				
EVENT DATE (5) (50 NUMBED (6) DEPORT DATE (7) OTHER	FACILITIES INVOLVED (8)				
MONTH DAY YEAR YEAR WEAR SEQUENTIAL WEAR REVISION MONTH DAY YEAR FACILITY NA	MES DOCKET NUMBER(S)				
NUMBER NUMBER	0 15 10 10 10 1 1				
0 9 0 8 8 8 8 8 0 0 7 0 0 9 3 0 8 8	0 5 0 0 0 1				
OPERATING THIS REPORT IS SUBMITTED PURSUANT TO THE REQUIREMENTS OF 10 CFR 'S: (Check one or more	of the following) (11)				
MODE (9) 4 20.402(b) 20.405(c) 50.73(a)(2)(iv)	73.71(5)				
POWER 20.405(a)(1)(i) 50.38(c)(1) 50.73(a)(2)(v)	73.71(e)

> D. C. Cook Nuclear Plant -Unit 1

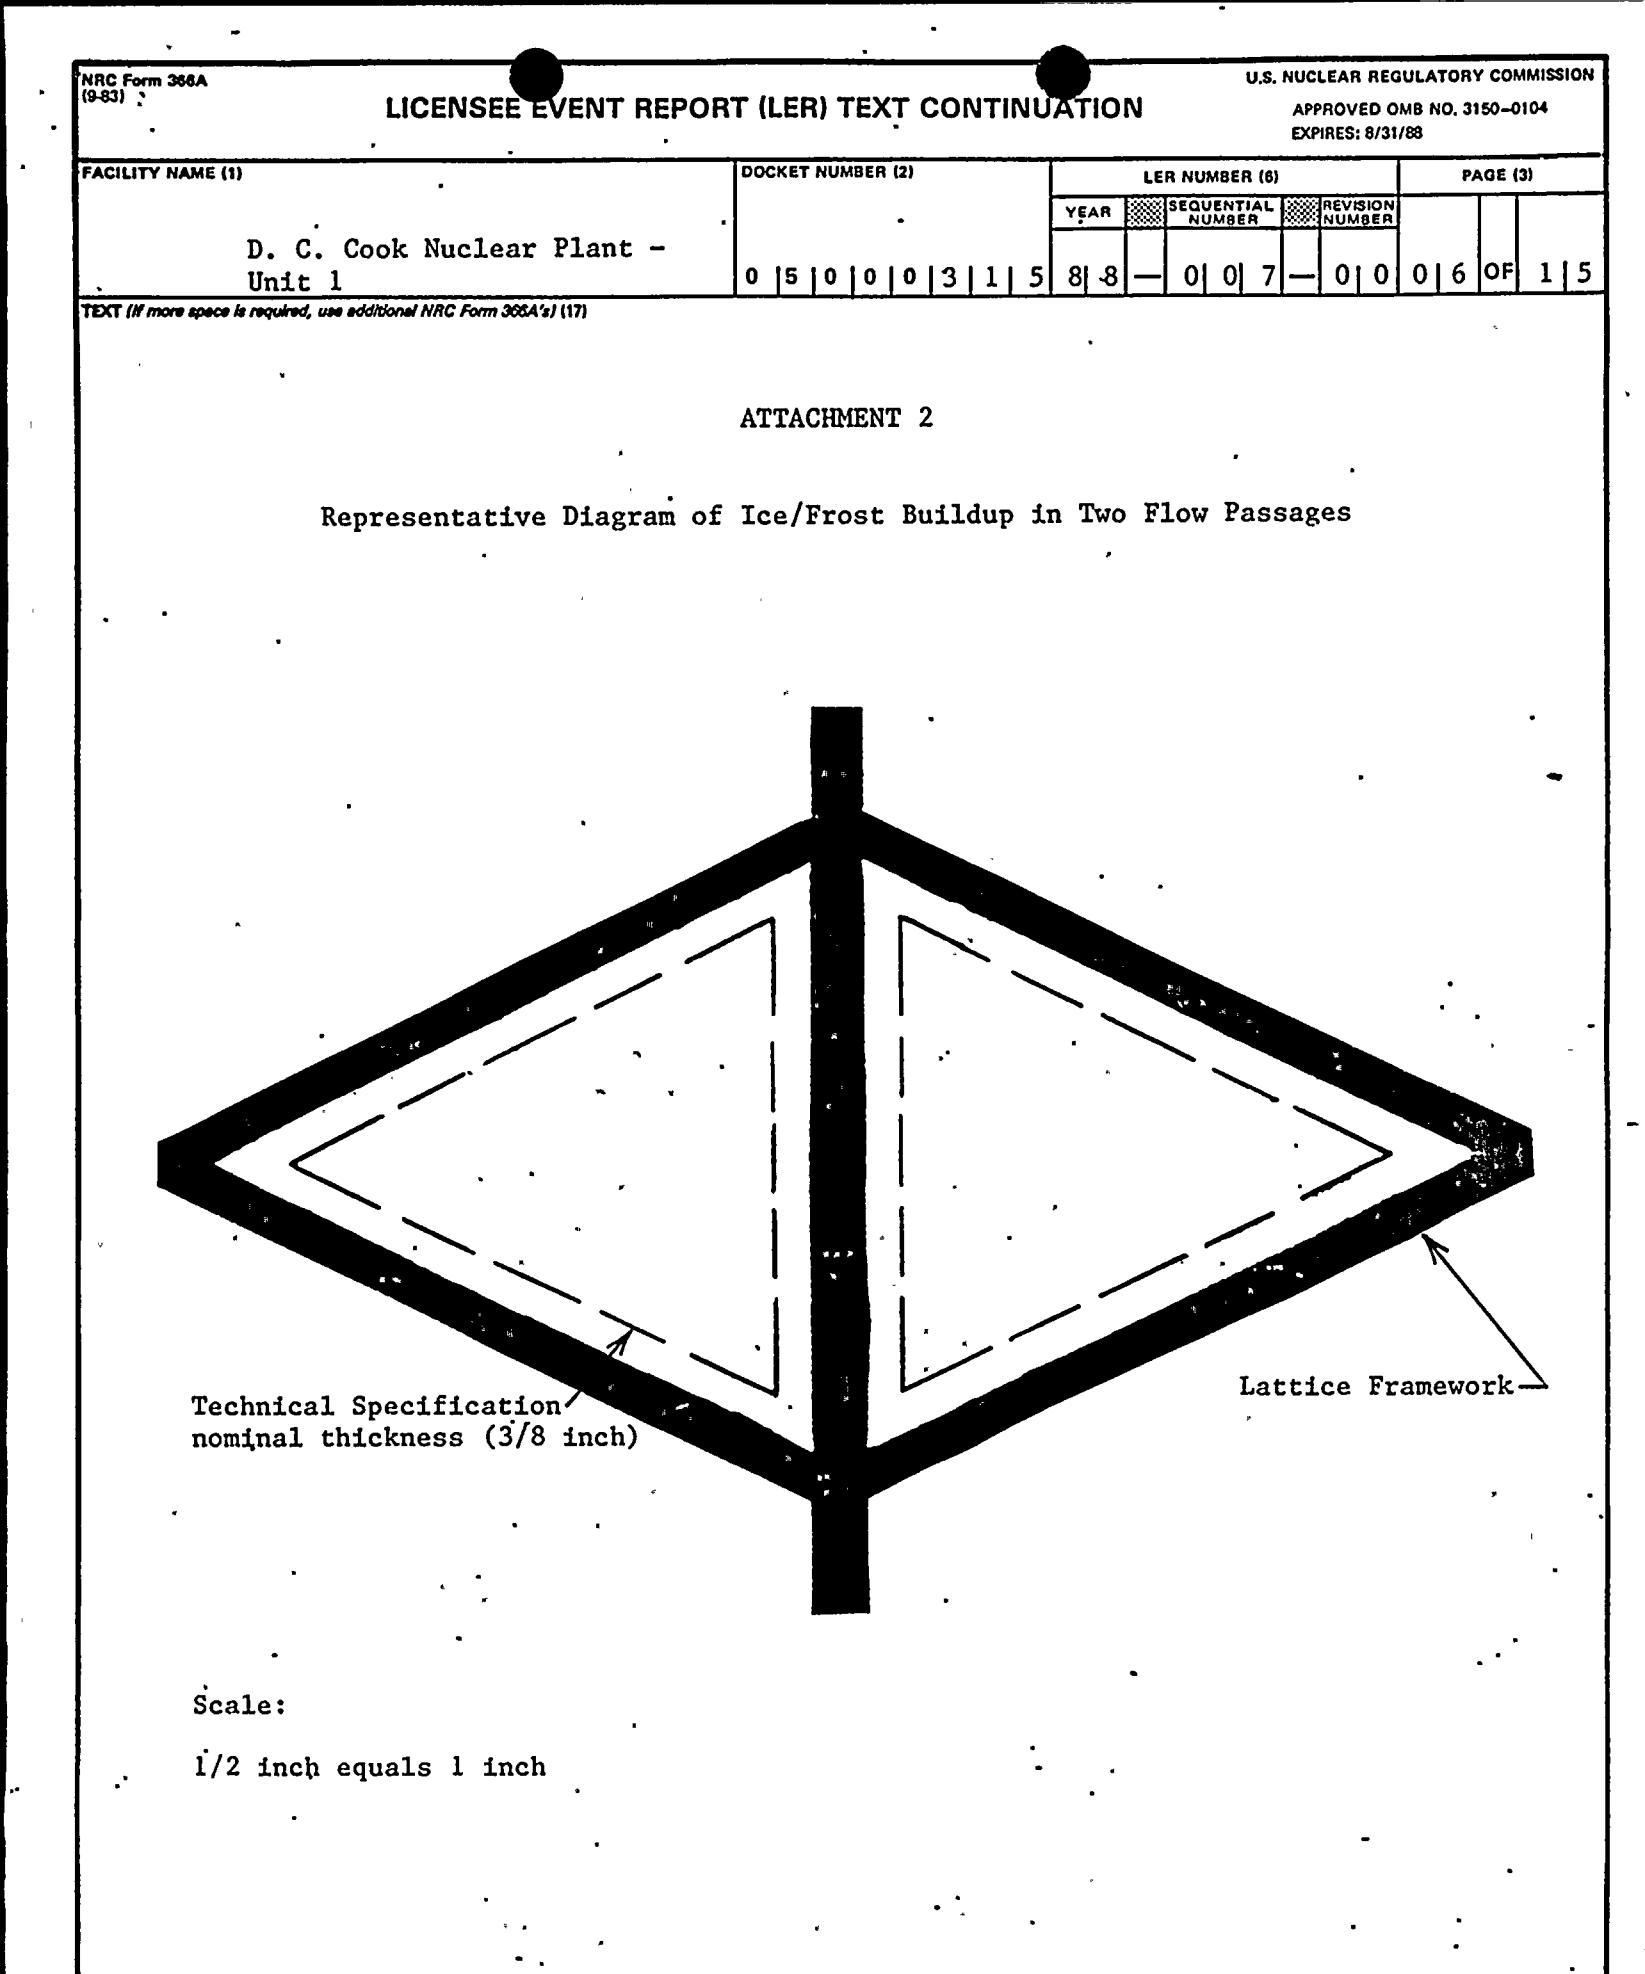
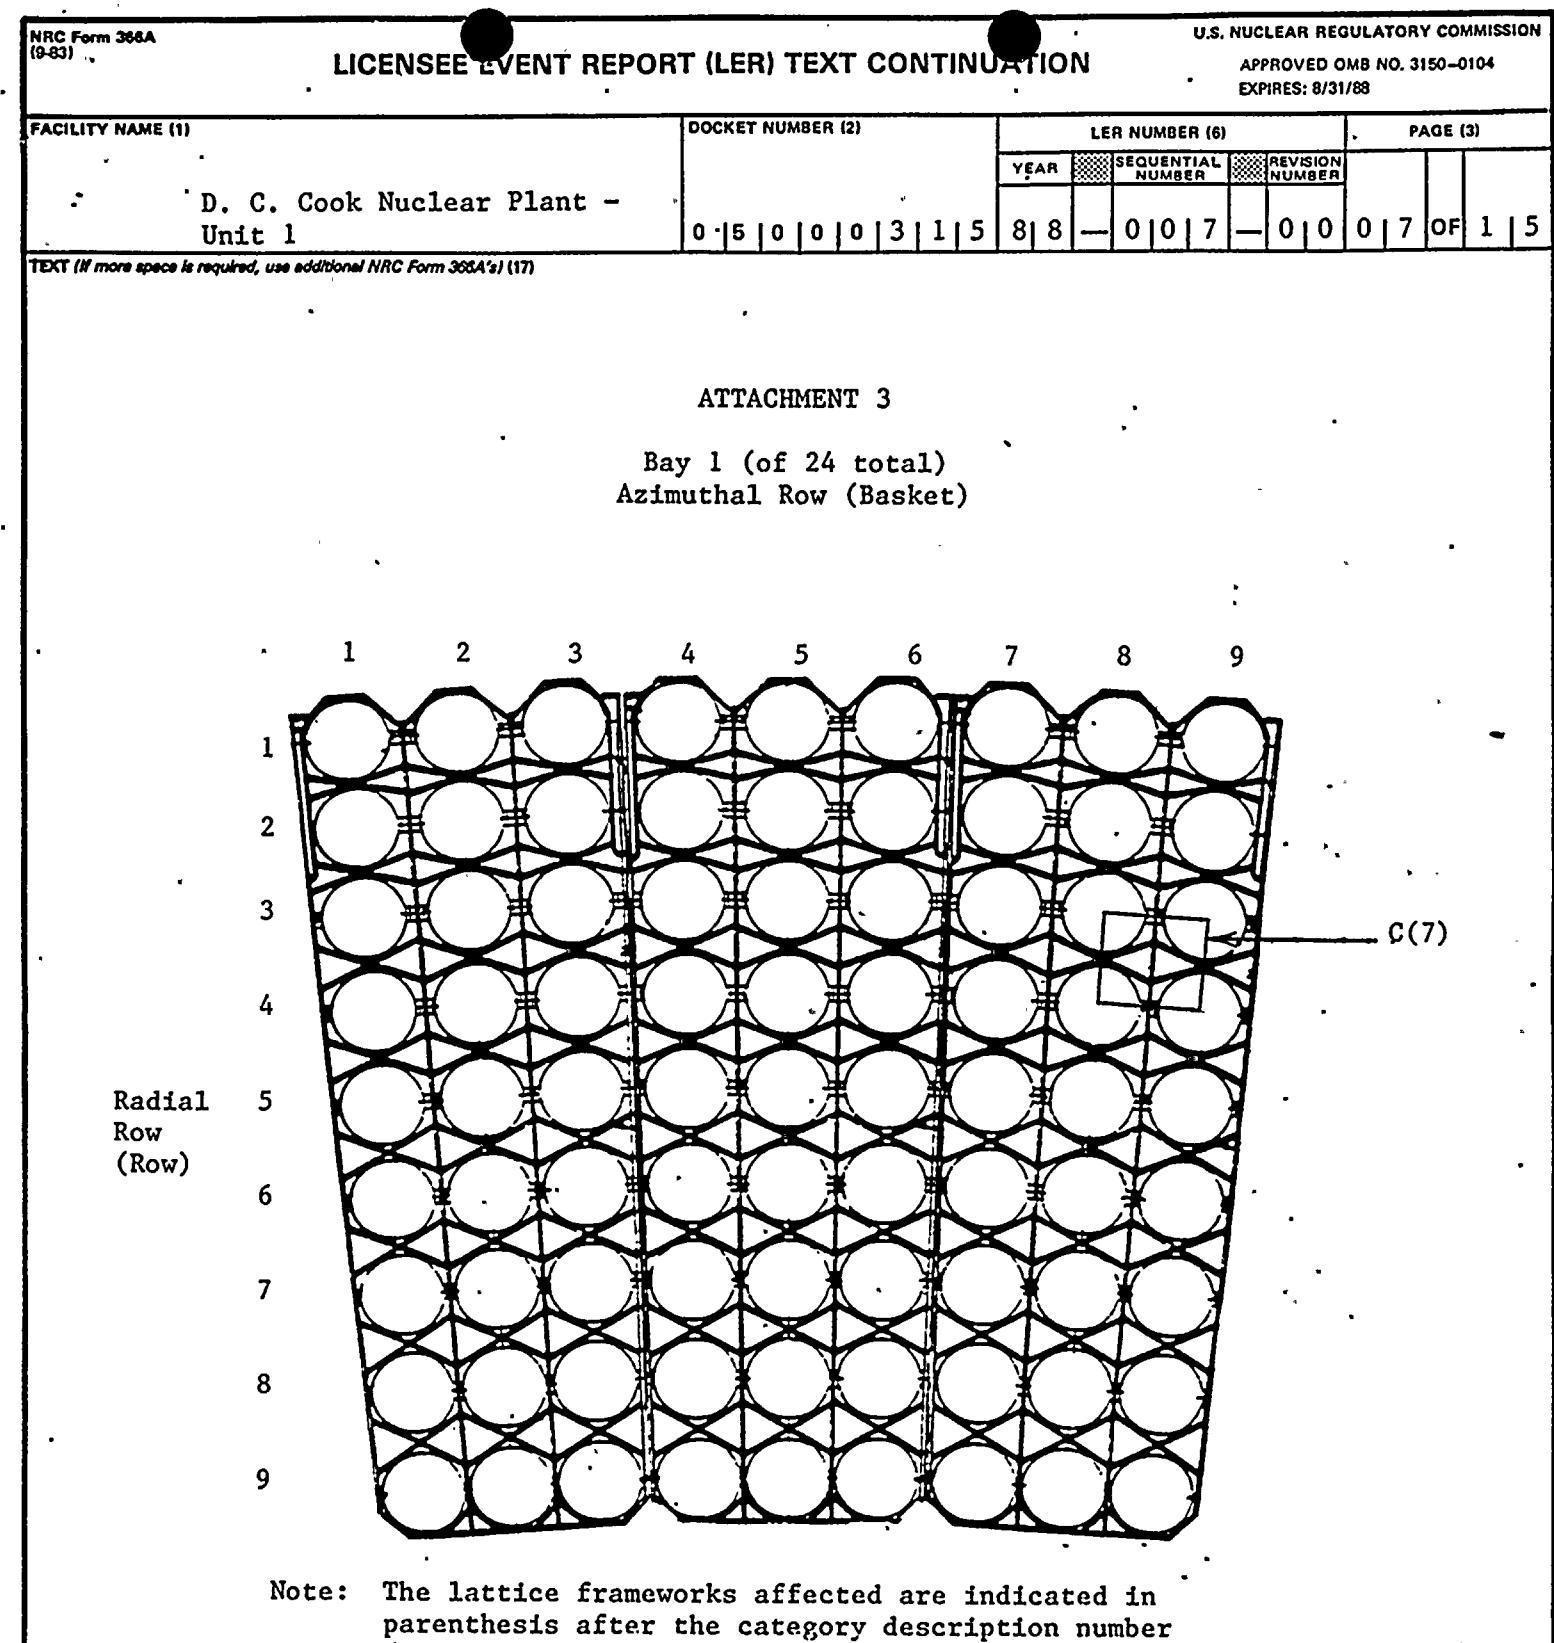
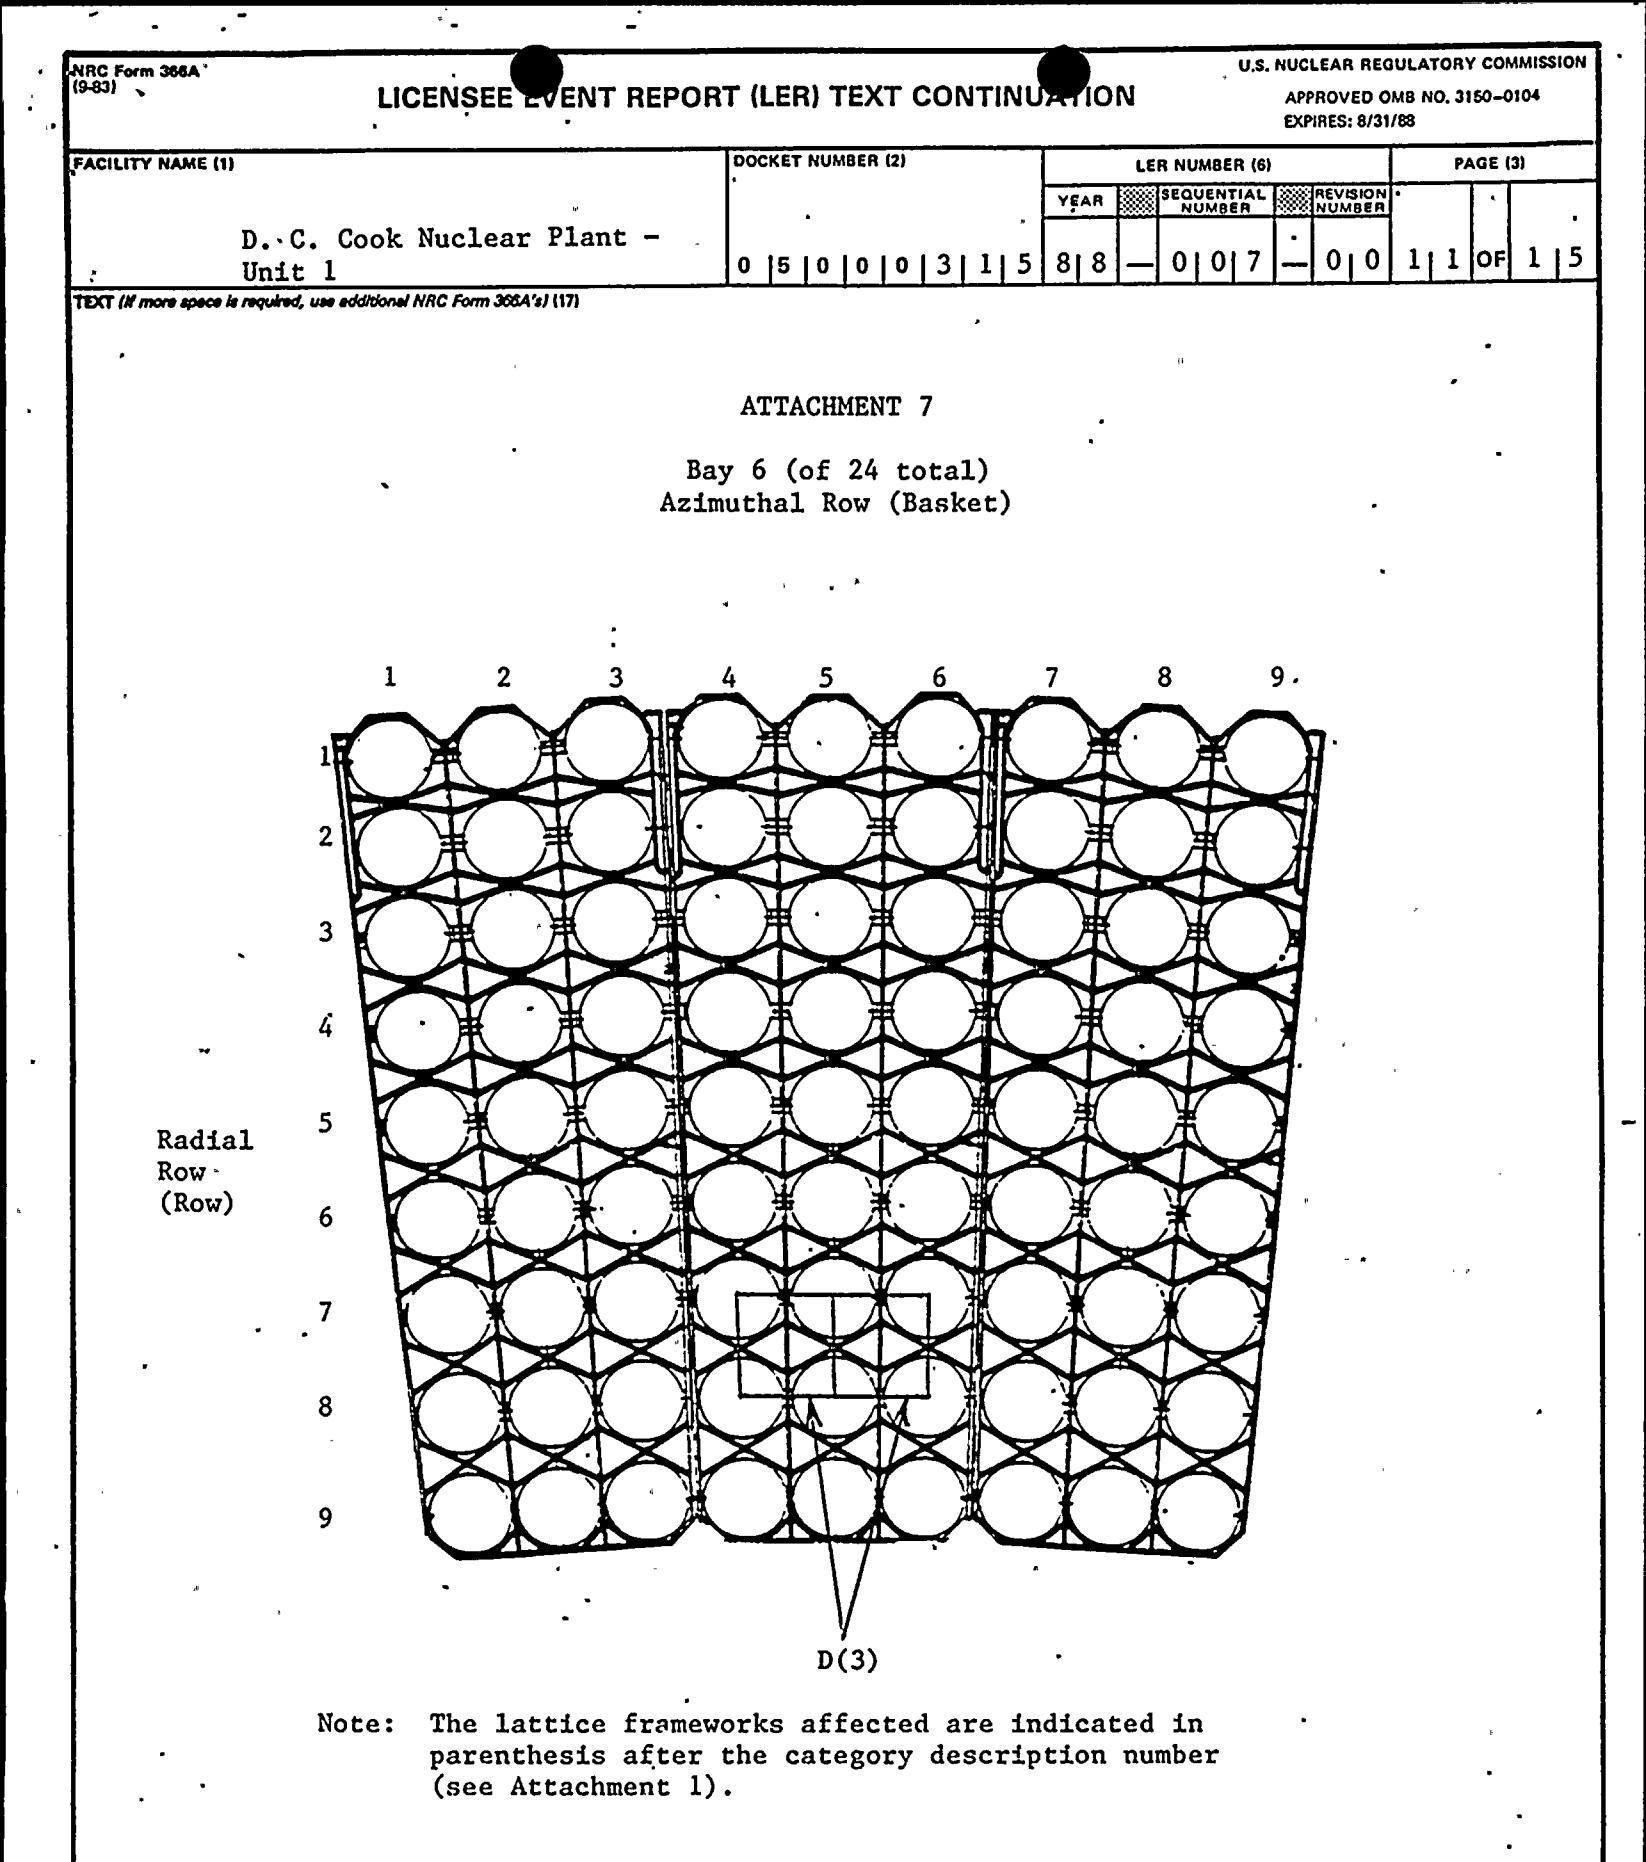
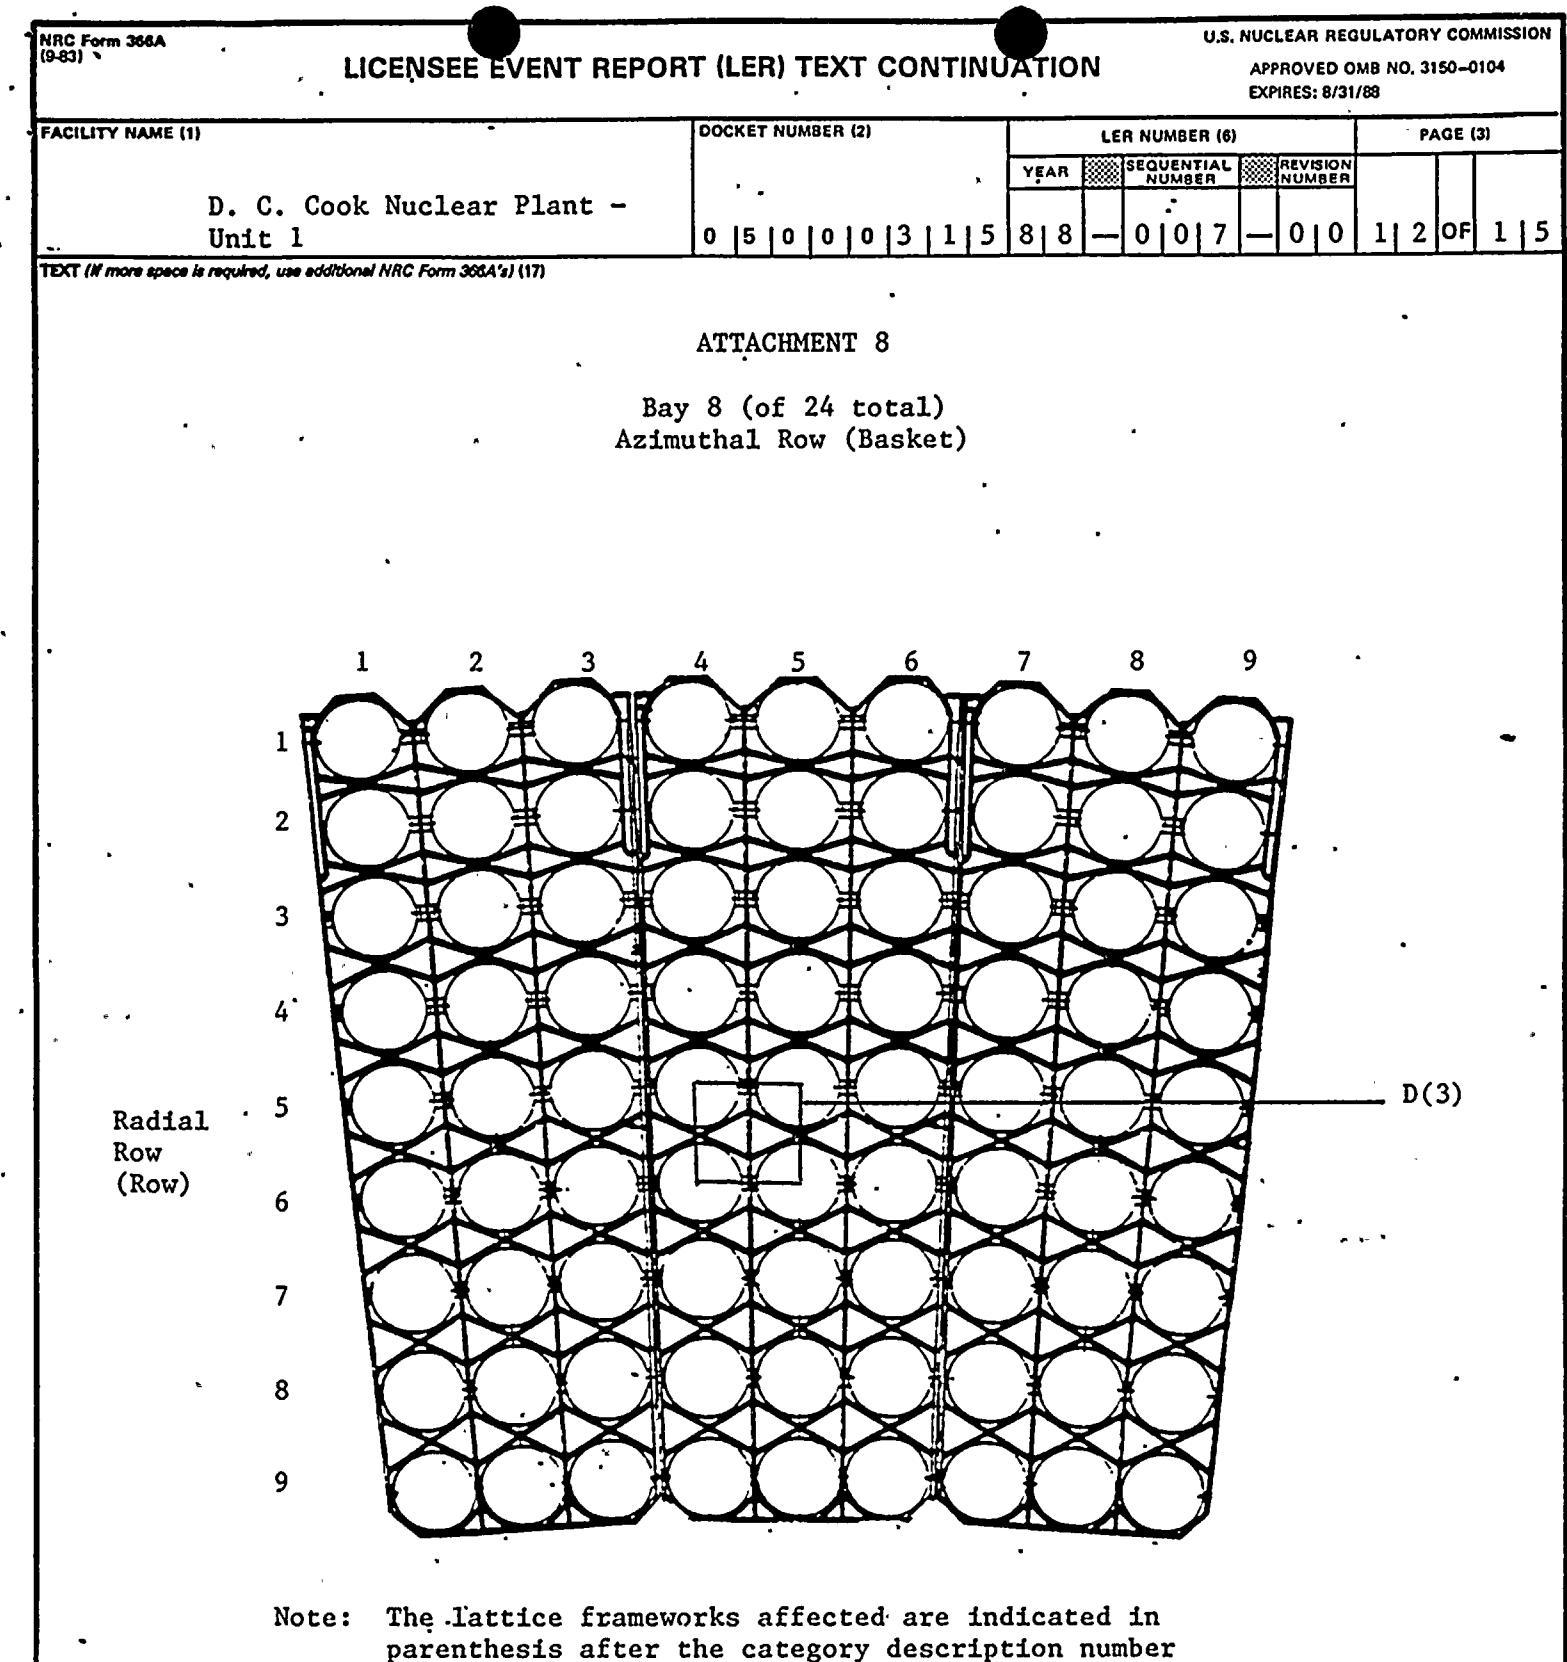
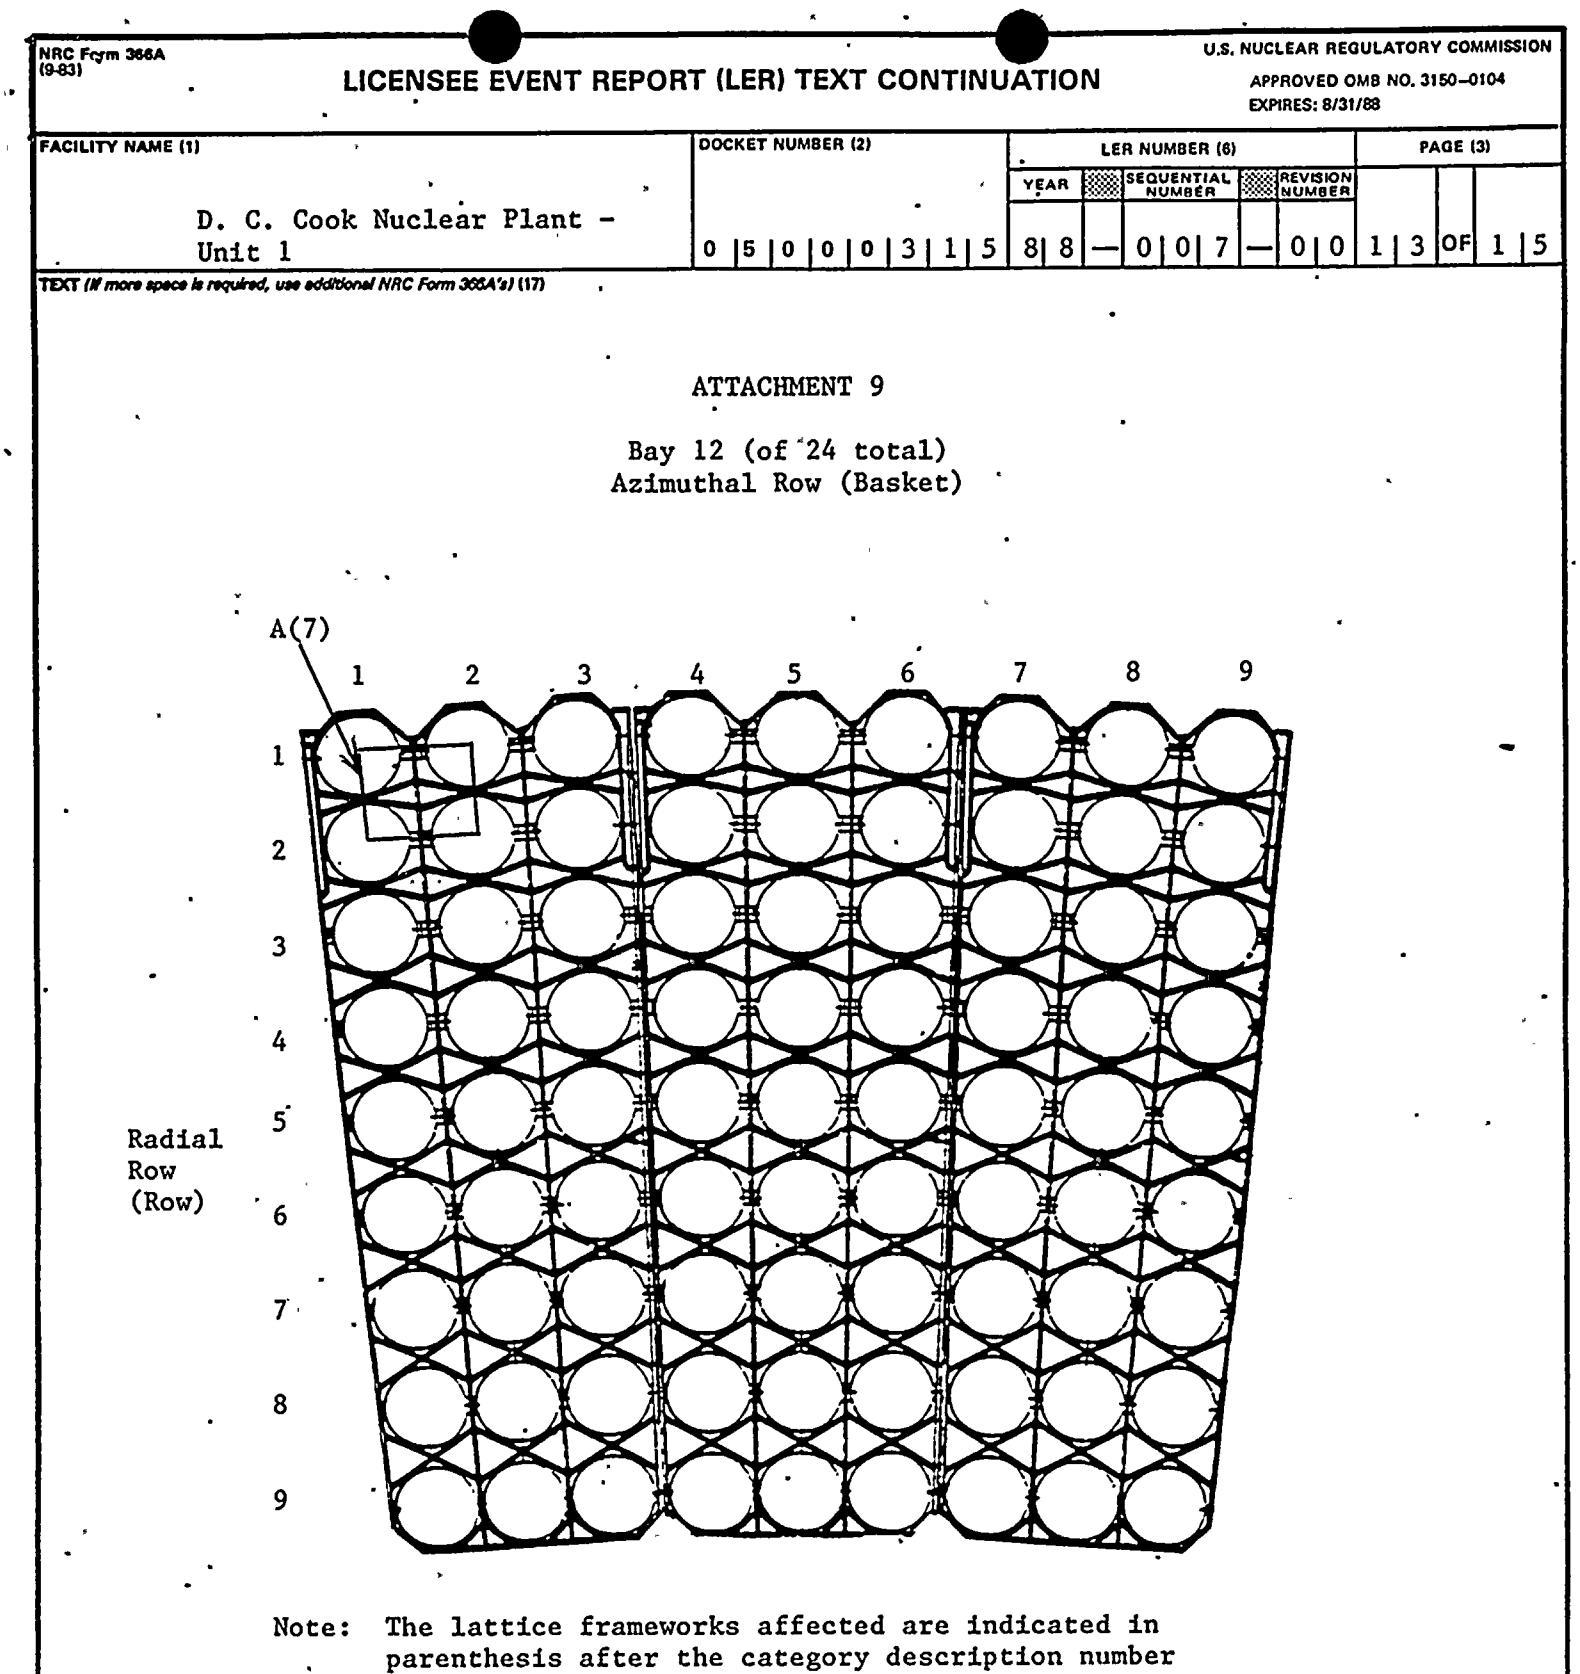
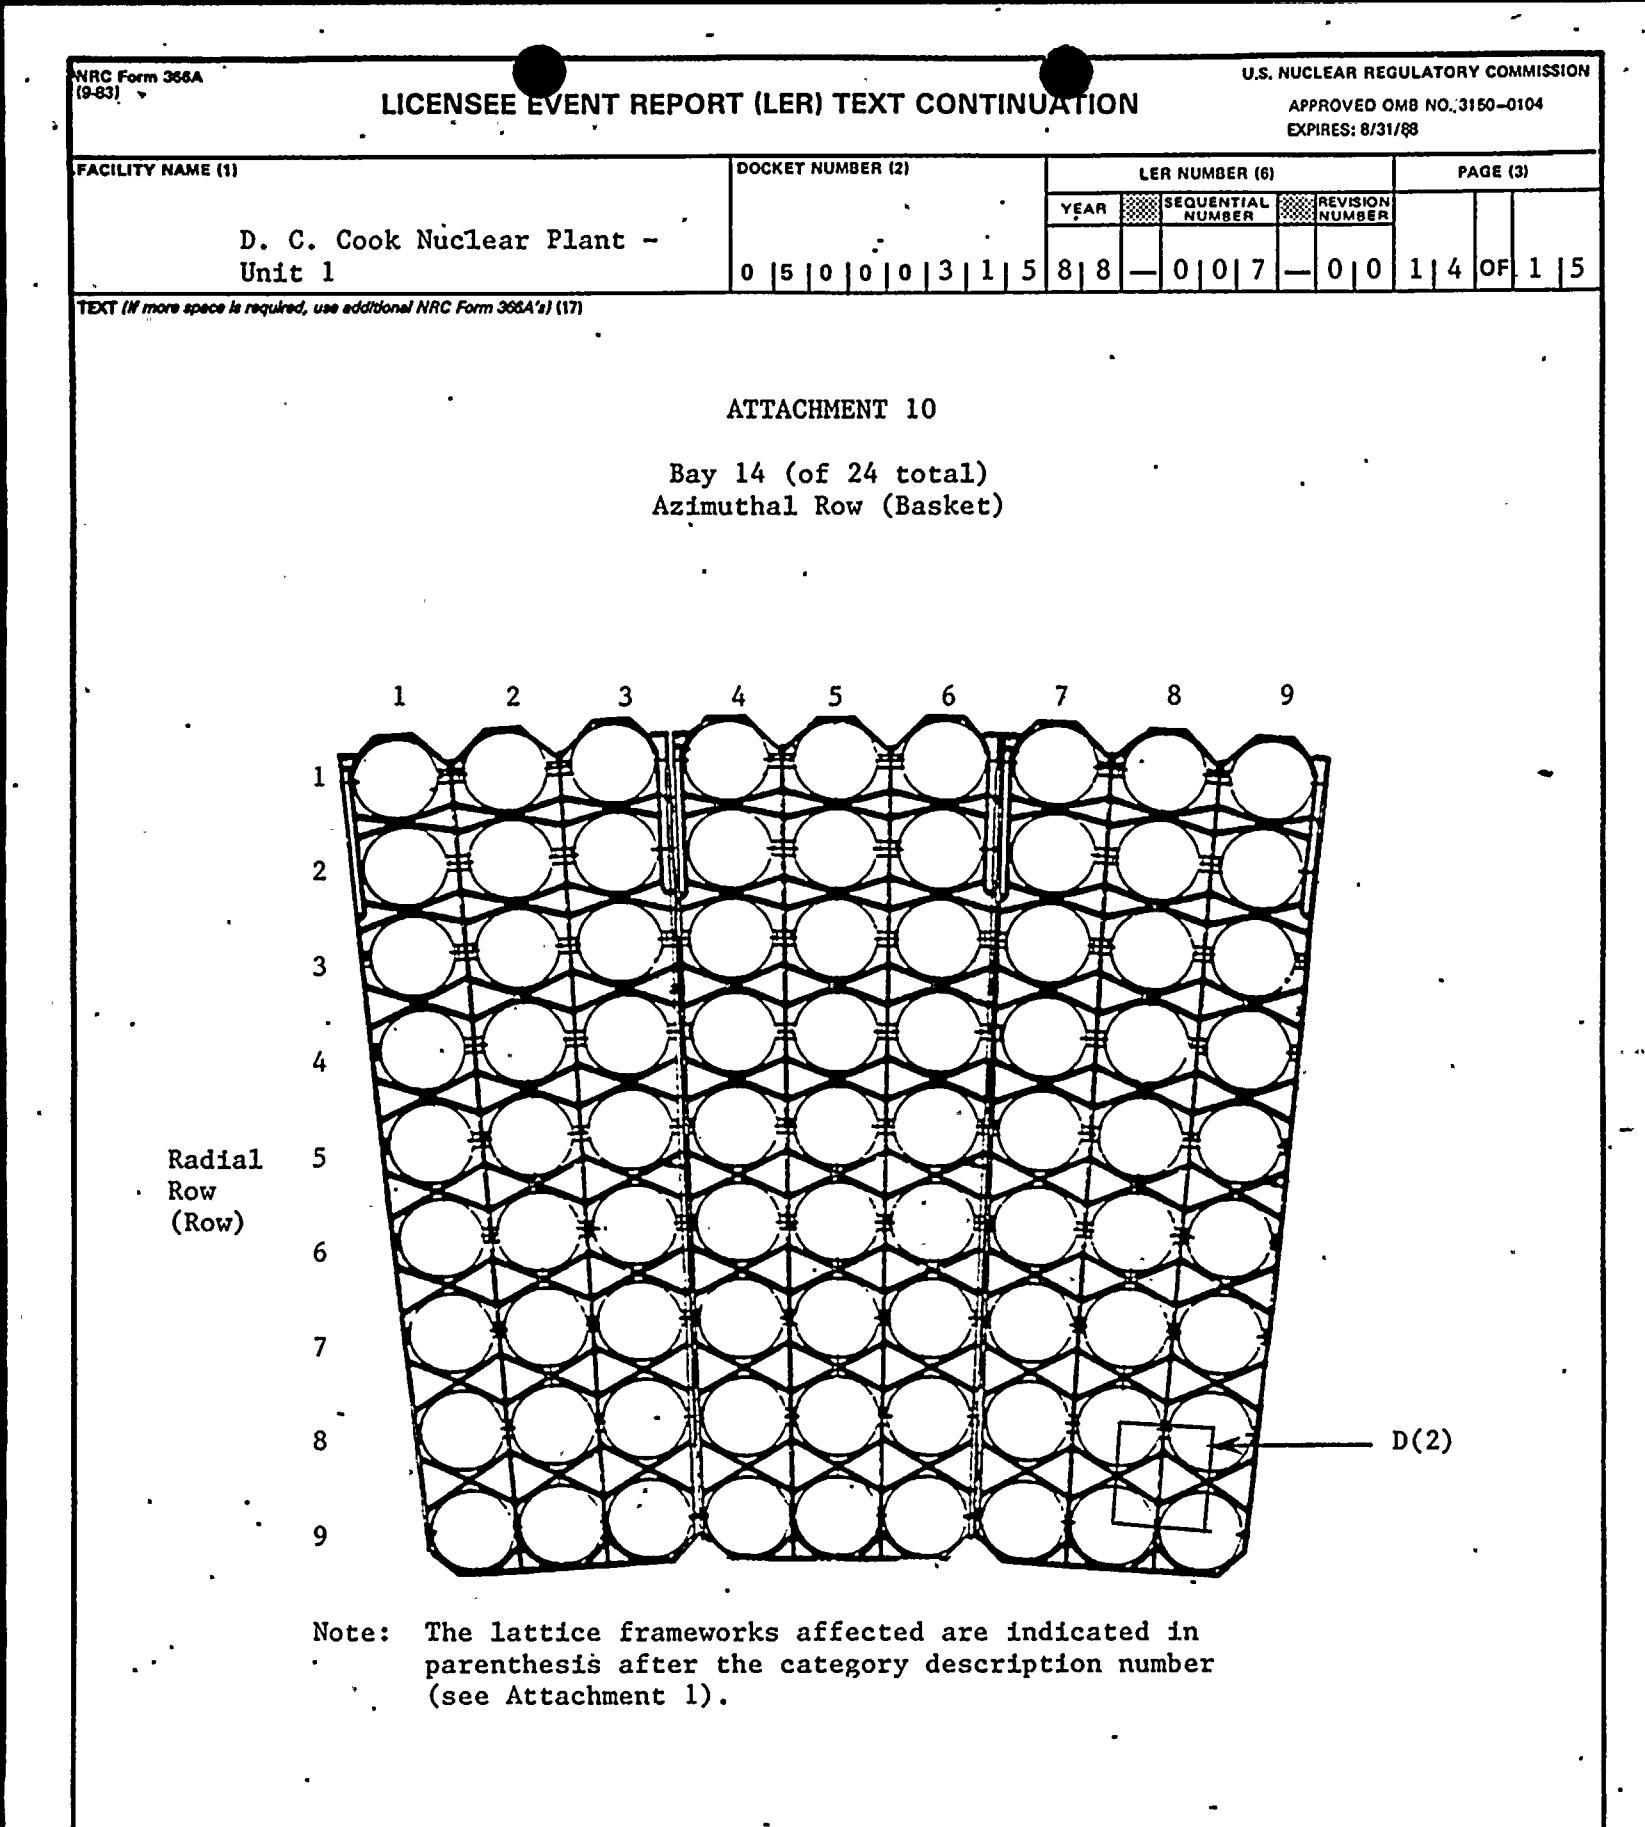
The as-found visual inspection of ice condenser (EIIS/COND) flow passages conducted on September 8, 1988, identified frost and ice accumulation greater than 3/8 inch in two flow passages in Bay 1, two flow passages in Bay 2, four flow passages in Bay 3, two flow passages in Bay 4, four flow passages in Bay 6, two flow passages in Bay 8, two flow passages in Bay 12, two flow passages in Bay 14 and two flow passages in Bay 15. Subsequently, the inspection was expanded to include at least twenty additional flow passages in each affected bay. This inspection revealed an additional two flow passages in Bay 2, six flow passages in Bay 3 and six flow passages in Bay 4 with more than 3/8 inch frost and ice buildup. A total of thirty-six flow passages were affected. There are a total of 3072 flow passages in the Ice Condenser. Attachments 1 through 11 graphically describe the geometry of the flow passages and the location of the ice/frost accumulation.

its entire length. Lattice Framework is located at the positions of cruciforms in the ice basket. Cruciforms are installed every six feet within the 48 foot ice basket (for convention the "top" lattice framework is referred to as number 1, etc.). The specific lattice frameworks affected are indicated on the individual Bay drawings (Attachments 3-11).

The corrective action was to manually clean the flow passages to remove the accessible frost and ice buildup.
