SUBJECT: LER 89-002-01: on 890116, non-svc induced deformation of  
 energy core cooling sys suction line. W/890407 ltr.  
W/8                      ltr.

FACILITY NAME (1) **D. C. Cook Plant - Unit 2** DOCKET NUMBER (2) **0 5 0 0 0 3 1 6 1** PAGE (3) **1 OF 0 6**

TITLE (4) **Non-Service Induced Deformation of Energy Core Cooling System Suction Line Seismic Restraint**

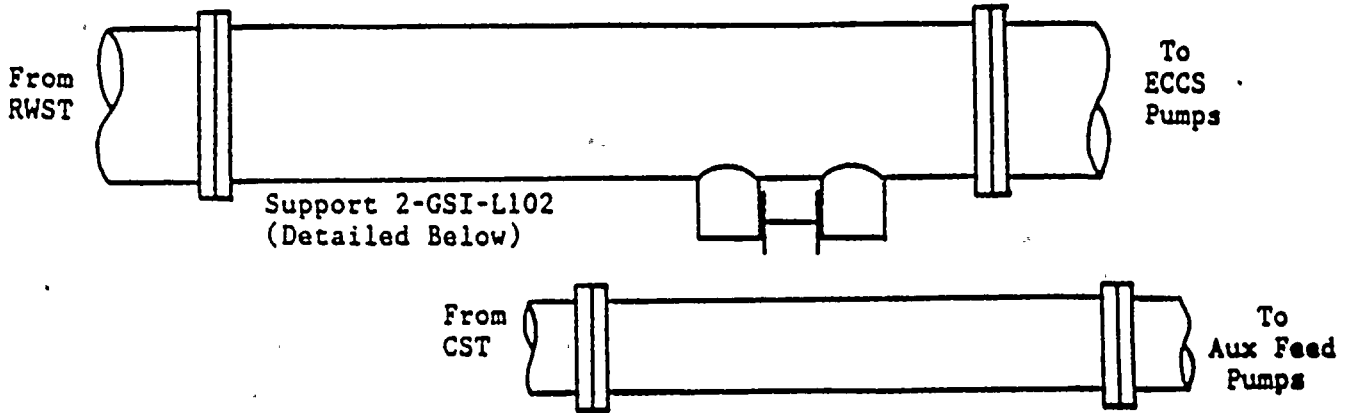
NORMAL PIPING CONFIGURATION

The investigation concluded that it is highly unlikely that the deformation of 2GSI-L102 was service induced as there have been no recorded unusual operating conditions, including a Design Basis Earthquake, which could have resulted in such significant deformation. The location of the restraint, on the suction side of the ECCS pumps, supports the likelihood that this type of deformation did not occur during service.

A review of modifications made to the system identified one potential cause for the deformation of 2GSI-L102. In order to facilitate flushing and other startup activities prior to initial unit startup a modification was made to the system, (changing this section of piping to a spool piece) to allow this portion of piping to be removed and replaced with a "jumper" spool piece. The modification, performed in 1976, was completed with one minor change to the original design; i.e., the subject restraint was moved to prevent interference with newly installed flanges. No other problems were noted. A Quality Control inspection report from August 1977 noted no problems with the restraint. The startup activities removed the modified pipe section and replaced it with a spool piece connecting the ECCS pump suction to the Condensate Storage Tank (CST) (see ATTACHMENT 1). Upon completion of the startup activities, the piping was restored. It is believed that the deformation of the restraint occurred during this evolution; however, no documentation of such deformation could be located. The corresponding restraint for Unit 1 was examined. There was no similar modification performed on Unit 1 and no deformation of the restraint was seen.

Due to the extent of the deformation of 2GSI-L102, it was not possible to return the restraint to its original design configuration. A revised design was developed to reinforce the restraint and reestablish the gap clearances specified by the original seismic design. A modification was initiated along with an ASME Section XI repair plan to repair the restraint. Repairs have been completed and the restraint visually inspected for final acceptance.
