SUBJECT: Informs of preliminary assessment of 900713 electrical contact accident at facility.

The purpose of this letter is to inform you of our preliminary assessment of the electrical contact accident that occurred at the Donald C. Cook Nuclear Plant on July 13, 1990.

DESCRIPTION OF ACCIDENT - July 13, 1990

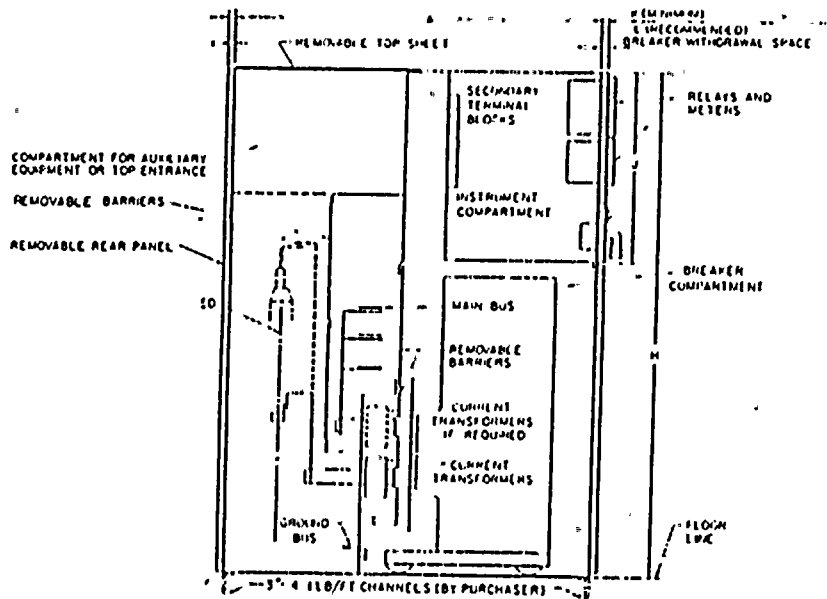
5 HK INDOOR SWITCHGEAR

Typical Drawing of ITE 5HK 250 4KV Metal-Clad Switchgear

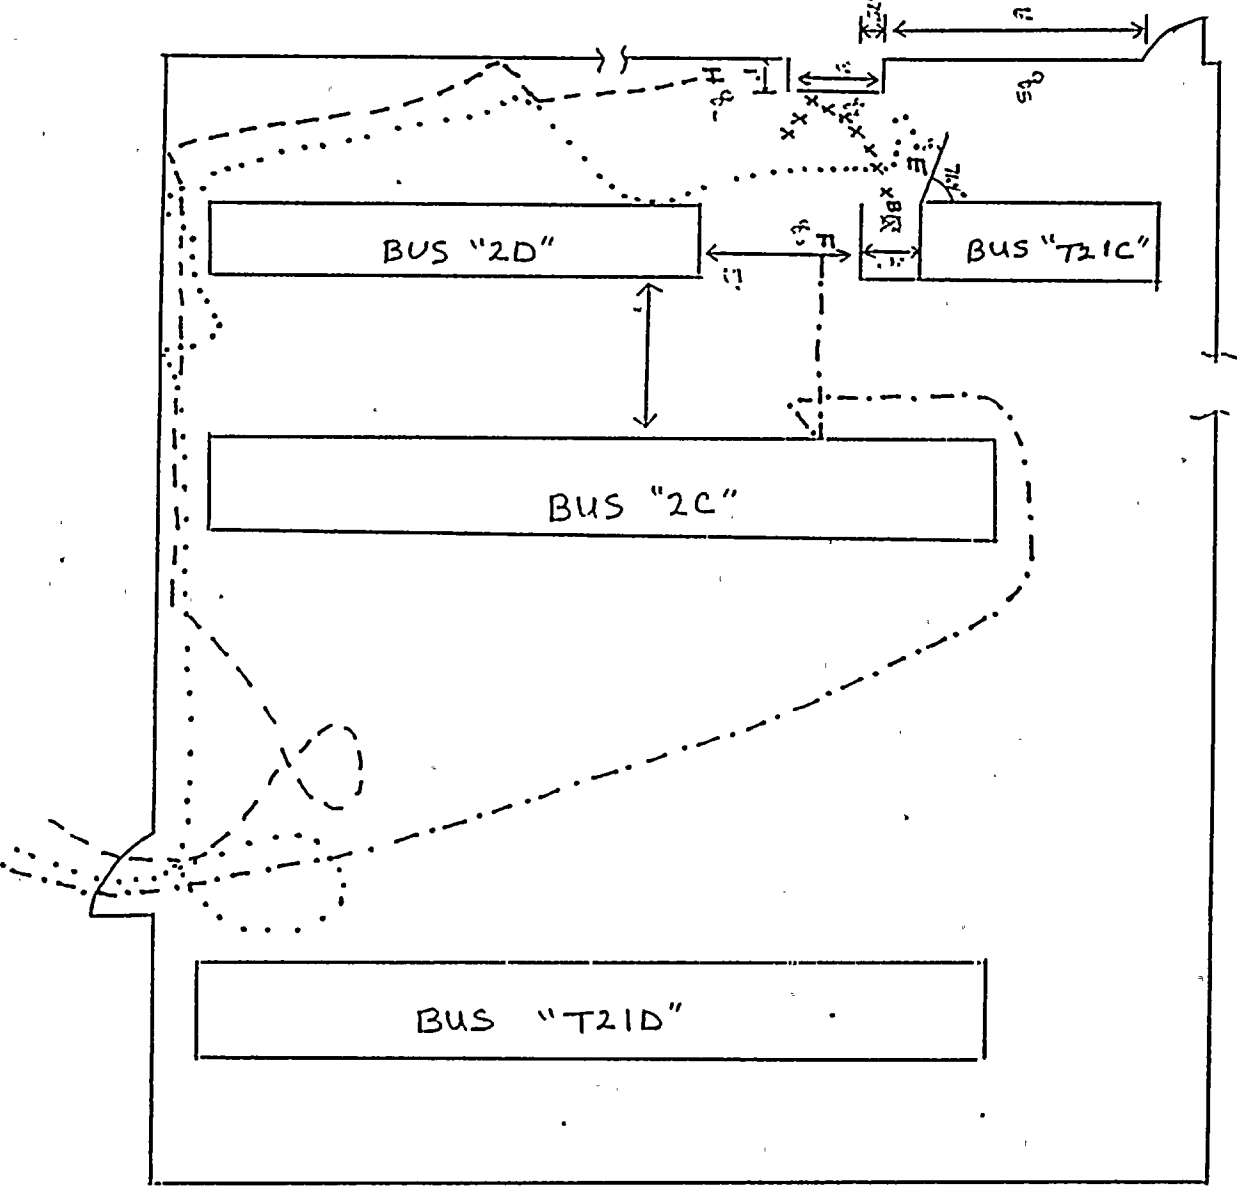
SUSPECTED MEANS OF ENTRY

..... ITC TECH (A)

----- NSS-2 (H)

----- M/M A (F)

XXXX NSS-1 (B)

ADDITIONAL PARAMETERS

Source: 4650F

Q₁ - greater than 2000°F

Q₂ - greater than 850°F

Q₃ - greater than 850°F

Q₄ - greater than 850°F

Q₅ - greater than 300°F
