WCAP-14447

Repair Boundary for Parent Tube Indications  
Within the Upper Joint Zone of  
Hybrid Expansion Joint (HEJ) Sleeved Tubes

September 1995

WESTINGHOUSE ELECTRIC CORPORATION  
NUCLEAR SERVICES DIVISION  
P.O. BOX 158  
MADISON, PENNSYLVANIA 15663-0158

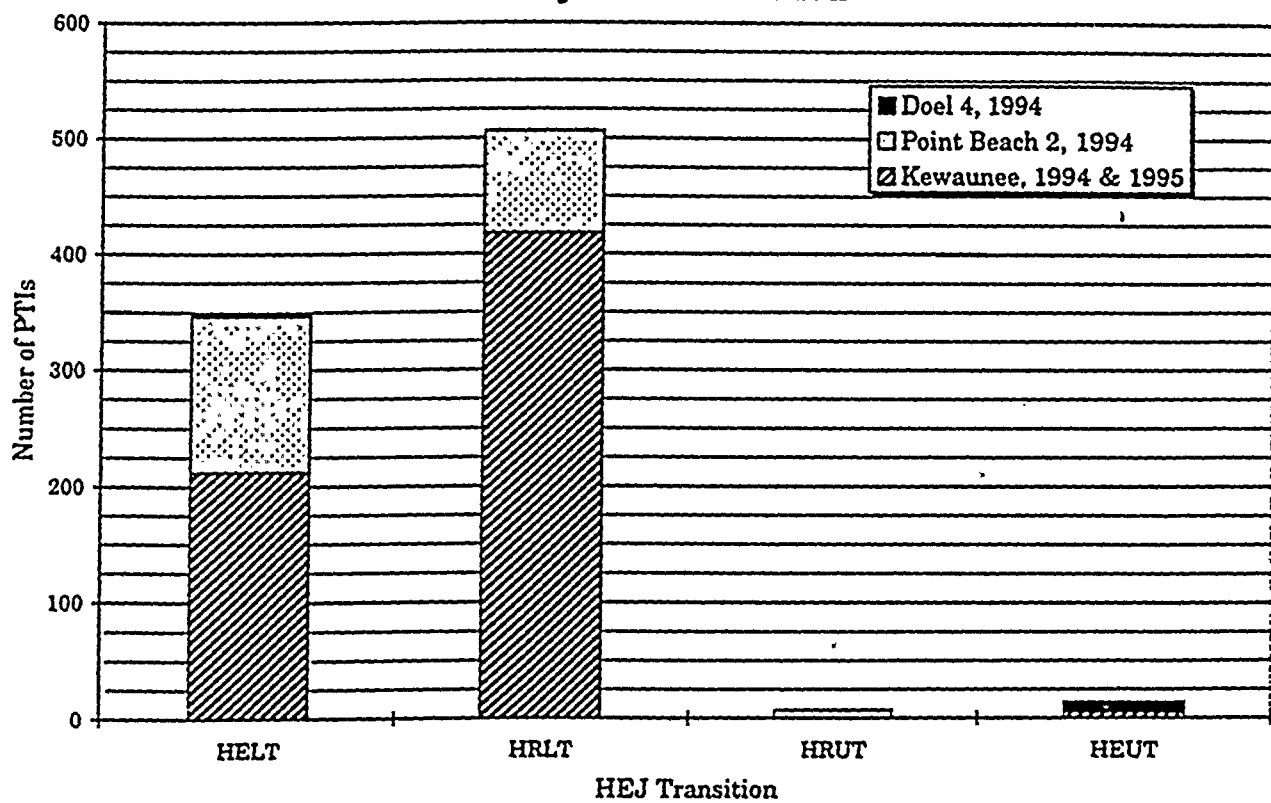
Figure 4-2

In summary, PTIs have been detected in HEJ sleeved tubes at three plants during a total of four inspection outages, two at Kewaunee, one at Point Beach 2, and the initial inspection outage at Doel 4. A summary of approximately all known PTIs is provided in Table 4-3. In total, about 60.5% occur at the HRLT and 37.2% at the HELT. About 0.7% have been found at the HRUT, and the remaining 1.6% at the HEUT. These distributions are illustrated in histogram form on Figure 4-1 and in "pie" chart form on Figure 4-2. The incidence of indications at the upper transitions in plants in the United States (US) comprises about 1.5% of the reported indications. Thus, the distribution at Doel 4 is atypical of the occurrences in the US. In no instances have indications been detected in the same tube at upper and lower transitions.

**Distribution of All Circumferential PTIs by Transition**

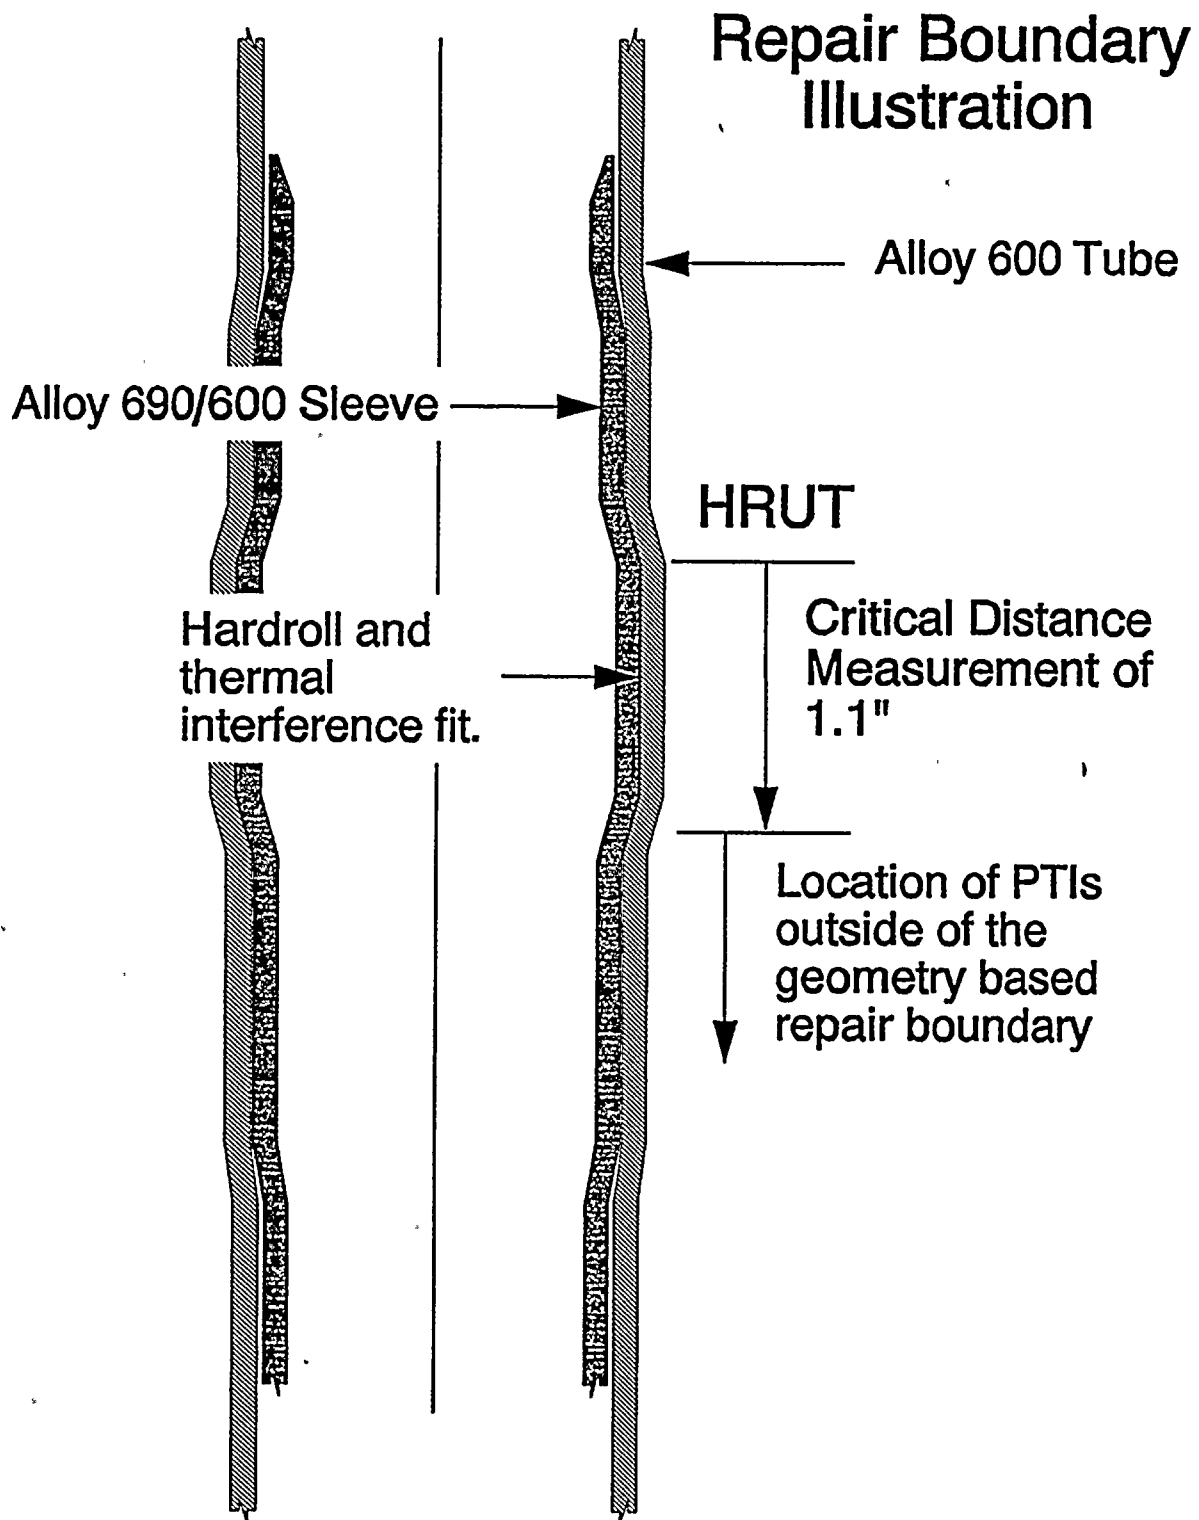
This evaluation forms the basis for the development of a repair boundary below which the need to remove a HEJ sleeved tube from service due to the presence of PTIs in the region extending downward from the upper part of the HRLT, e.g., see Figure 7-1. The integrity of the tube bundle with PTIs under normal operating and postulated accident conditions is addressed. The results of the evaluation apply to sleeved tubes in Westinghouse Model 44 and 51 steam generators with partial depth rolled tubes. Three aspects of bundle integrity are addressed:

Figure 7-1: Illustration of the leak based criterion for HEJ sleeved tubes.

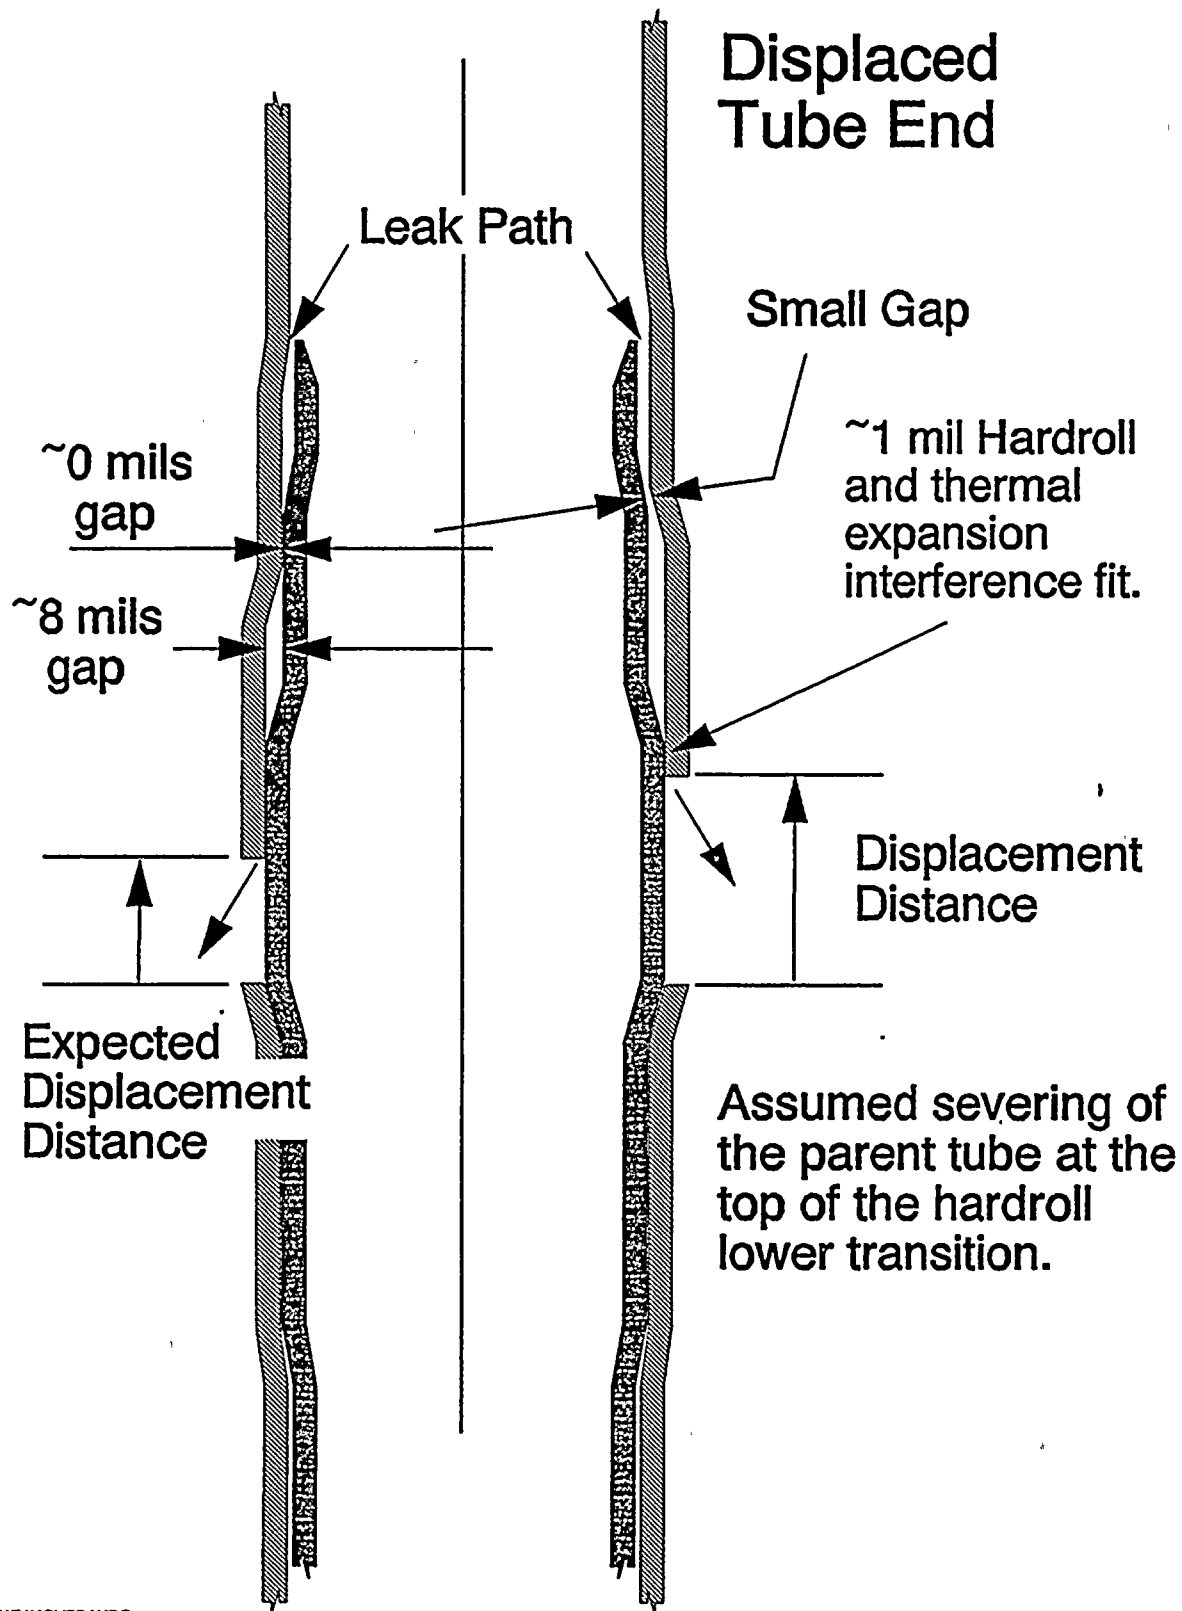
Since hop-off is precluded, the pertinent basis for the development of the leak rate repair boundary is the potential leakage from tubes with throughwall, 360°, PTIs which could displace upward either during normal operation or during a postulated SLB. The potential displacement during a postulated SLB is greater than that during normal operation, as is the primary-to-secondary differential pressure, hence, it is appropriate to develop the repair boundary based on the consideration of potential leakage during a postulated SLB. Vertically displaced severed tube conditions are illustrated on Figure 7-2. The expected displacement for a tube end severed at the top of the hardroll lower transition would be about midway along the length of the hardroll, with a 95 % confidence bound on the displacement such that the location of the severed end would be about even with the top of the hardroll. Indications below the top of the hardroll would not be expected to lead to a configuration such that the severed end could achieve an elevation coincident with the top of the hardroll.

Figure 7-2: Leak path for a moved tube segment relative to the sleeve.

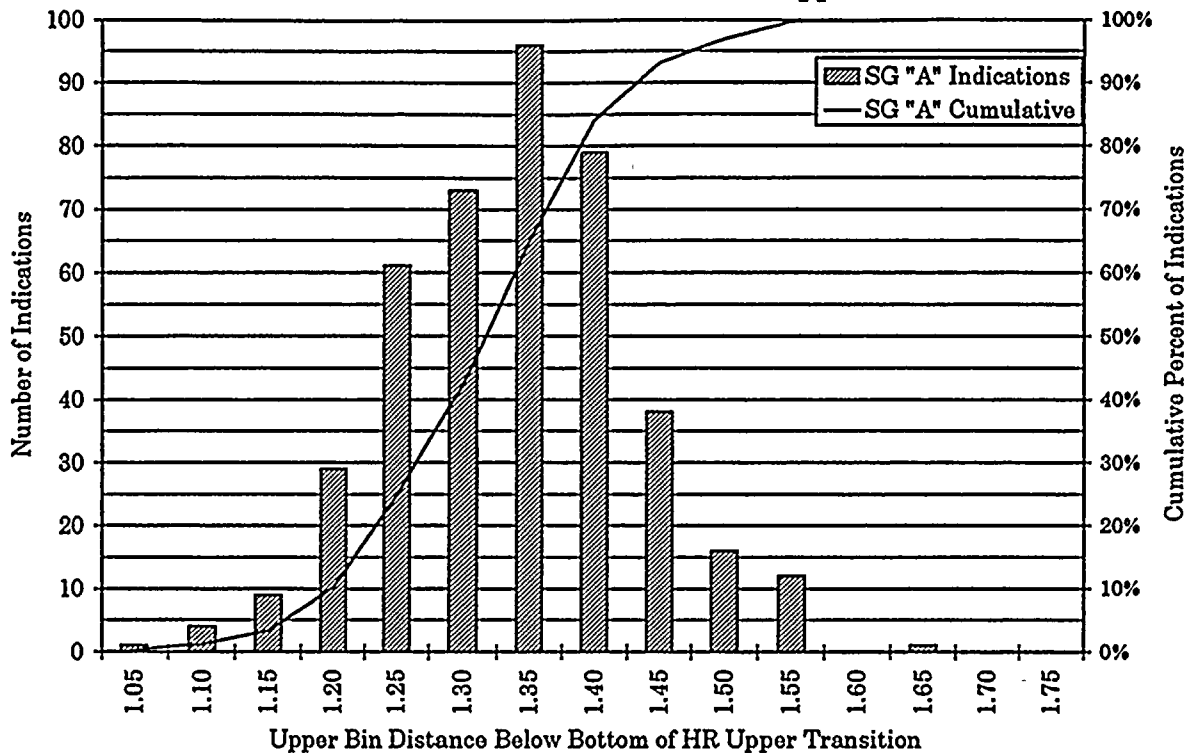
The distance from the bottom of the hardroll upper transition to the elevation of the indications in the Kewaunee SG tubes was measured for each indication near the elevation of the hardroll. A summary of the measured distances for each SG and for the combined SGs is provided in Table 7-3. Histogram and cumulative frequency plots of the distribution of indications in SGs "A" and "B" are provided on Figure 7-3 and Figure 7-4 respectively. The combined distribution and cumulative frequency information for both SGs is provided on Figure 7-5.

SG "A" HEJ Sleeved Tube Indications vs.  
Distance Below the Bottom of the Hardroll Upper Transition

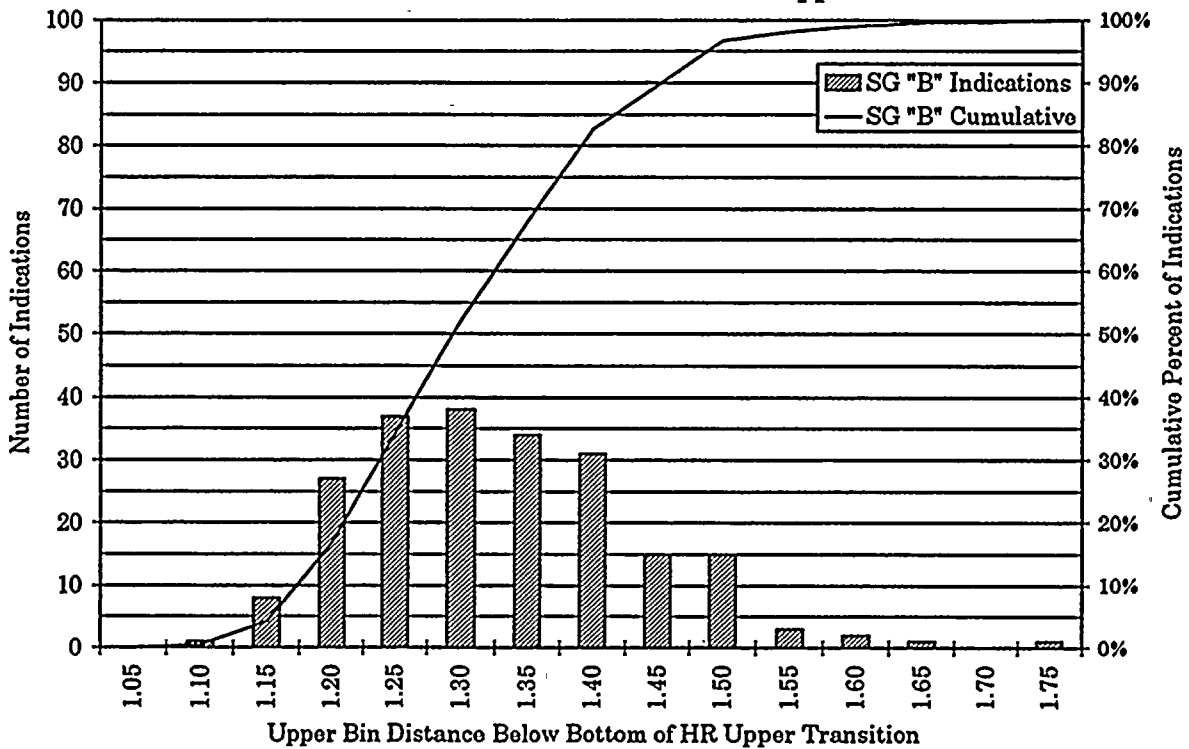
Figure 7-4

SG "B" HEJ Sleeved Tube Indications vs.  
Distance Below the Bottom of the Hardroll Upper Transition
