TURKEY POINT 3 STEAM GENERATOR  
INSPECTION PROGRAM

I. Introduction

An extensive inspection program for the Turkey Point Unit 3 steam generators was conducted in October, 1980. The following items were accomplished:

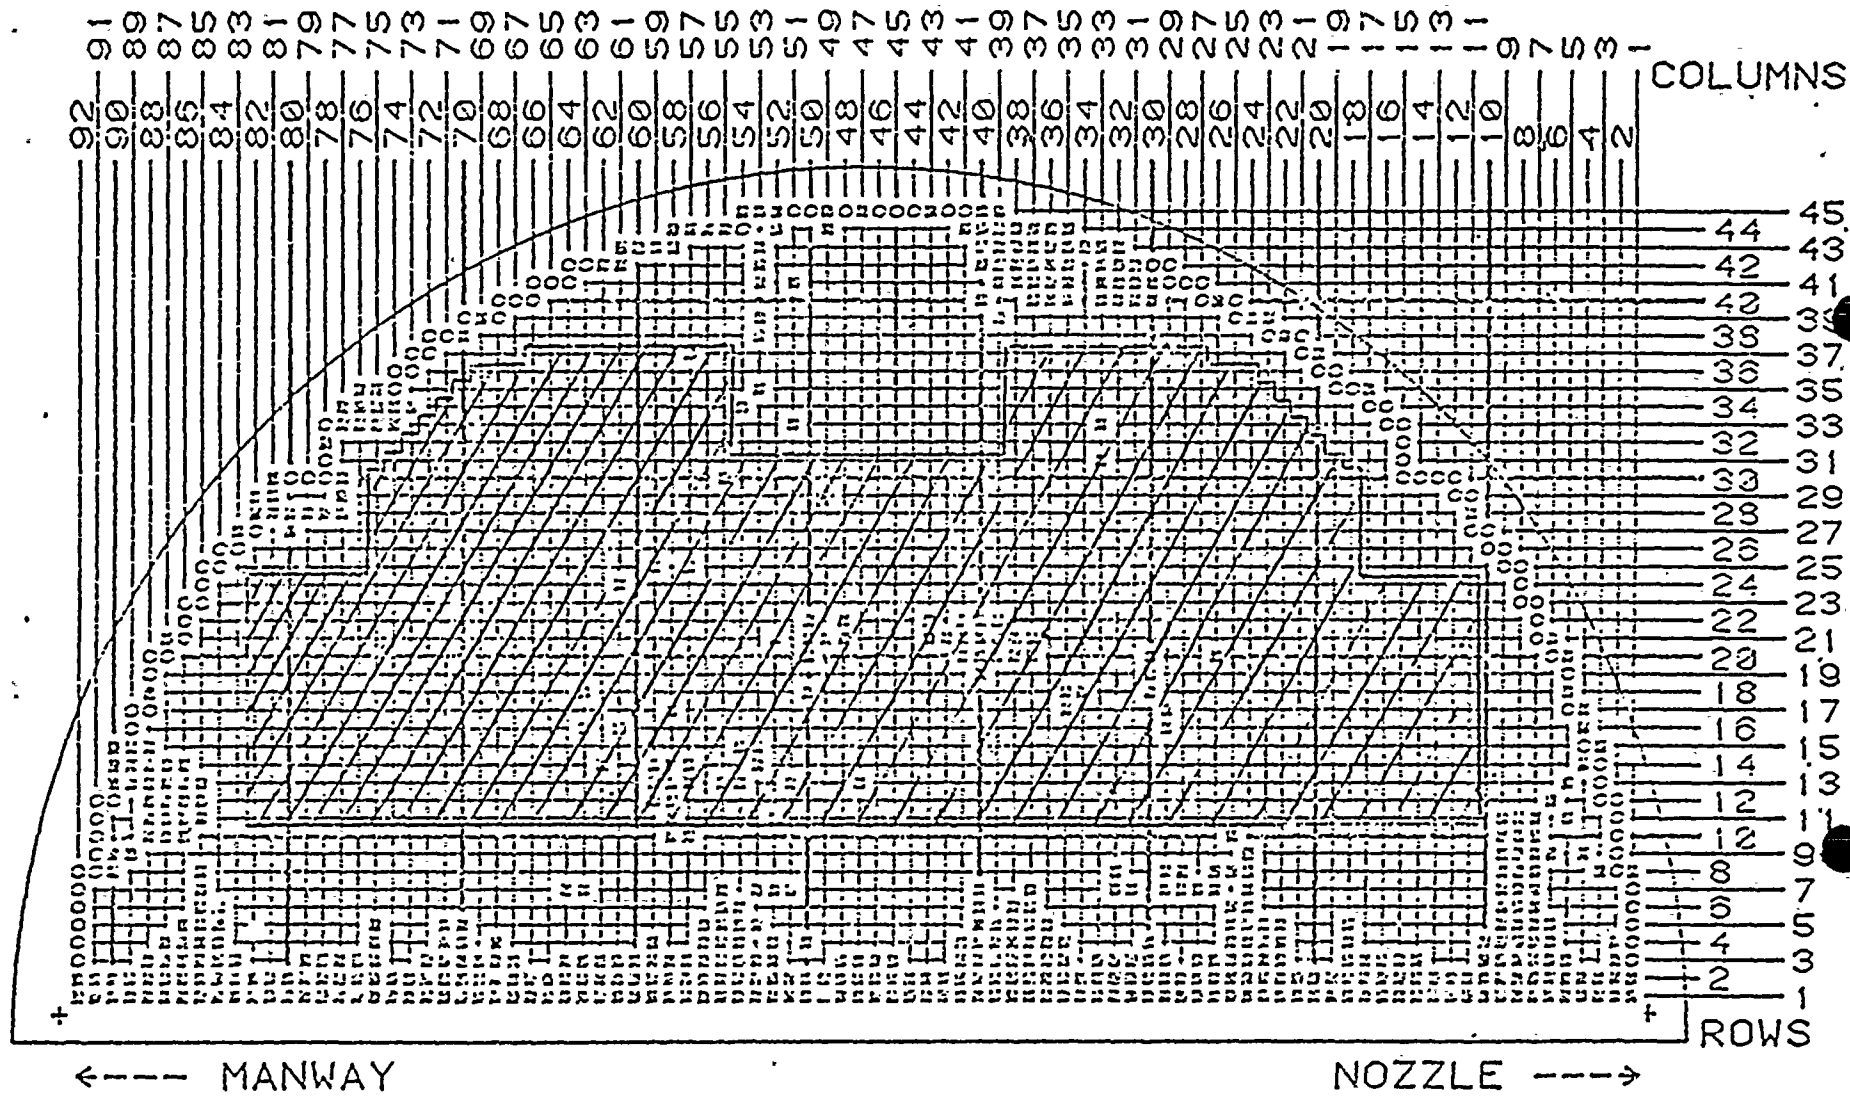
FIGURE 2 A

The inspection boundary for the December 1979 inspection (Figure 2) is included for reference. The gauging inspection boundaries for the October 1980 inspection are indicated in Figure 3 (typical hot leg) and Figure 4 (typical cold leg).

TYPICAL GAUGING INSPECTION  
 BOUNDARY - HOT LEG  
 DECEMBER 1979 INSPECTION  
 Test Unshaded Region

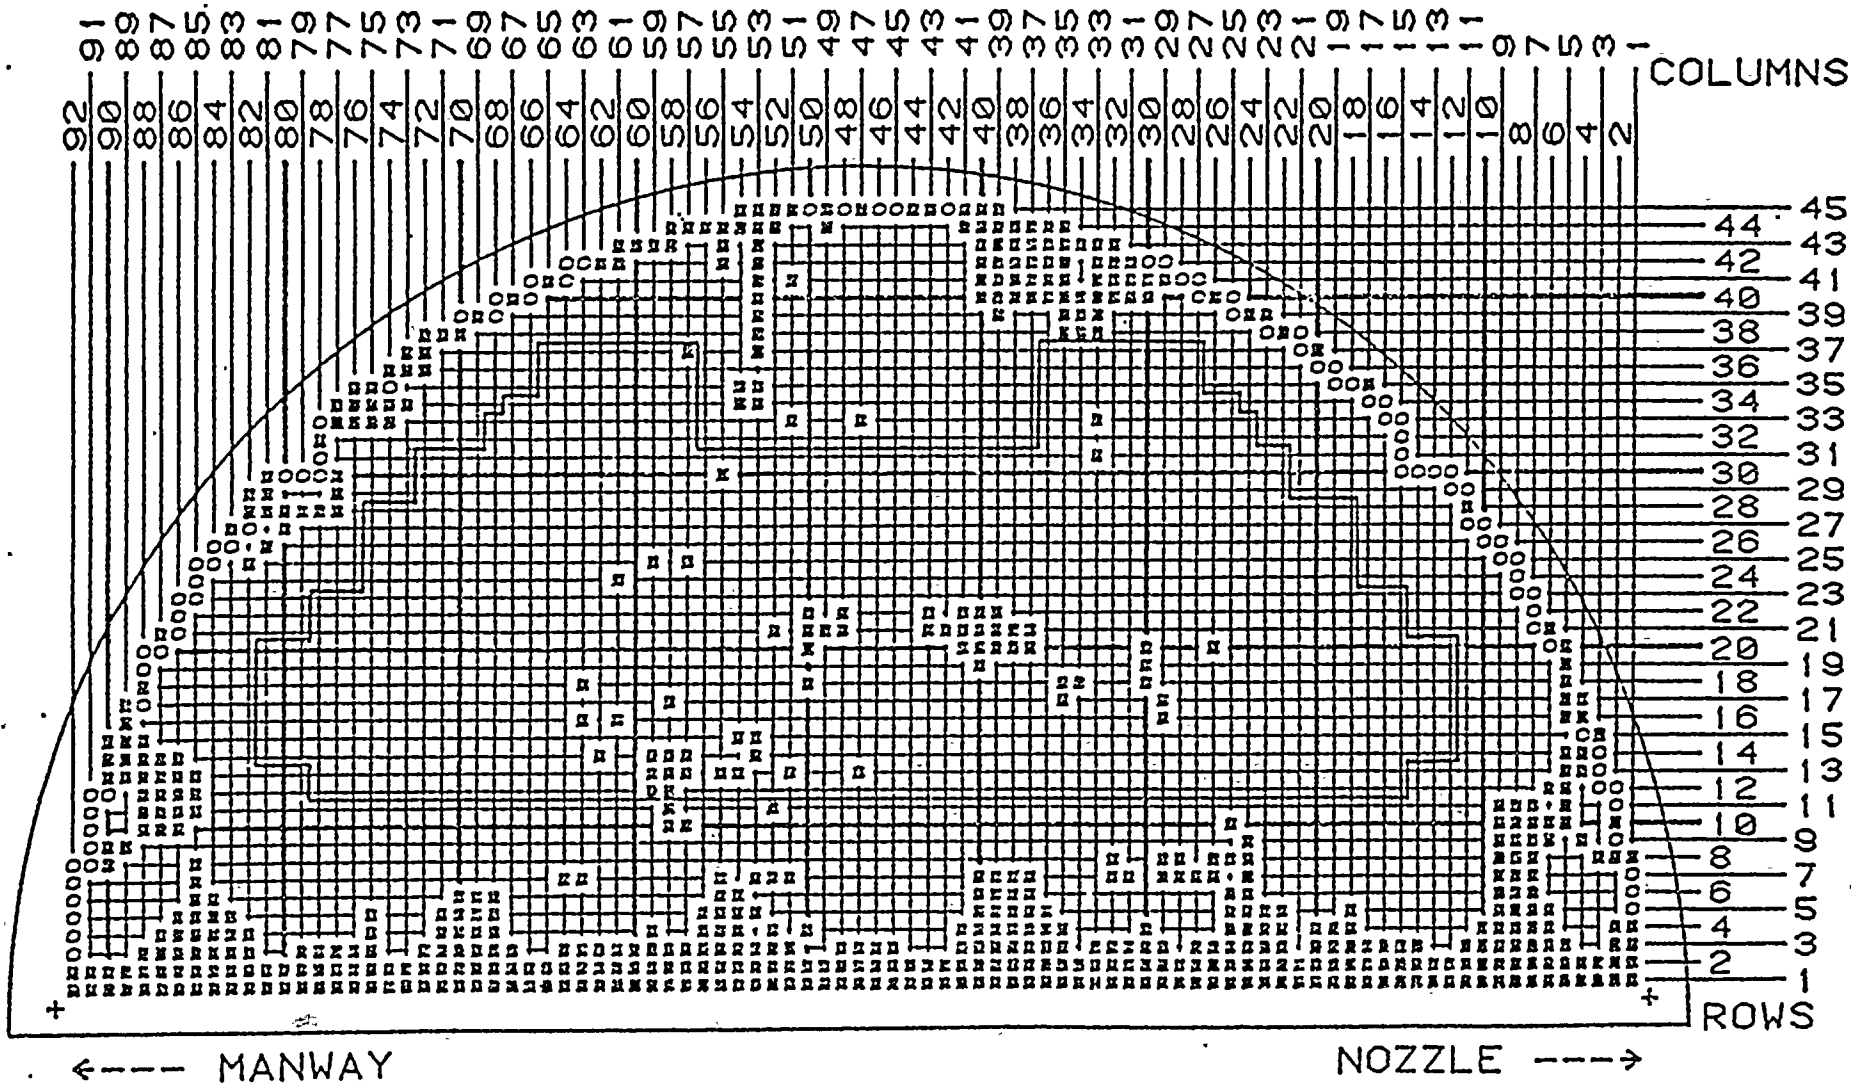
FIGURE 3

GAUGING PROGRAM (TYPICAL) INLET

GAUGE ALL TUBES OUTSIDE BOUNDED AREA, OCTOBER, 1980

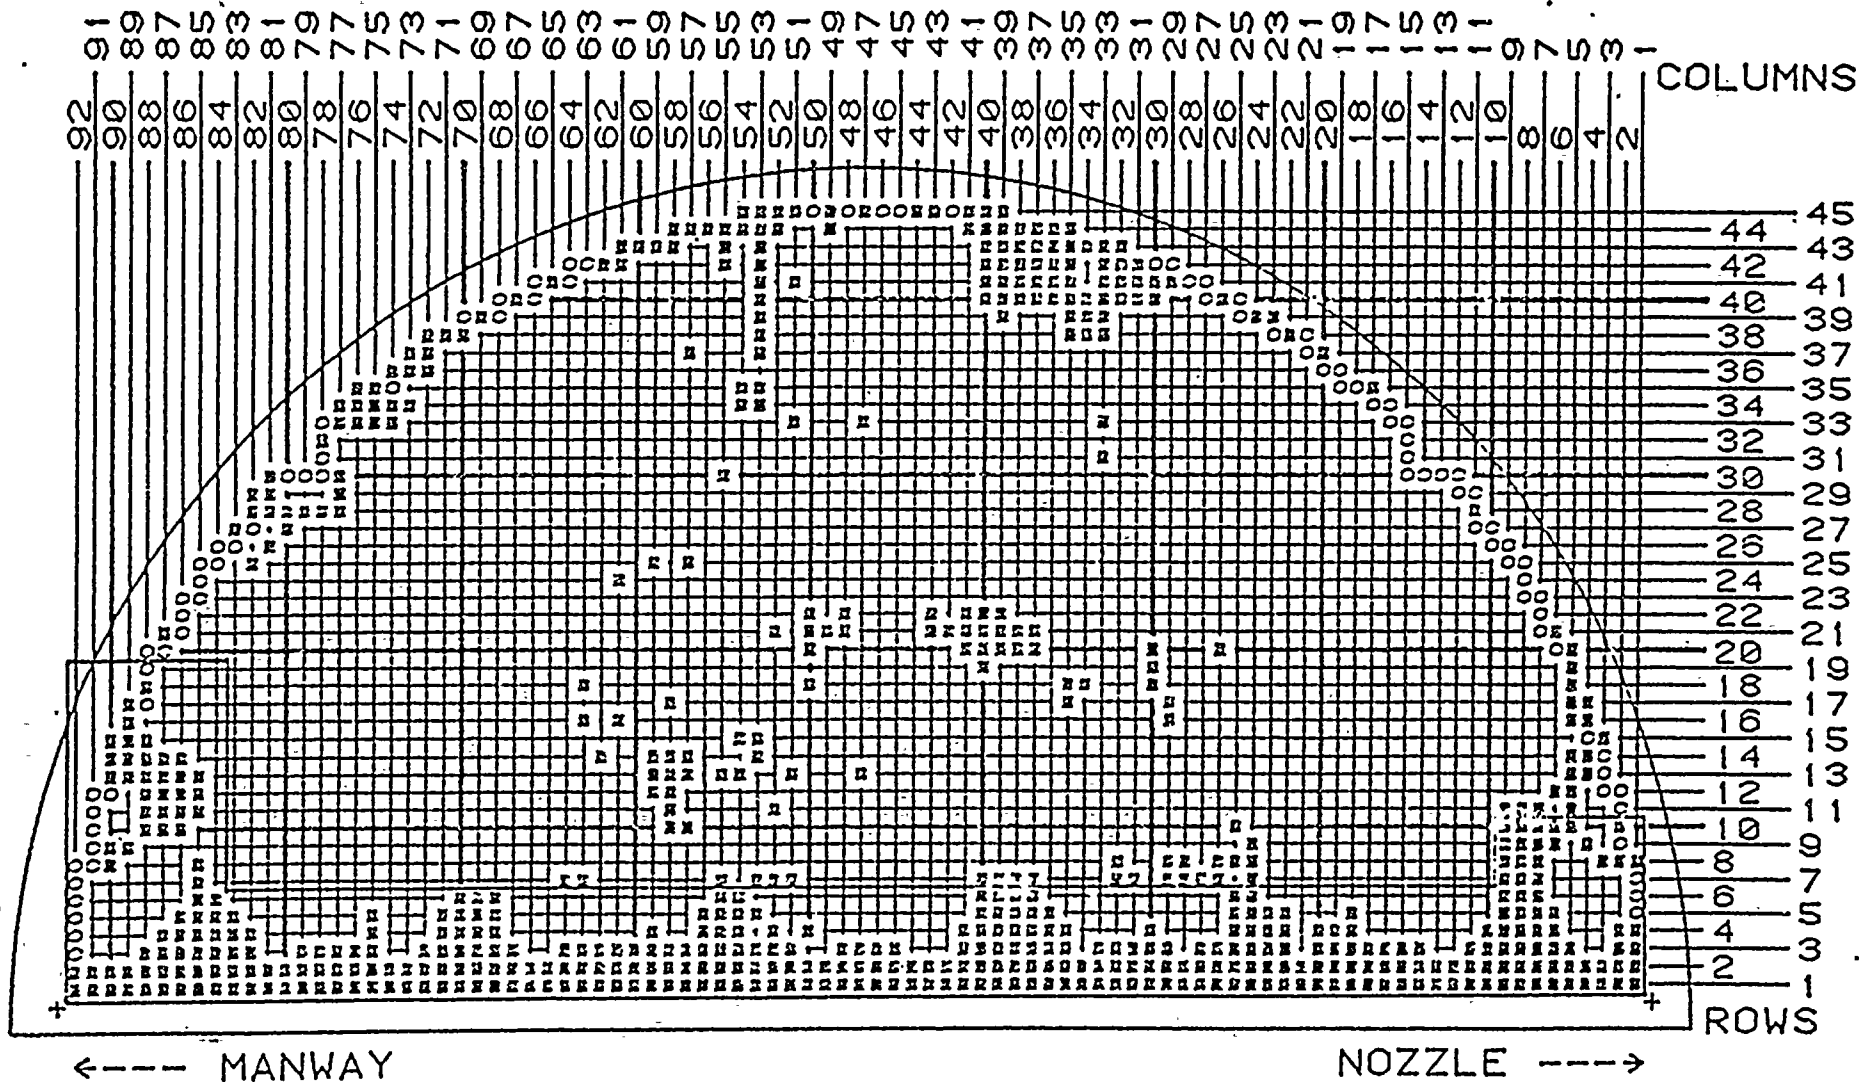
FIGURE 4

GAUGING PROGRAM (TYPICAL) OUTLET  
 GAUGE ALL TUBES WITHIN BOUNDED AREA  
 OCTOBER, 1980

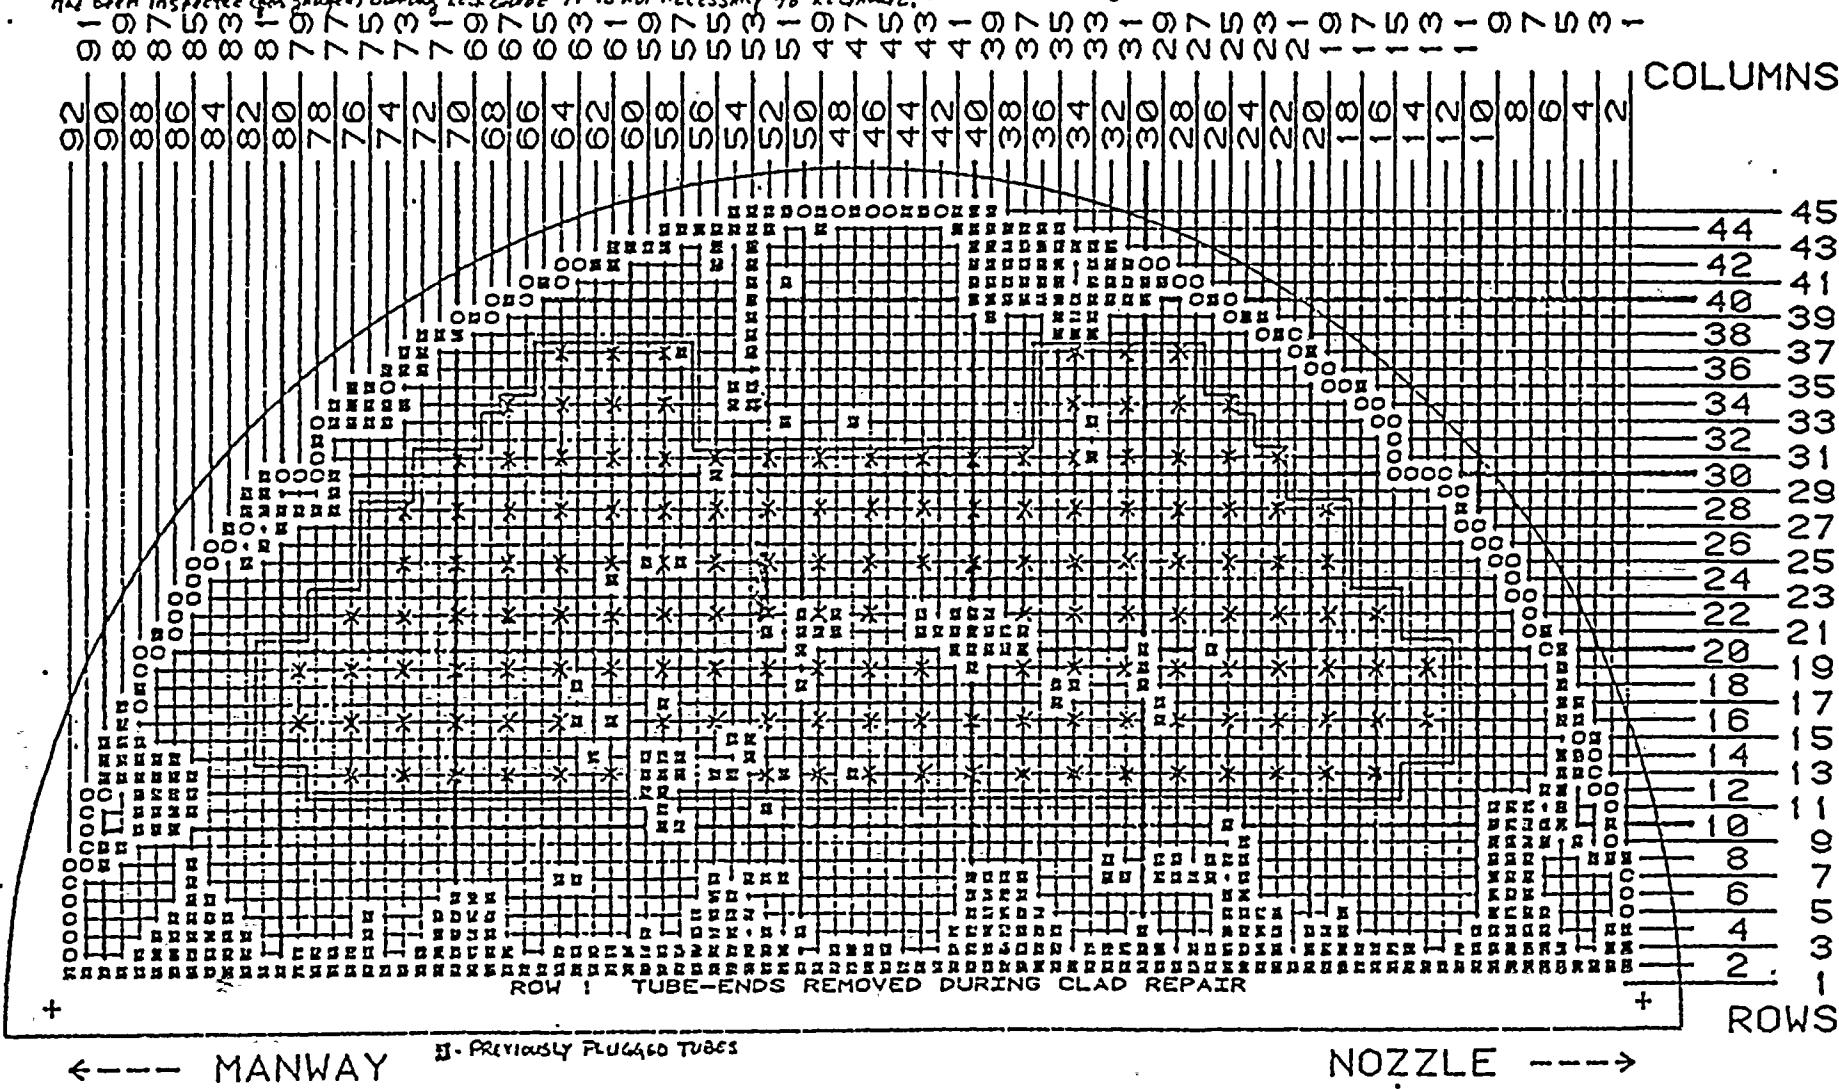
FIGURE 5

The types and extent of inspections required in this area are specified in R.G. 1.83. Typical inspection plans are included (Figures 5 and 6). During the inspections, expansions of the program in steam generators A and C were accomplished as required by R.G. 1.83. Results of the inspection are discussed later in this report.

Regulatory Guide 1.83 Inspection  
Program (Typical) - Inlet Leg

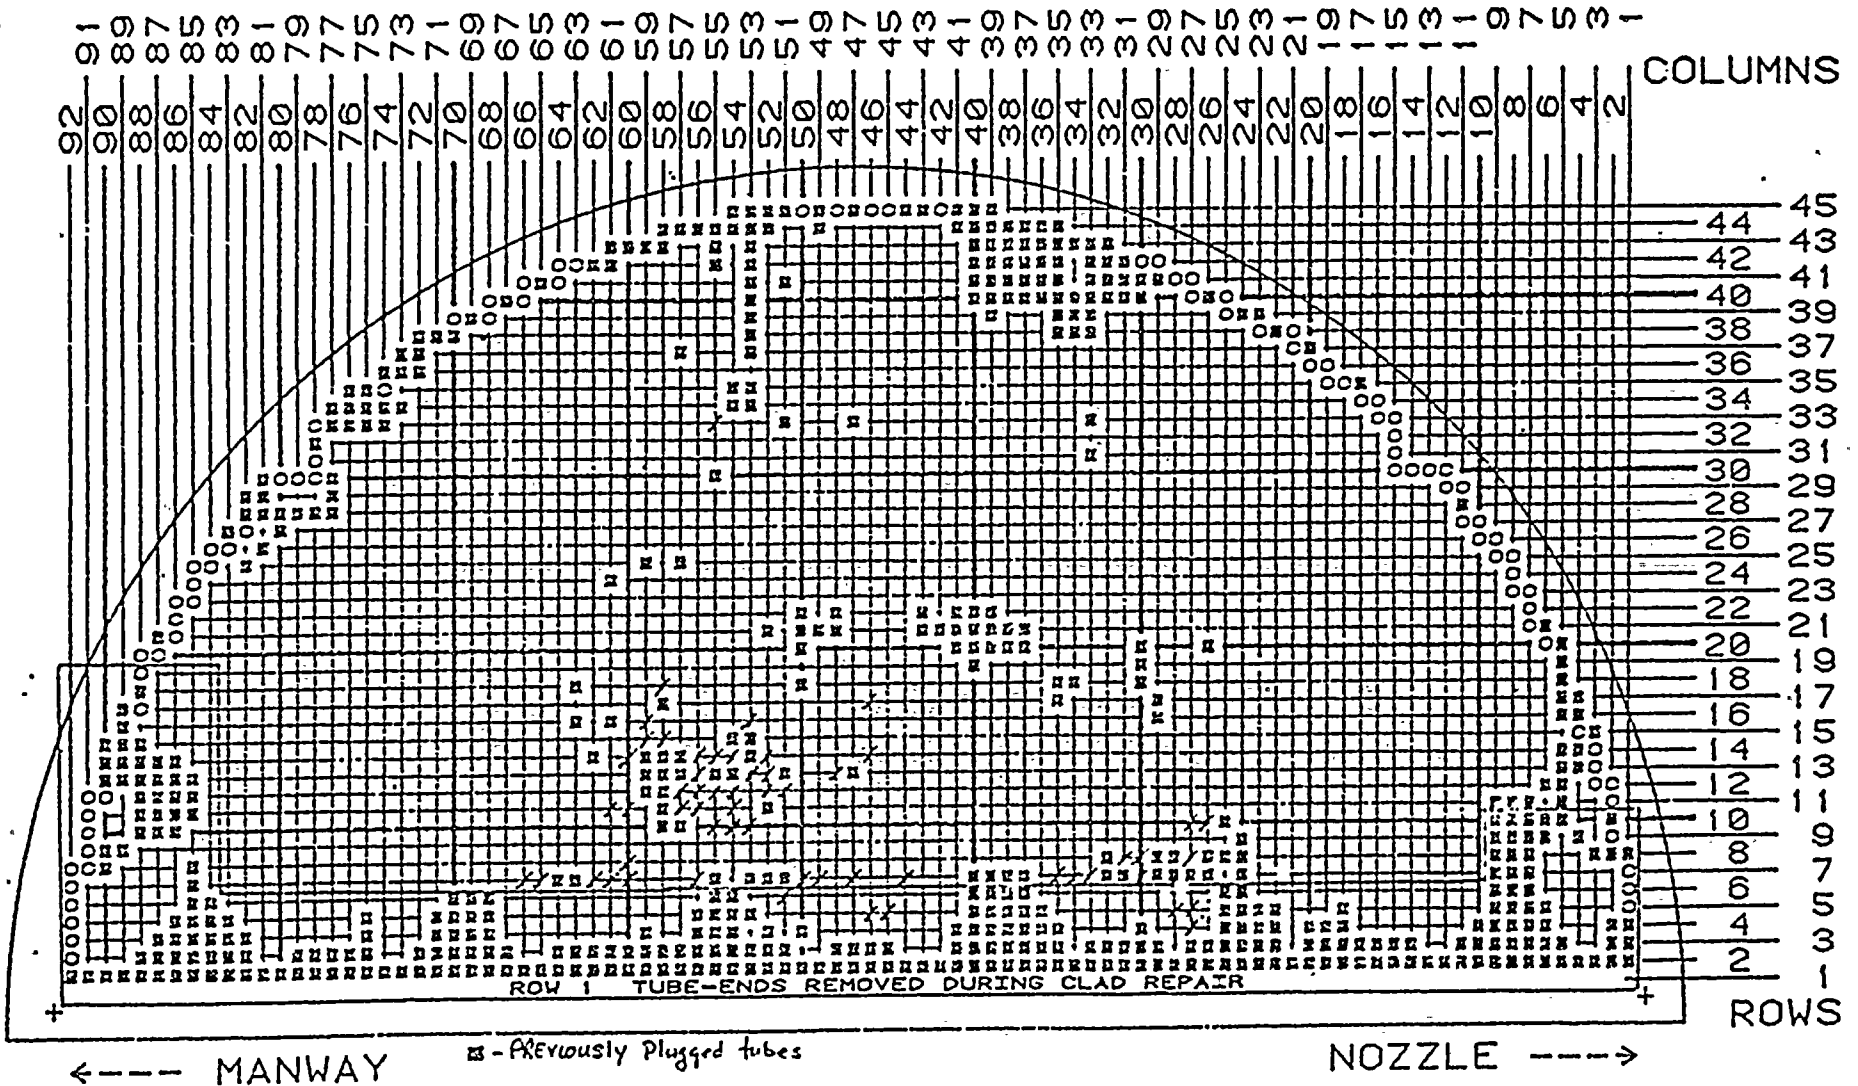
FIGURE 6

Regulatory Guide 1.83 Inspection Program (Typical) - Outlet Leg
