REPORT ON INSTRUMENTATION PORT

COLUMN ASSEMBLY LEAKAGE

FLORIDA POWER & LIGHT COMPANY

TURKEY POINT UNIT 4

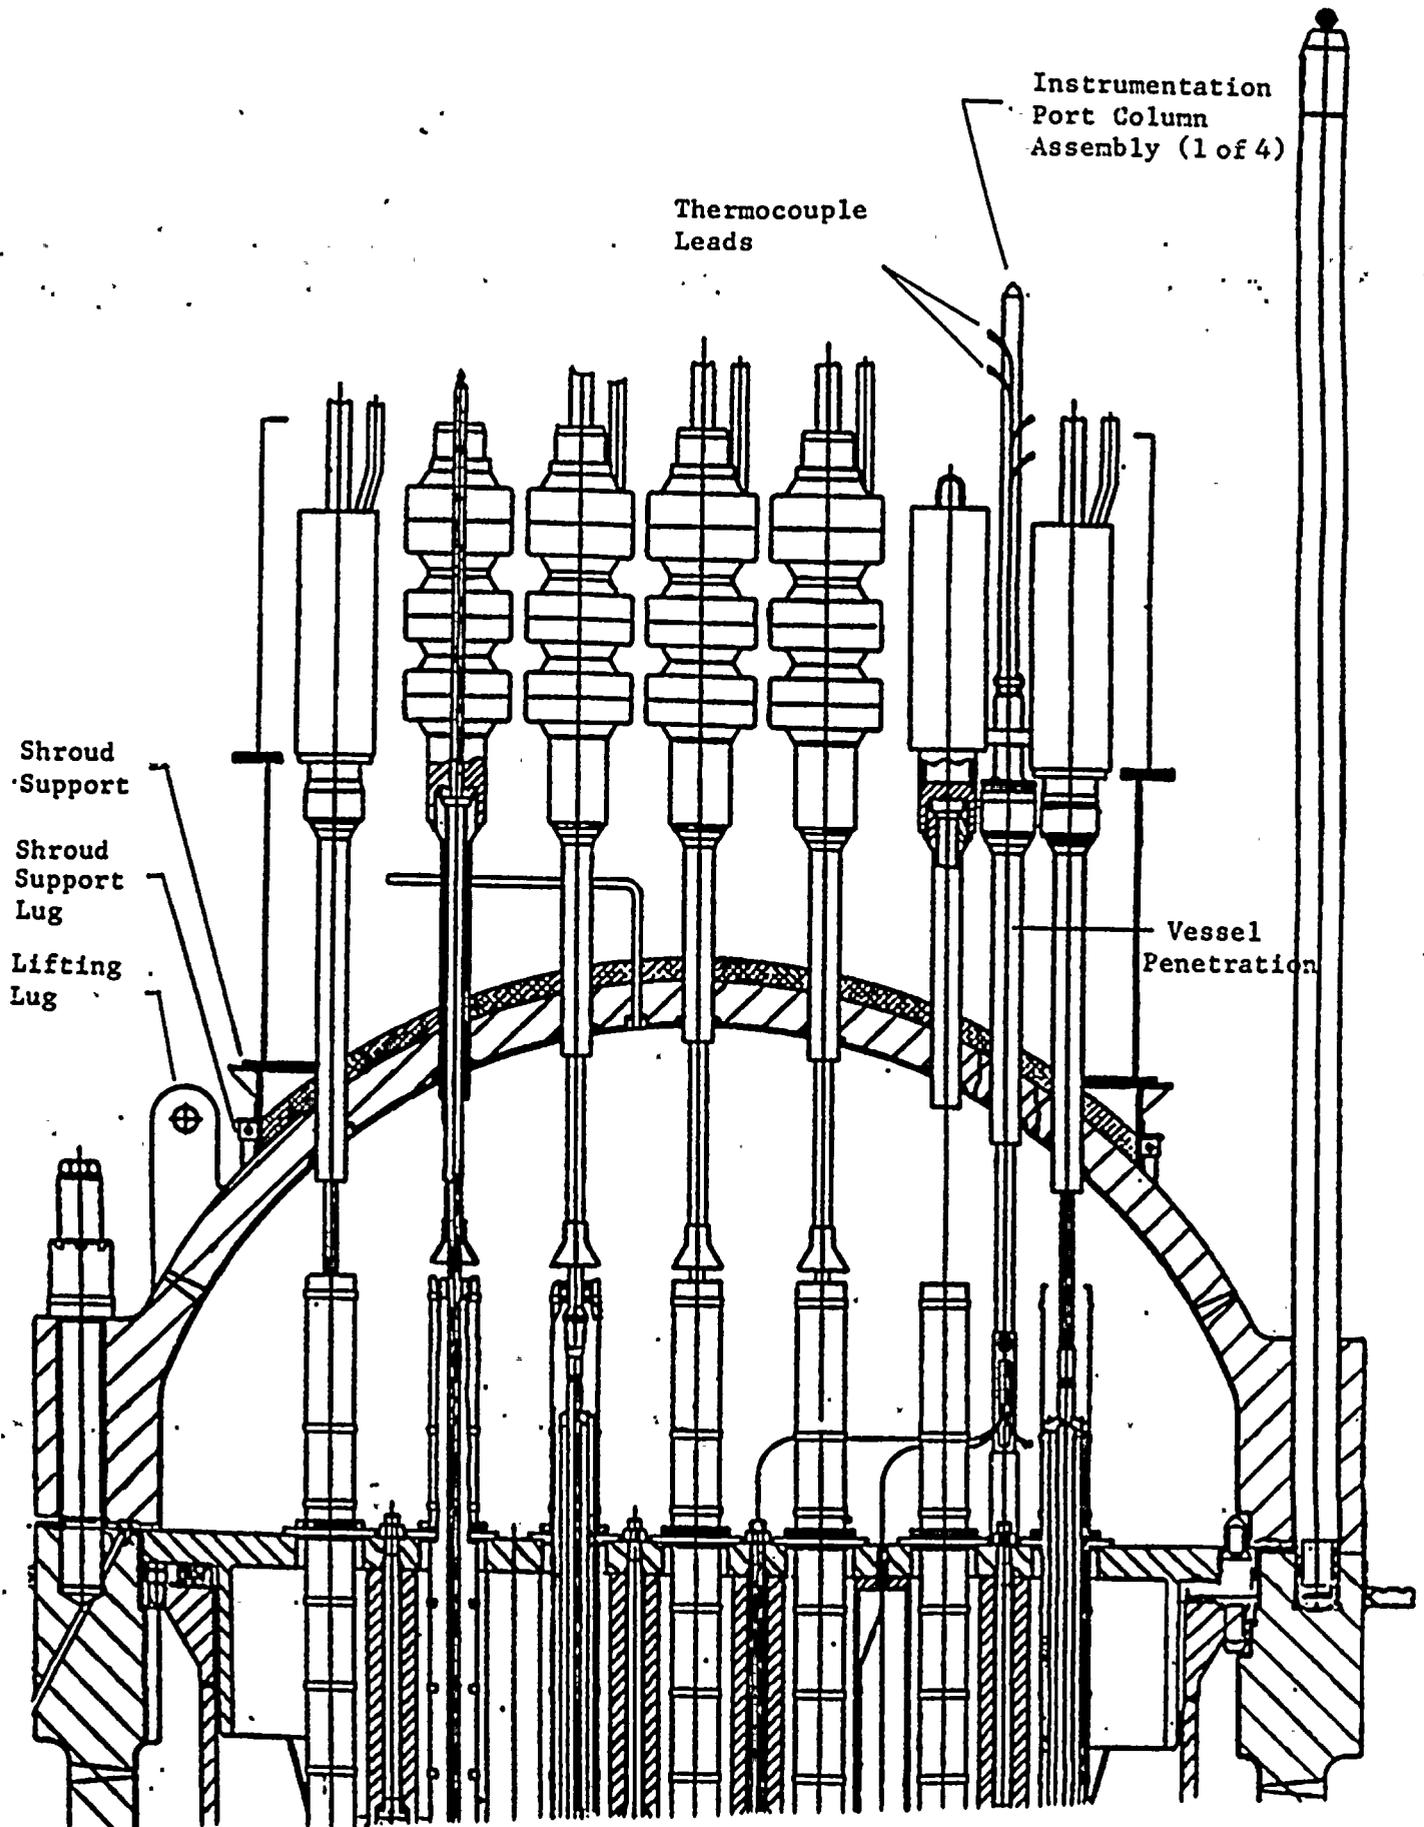
Figure 3-1: General arrangement of instrumentation port column assemblies

As shown in Figure 3-1, the thermocouples penetrate the reactor vessel closure head by utilizing four instrumentation port column assemblies. These instrumentation port column assemblies are pressure-retaining vessel appurtenances which can be disassembled to permit removal of the reactor vessel head from the reactor vessel for activities such as refueling.

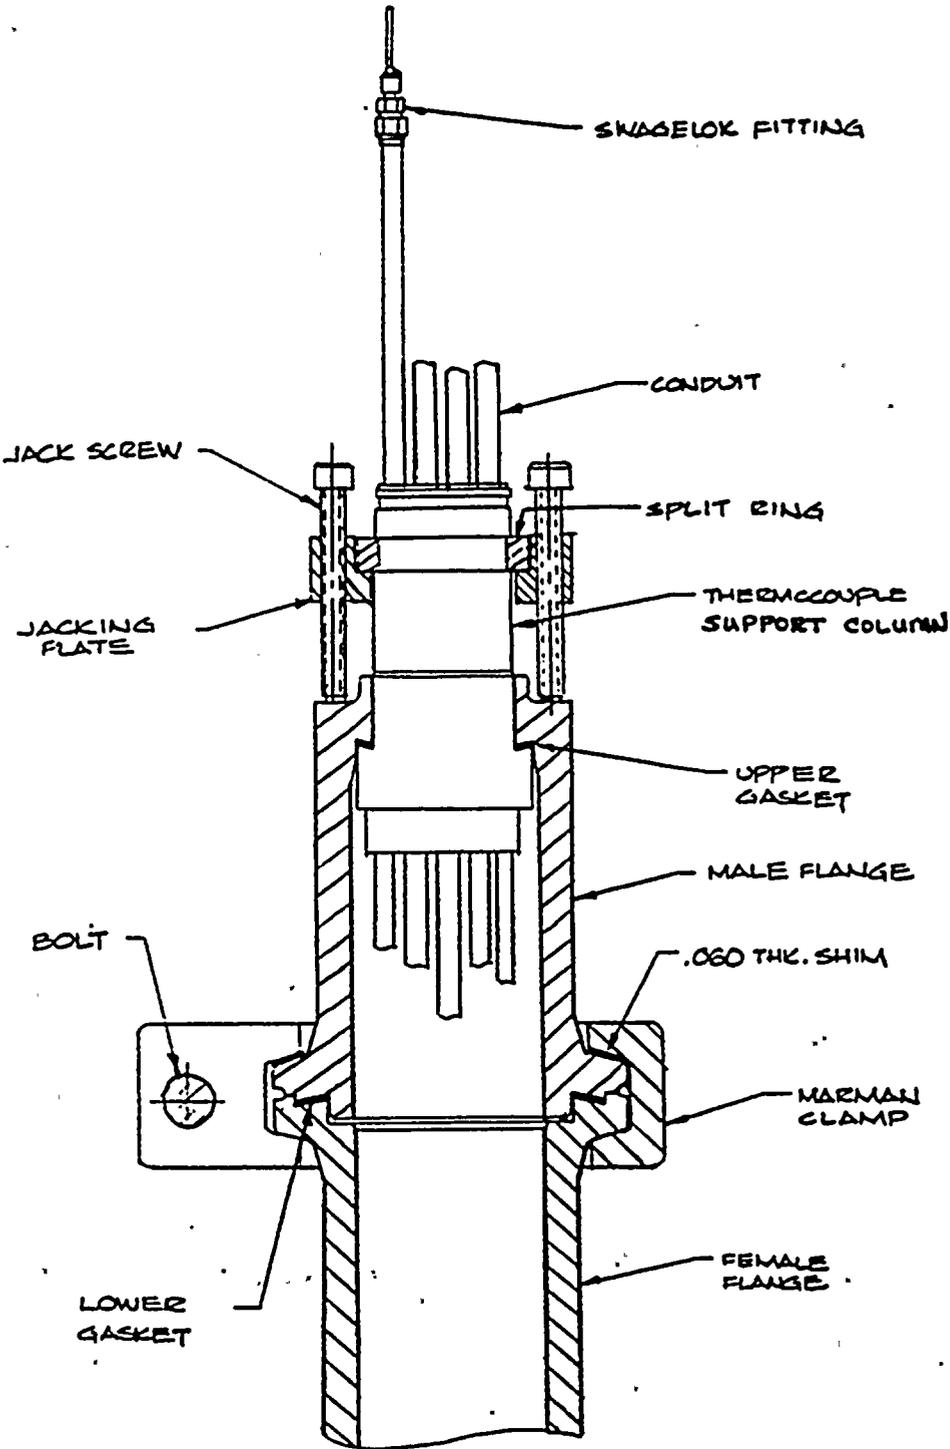
Figure 3-2: Instrumentation port column assembly

As shown in Figure 3-2, each assembly consists of a lower and upper seal joint, each of which use a conoseal gasket for leak tightness. The lower seal is between a male flange and female flange, which is threaded and seal welded to the reactor vessel head penetration. The upper seal is between the male flange and a thermocouple support column. Each conoseal gasket is used only once and is replaced with a new gasket each time the thermocouple column is re-assembled.
