SUBJECT: Requests relief from visual (VT-2) exam required by  
 IWA-5246, "Repaired or Replaced Components & Alteration of  
 Sys." required by ASME Boiler & Pressure Vessel Code Section  
 XI. Basis for request encl. Fee paid.

Re: Turkey Point Unit 3  
Docket No. 50-250  
Request for Relief for the  
Second Inservice Inspection Interval

TURKEY POINT PLANT UNIT NO. 3  
SECOND INSPECTION INTERVAL  
INSERVICE INSPECTION

RELIEF REQUEST NO. 15

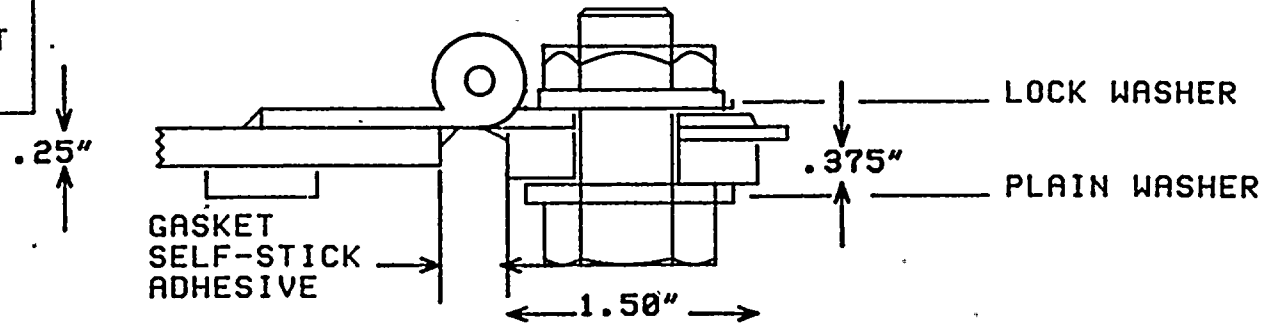
# GENERAL ARRANGEMENT DRAWING

FOLLOWING THE REPAIR AND AFTER THE CLOSURE HEAD IS BACK ON THE VESSEL, THE FOLLOWING RESTRICTIONS PROHIBIT THE VT-2 EXAMINATION DURING THE RCS OVER PRESSURE TEST: SEE DRAWING NO. CIS-V-02F FOR GENERAL ARRANGEMENT DETAIL.
