SUSQUEHANNA STEAM ELECTRIC STATION  
FINAL REPORT OF A DEFICIENCY RELATING TO  
LIMITORQUE CORPORATION TORQUE SWITCHES  
ERs 100450/100508                      FILE 840-4  
PLA-577

ATTACHMENT TO PLA-577

Defective Limitorque Torque Switches

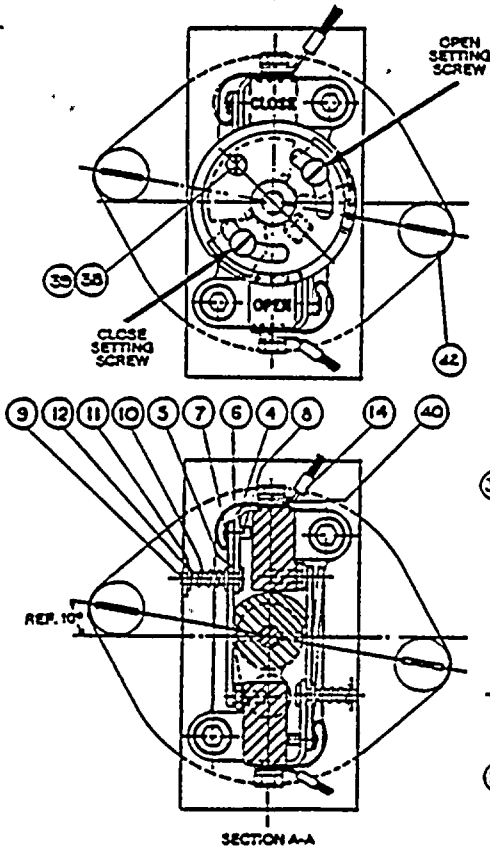
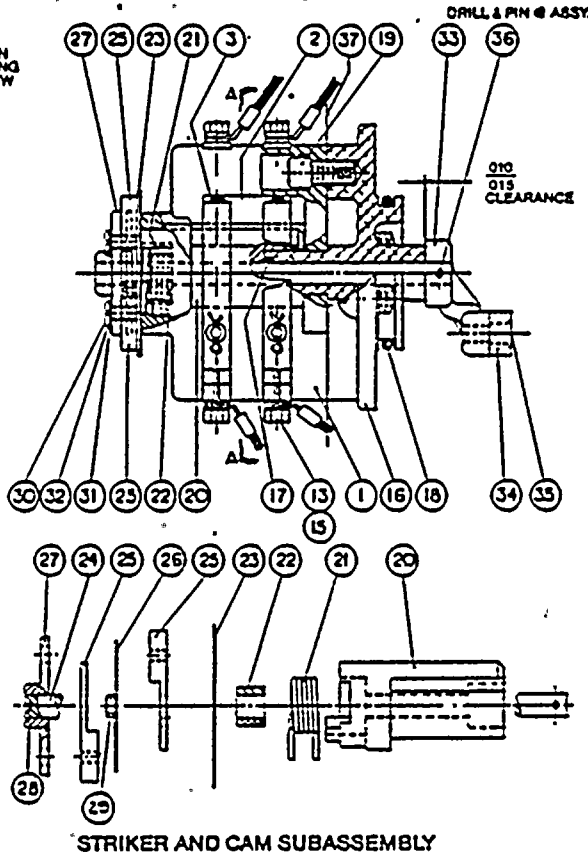
A Consultant for the Company, in conjunction with the scope of work they were performing for PP&L at the Susquehanna Site, issued a report on Limitorque Torque Switches which stated as follows: "Adjustments and preoperational checks on both safety related and non-safety related motor operated valves, made prior to post-construction startup tests of Limitorque valve operator models SMB-00 SMB-000, revealed that the stationary electrical contacts on the 'close' side of the torque switch had loosened. The torque switches in question are of the leaf type. The electrical contacts are small machined hex-head cap screws (see page 4 of Attachment, piece #3). Locking devices for the cap screws were not installed.

In some cases the loose cap screws backed out sufficiently to prevent the contacts from breaking open when the valve seated."

Visual inspection of four valves (1F001A, 1F001B, type SMB-00; HV11314, HV15112, Type SMB-000) confirmed that the hex-head contact screws were loose.

Inspection has shown that none of the #6 cap screws were loose enough on any of the sixty Limitorque torque switches inspected to have backed out sufficiently to prevent the contacts from breaking open when the valve seats. The amount of rotation to achieve 6 inch-pounds tightening torque for the screws ranged from 1/8 to 3/4 turns, with the exception of two valves (S/N 253336 and 225875), and the second of these had been previously tightened on July 2nd by the Limitorque representative. Another valve, S/N 203912, also tightened on July 2nd, required 1/4 turn. Also, S/N 233837 had a different design of torque switch with no contact screws. The number of shims observed under the contact screws was two for 58 of the valves. S/N 233837 had no shims because of this unique design and S/N 241655 had three shims. The screws without shims were found to be tight to the torqued requirements.

There is, however, a problem with the use of fiber shims under contacts. Based on the fact that all contacts with fiber shims underneath exhibit looseness and that further loosening could cause the operator to fail to function, the problem is considered reportable under 10CFR50.55(e). The affected Limitorque operators are used in many systems required for safe shutdown. A typical example is valves FV-1F001 and 1F004 of the Reactor Water Cleanup (RWCU) system. The above valves are part of the containment isolation system and failure of the valves to operate would be a breach of the containment boundary.

Project engineering has directed the field to use "Loctite" on the threads of all the Limitorque torque switch no. 6 cap screws on the unit 1 and 2 motor operators. They will continue to maintain the same number of fiber shims under the metal bridge plate. They will also torque these screws to the manufacturers recommended torque requirements of 6 inch lbs.

Once the application of "Loctite" has been applied to the contact screw and the screws retorqued to the manufacturers requirements, no loosening of screws will occur that could prevent Limitorque operators from performing their intended function.
