# Analysis of Incomplete Control Rod Insertion at Browns Ferry 3

**NSAC-20/INPO-3**

**December 1980**

Keywords: Browns Ferry 3, Incomplete Control Rod Insertion, Water Accumulation In SDV, Common Mode Failure of Scram Systems

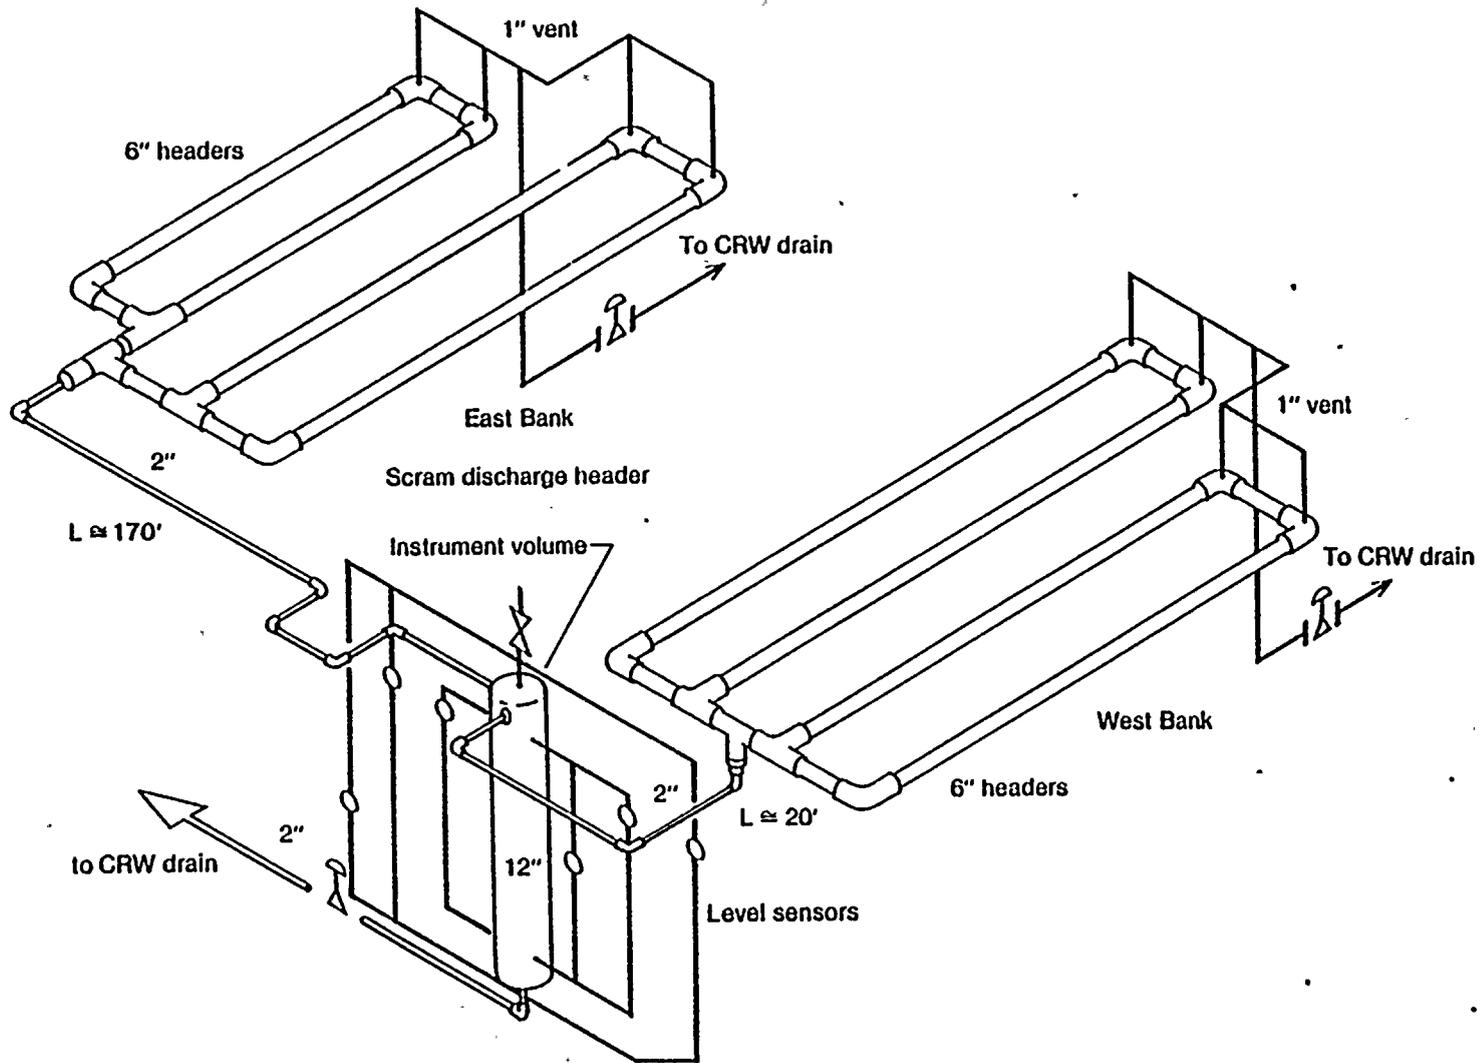
Figure 2. Browns Ferry SDV Equipment Layout (isometric view)

After the first scram attempt, the operators observed that all but one of the control rods which failed to insert were on the east half of the reactor.\* This behavior of the system led plant personnel and others to believe that the east scram discharge volume (SDV), a void into which reactor water is displaced when
