Summary of LaSalle SIT exit (the team made it clear to the licensee that info presented was based upon management review)

Operating Experience Spring 2017 Counterparts Briefing

LaSalle 2 – HPCS Injection Valve Failure – Stem-Disc Separation

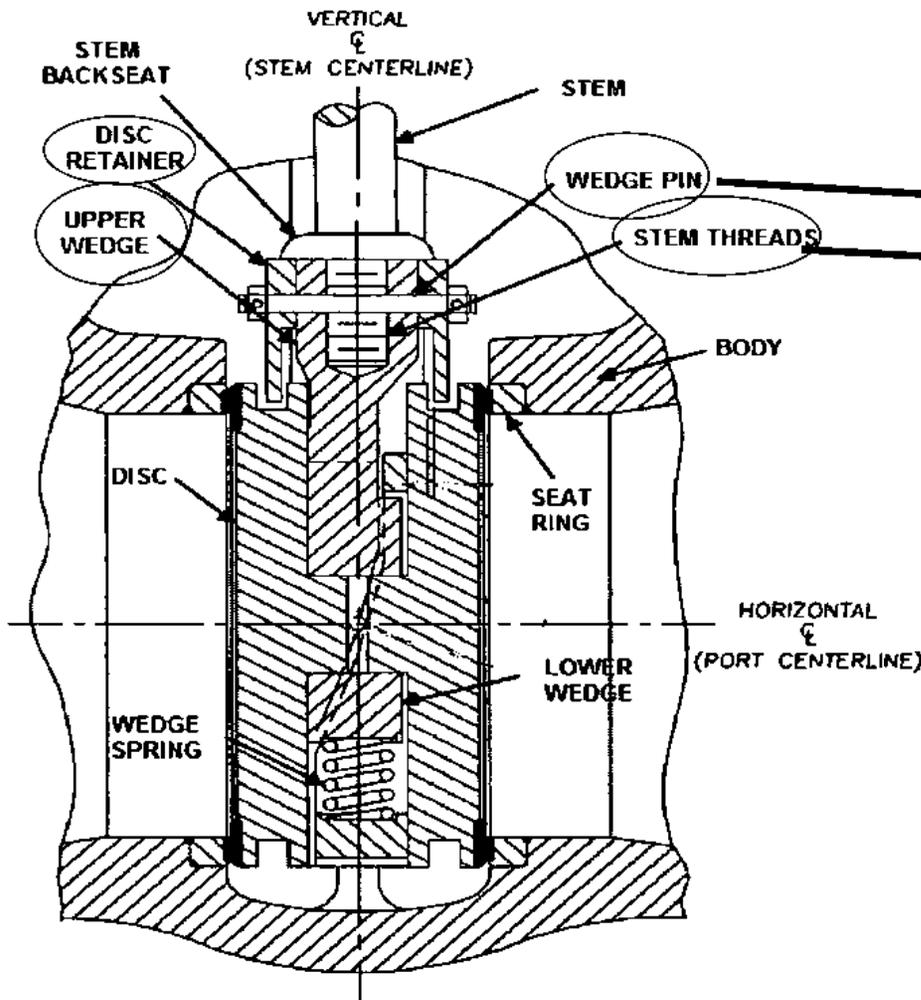
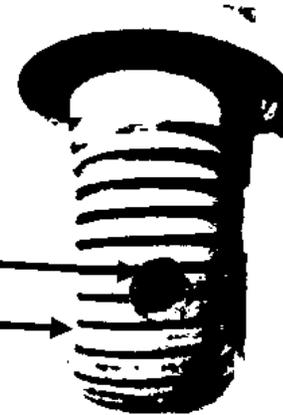
Anchor Darling DDGV Internals

- The stem-to-upper wedge threaded connection is torqued into the upper wedge, and then the anti-rotation (wedge) pin is inserted
- If operating torque exceeds stem torque, the stem can loosen during valve opening, eventually leading to wedge pin failure

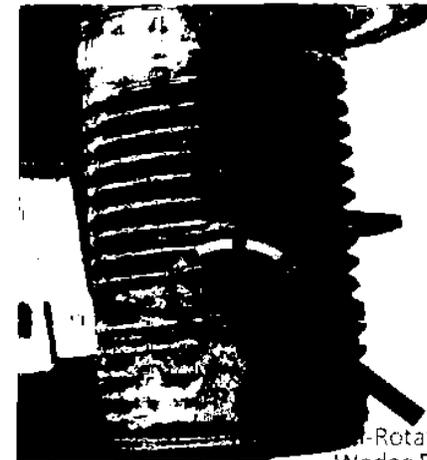
- The analysis demonstrates that it is not a question of "if" the valve is going to fail, but "when" the valve will fail.

Anti-Rotation
Wedge Pin
(still inserted but
sheared)

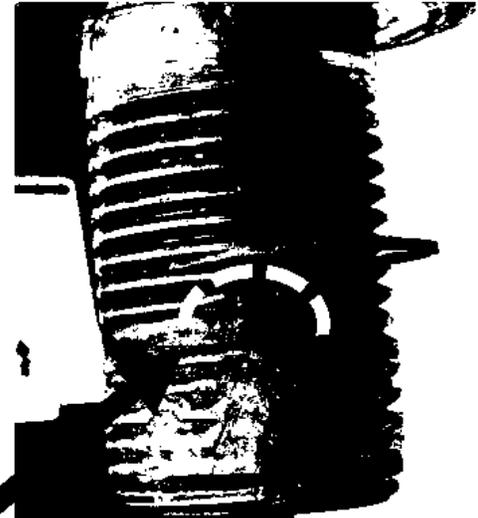
Anti-Rotation
Wedge Pin
(still inserted but
sheared)
