FACIL: 50-259 Browns Ferry Nuclear Power Station, Unit 1, Tennessee 05000259

SUBJECT: Responds to NRC 890130 ltr re violations noted in Insp Repts
 50-259/89-04, 50-260/89-04 & 50-296/89-04.

MAR 01 1989

BROWNS FERRY NUCLEAR PLANT (BFN) - RESPONSE TO NRC INSPECTION REPORT
NUMBERS 50-259/89-04, 50-260/89-04, AND 50-296/89-04

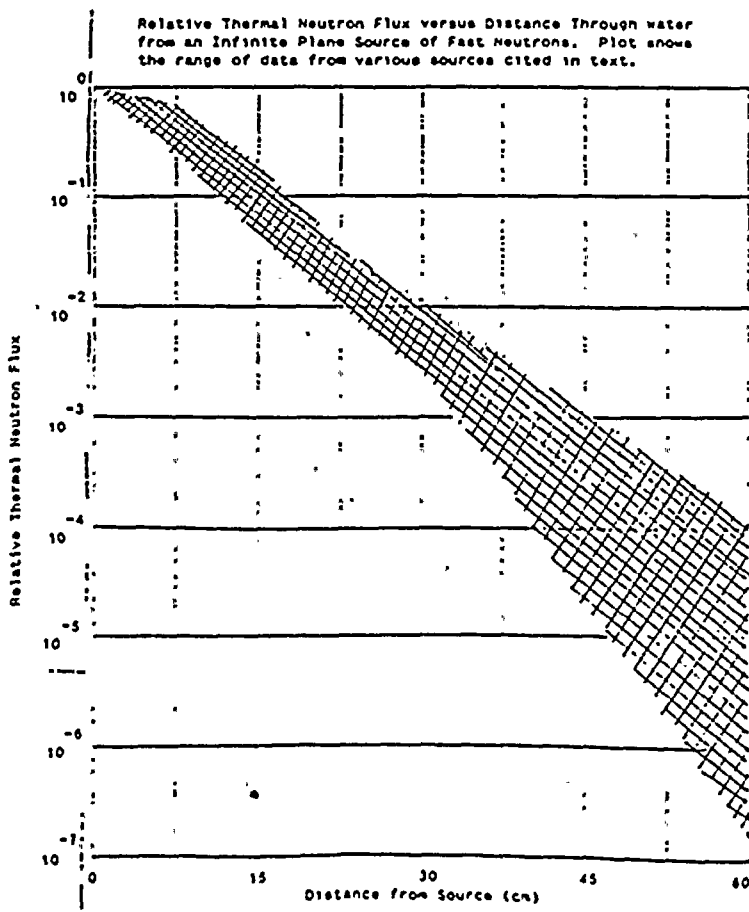
FIGURE 2

As stated earlier, the failure of the SRMs to obtain readings of 3 cps or greater was due to the location of SRMs with respect to the loaded fuel bundles rather than an inadequate neutron source. Up to the time fuel loading was halted with 74 fuel assemblies in the core, none of the SRMs were closer than a foot, and two of the four detectors were more than 2 feet from the nearest fuel bundle.

BROWNS FERRY UNIT 2
 CORE CONFIGURATION AS OF 1/05/89
 74 BUNDLES LOADED
