**ROOT CAUSE REPORT FOR THE
EXIDE UPS 1A, B, C, D, G
TRIP EVENT OF AUGUST 13, 1991**

SEPTEMBER 9, 1991

FILE CODE: NMP77748

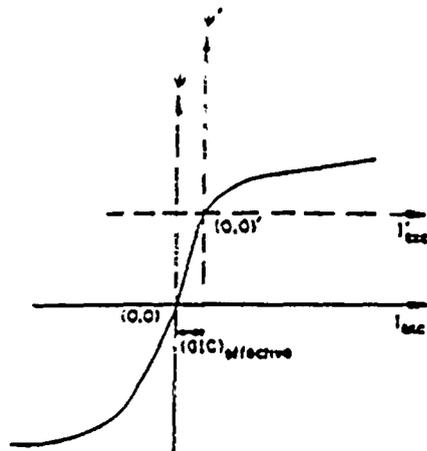
Figure 3. DC Bias of Transformer Core Flux Due to GIC.

many times larger than the RMS ac magnetizing current, resulting in a dc bias of transformer core flux, as in Figure 3.

The half-cycle saturation of transformers on a power system is the source of nearly all operating and equipment problems caused by GIC's during magnetic storms. The direct consequences of the half-cycle transformer saturation are:
