NIAGARA MOHAWK POWER CORPORATION

NINE MILE POINT 1

SHROUD CRACKING SAFETY ASSESSMENT

REPORT NO. NER-1M-014

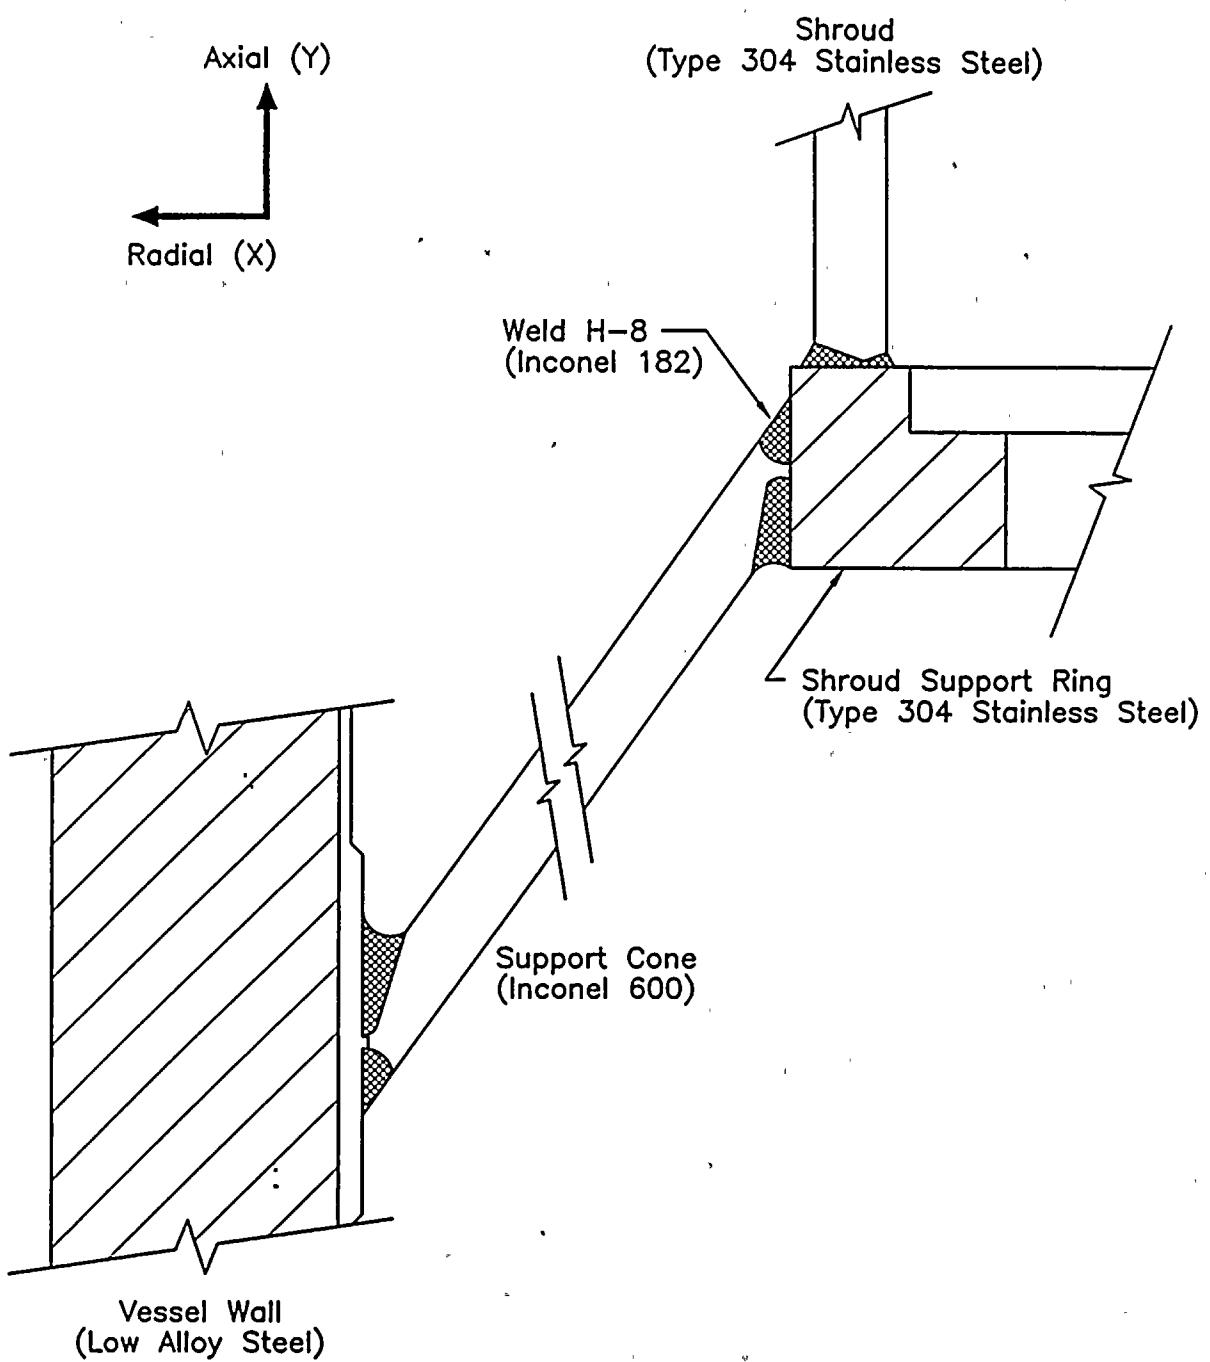
Weld H-8 attaches the Type 304 forged stainless steel shroud support ring to the Alloy 600 support cone as shown in Figure 1. The shroud support assembly, including the vessel shell, the cone and the ring, but not the shroud itself, was post weld heat treated (PWHT) at 1150°F during vessel fabrication. As a consequence, weld H-8 was stress relieved during PWHT, and peak tensile residual stresses were reduced by the heat treatment. In addition, the PWHT sensitized the stainless steel ring which increases concern for IGSCC on the ring side of weld H-8. While the weld metal and cone were also sensitized, these are Inconel materials which are more resistant to IGSCC than the stainless material, especially in the absence of crevices. Normal operating stresses in the support ring are expected to be compressive due to the difference in thermal expansion coefficients of the ring and the cone/vessel.
