**LICENSEE:** Niagara Mohawk Power Corporation  
**FACILITY:** Nine Mile Point Nuclear Station, Unit No. 1  
**SUBJECT:** SUMMARY OF MEETINGS WITH LICENSEE AND PUBLIC ON APRIL 14, 1997,  
REGARDING CORE SHROUD (TAC NO. M98170)

# MEETING ON CORE SHROUD CRACKING AT NINE MILE POINT UNIT 1

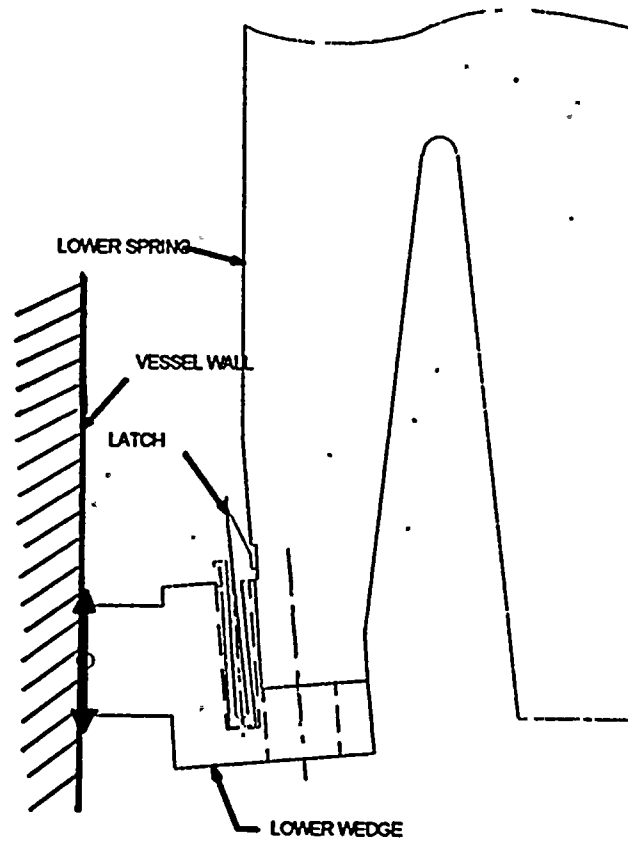
ORIGINAL LATCH

- The evaluation of the as-found condition shows that both the latch failure and the loss of tie rod preload were related.
- The design of the lower spring contact implicitly assumed that the lower spring contact would slide along the Reactor Pressure Vessel (RPV) wall.
- There were two conditions causing differential movement that were not expected:
  - The lower support assemblies were able to shift up the shroud cone toward the shroud due to original installation clearances between the toggle bolts and the cone holes. The impact of the clearances was not recognized.
  - Differential motion could also be caused by the deflection of the C-spring under tie rod load for heat up. This could also cause stresses in the latch, although somewhat less than in the previous case.

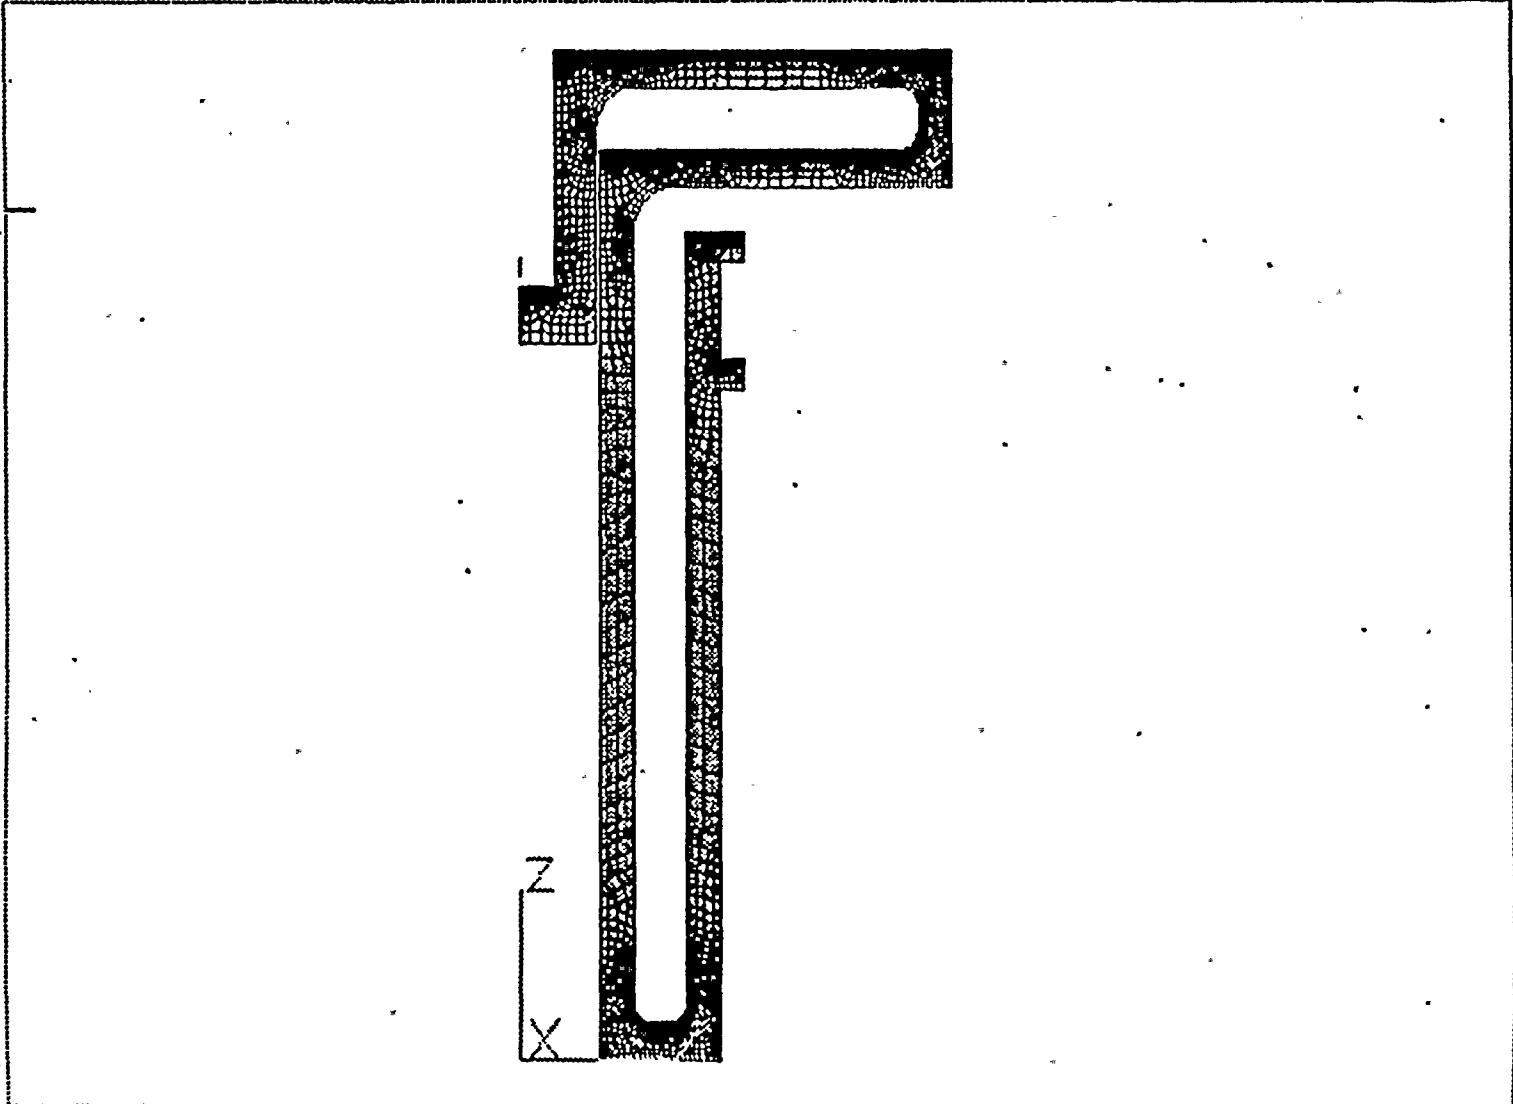
NEW LATCH

- The improved latch design stresses are 8 to 12 times lower than the original design
  - membrane + bending  
ratio = 8.6
  - membrane + bending + peak  
ratio = 12.8
- No permanent deformation in new latch design even under worst case conditions

- Removed clearance between the lower support toggle bolts and the shroud side of the cone holes.
- Re-torqued the tie rods to their original design installation torque.
- Installed new modified latches which are more tolerant of differential vertical displacement.

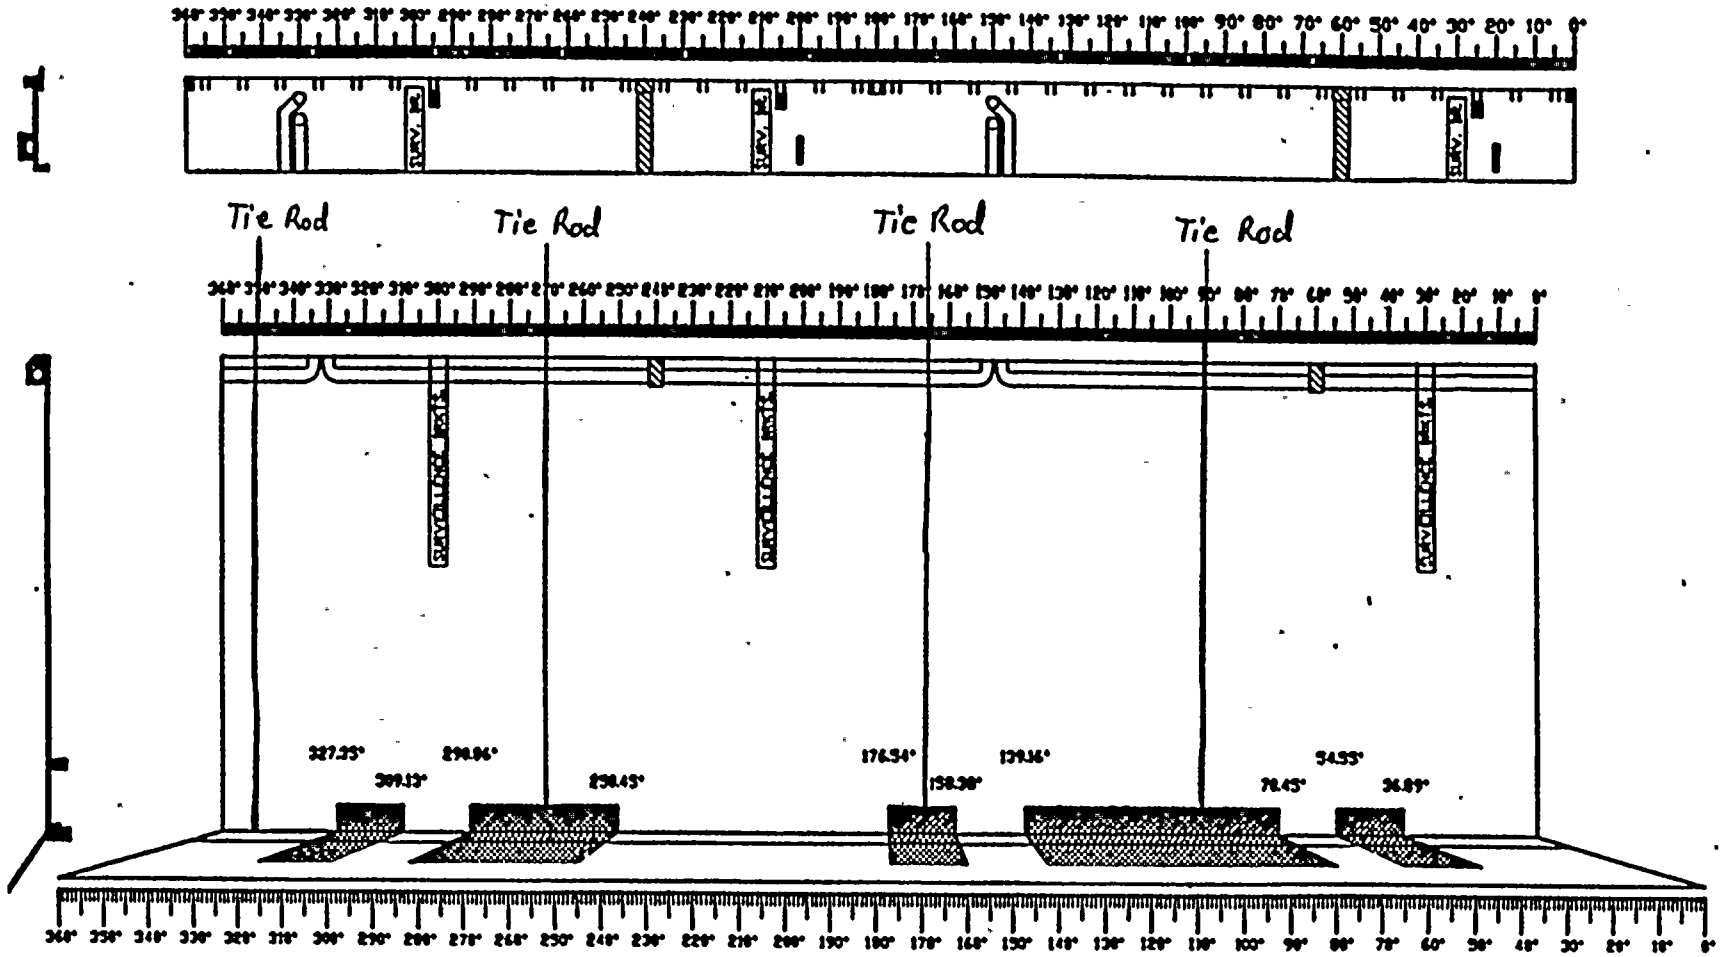
**ACTUAL H8 CIRCUMFERENTIAL SCAN TOTAL: 45.32%**

(BASED ON WHERE ANY TRANSDUCER PASSED AREA)
