ONS-2018-016

February 12, 2018

Duke Energy Carolina, LLC (Duke Energy)  
Oconee Nuclear Station, Units 1, 2 and 3  
Docket Numbers 50-269, 50-270, 50-287  
Renewed License Numbers DPR-38, DPR-47, and DPR-55

**Subject:** Duke Energy Responses to Request for Additional Information (RAI); Request for Alternative to Codes and Standards Requirements Pursuant to 10 CFR 50.55a(z) to Satisfy 10 CFR 50.55a(h)(2) Associated with Bronze Tape Wrapped Emergency Power Cables in Use at the Oconee Nuclear Station

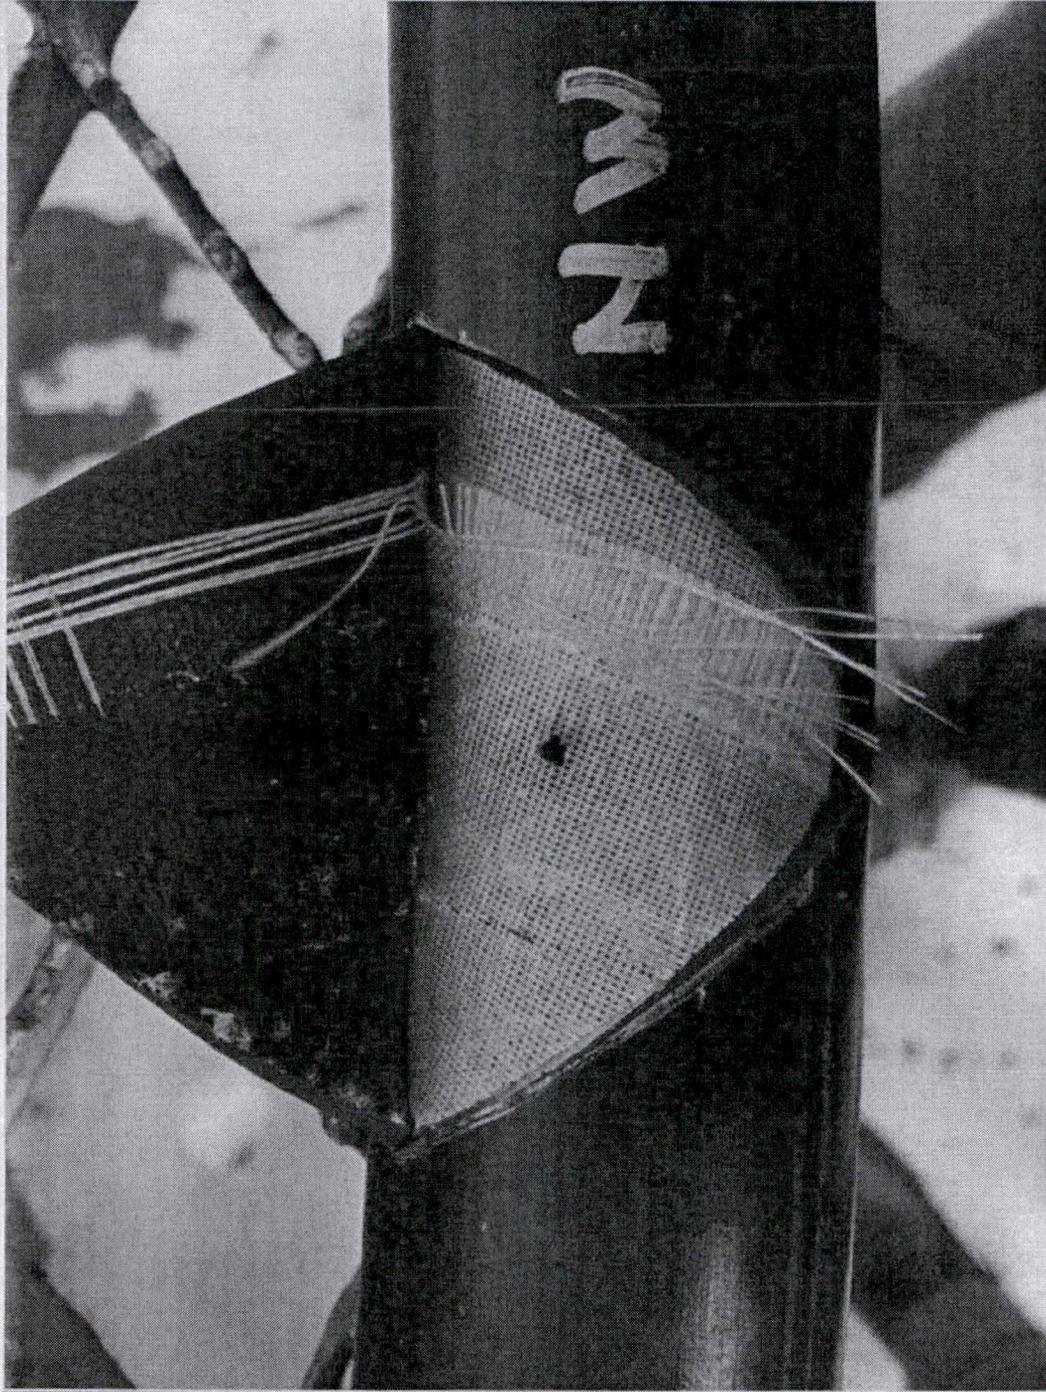
In order to ensure a reliable cable insulation failure at a specific location, an alternate method was developed and tested. This method consisted of cutting a triangular flap in the cable jacket and drilling a small hole through the cable bronze metallic shield, insulation semicon, insulation and conductor semicon to the conductor. The jacket flap was then positioned back in place and secured to the cable jacket with tape while avoiding covering the jacket at the hole location.

Using AC hipot test equipment, the cable insulation failed at 3.7 kV. This test was repeated several times at the same voltage with insulation failure occurring each time. Inspection of the faulted area beneath the cable jacket revealed a small soot deposit around the drilled hole. As a contingency in case the drill hole method fails to produce the required fault, the same test was performed at Okonite with a #18 AWG copper wire inserted in the hole thus forming a solid conductive path between the conductor

Fault Induced by Drilled Hole Only

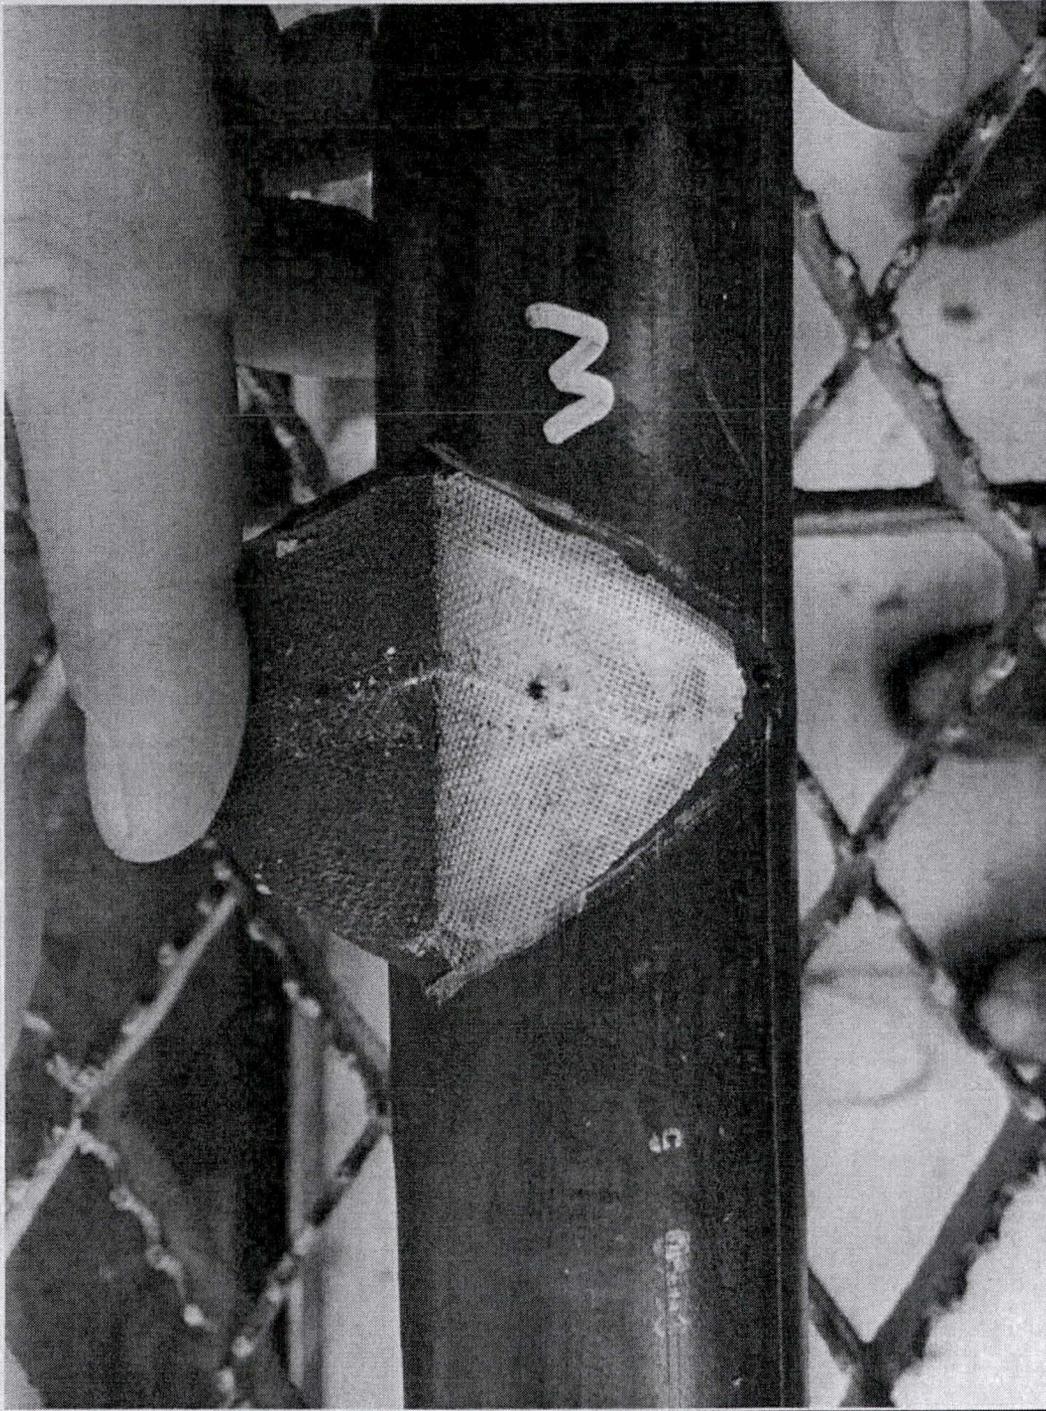
Fault Induced by Wire Inserted in Drilled Hole

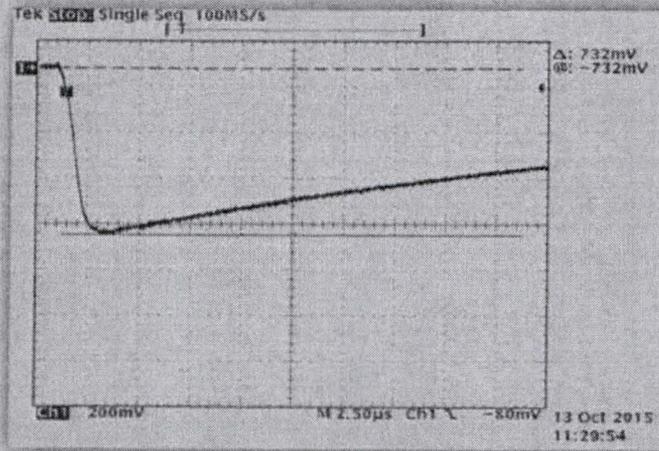
Two series of high voltage impulse tests were conducted. The first test began at 140 kV and continued to 530 kV when an insulation failure occurred. However, the insulation failure location was not externally visible. A DC hi-pot tester was next used to locate the fault by the application of repetitive sustained voltage which had the effect of causing the bronze tape and jacket to form a small convex area. The convex area identified the fault location as approximately six feet from a cable end which was outside the heated area. A second impulse test was performed on another cable beginning at 300 kV and ending at 420 kV with insulation breakdown. In the same manner as before, the fault was located at approximately five feet from a cable end which was also outside the heated area.

Test #2 impulse at -300kV

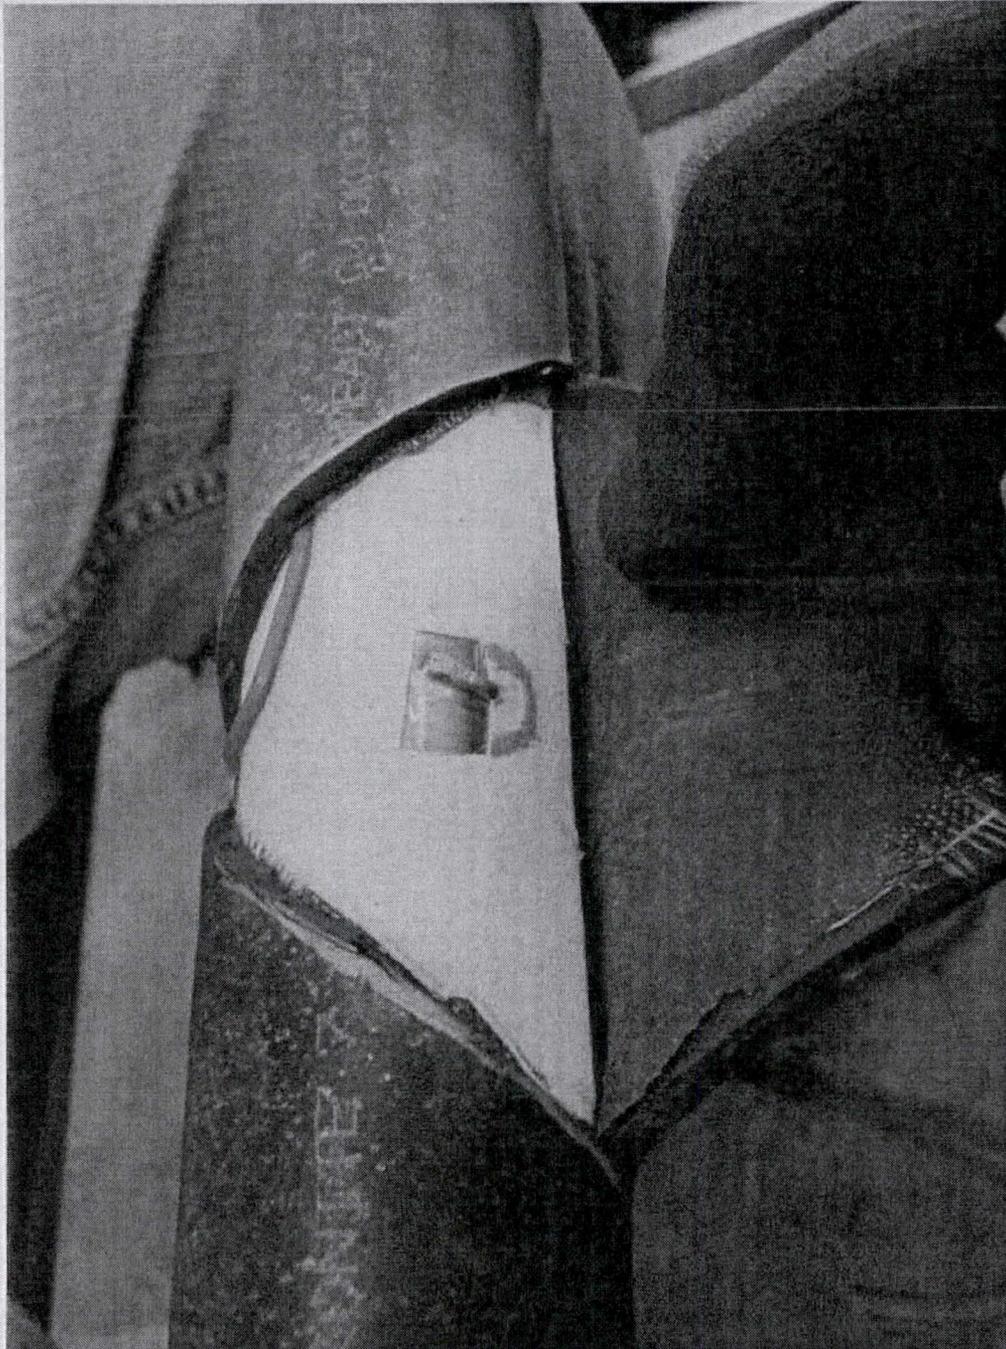
Copper Wire Inserted Beneath C-Phase Jacket Flap

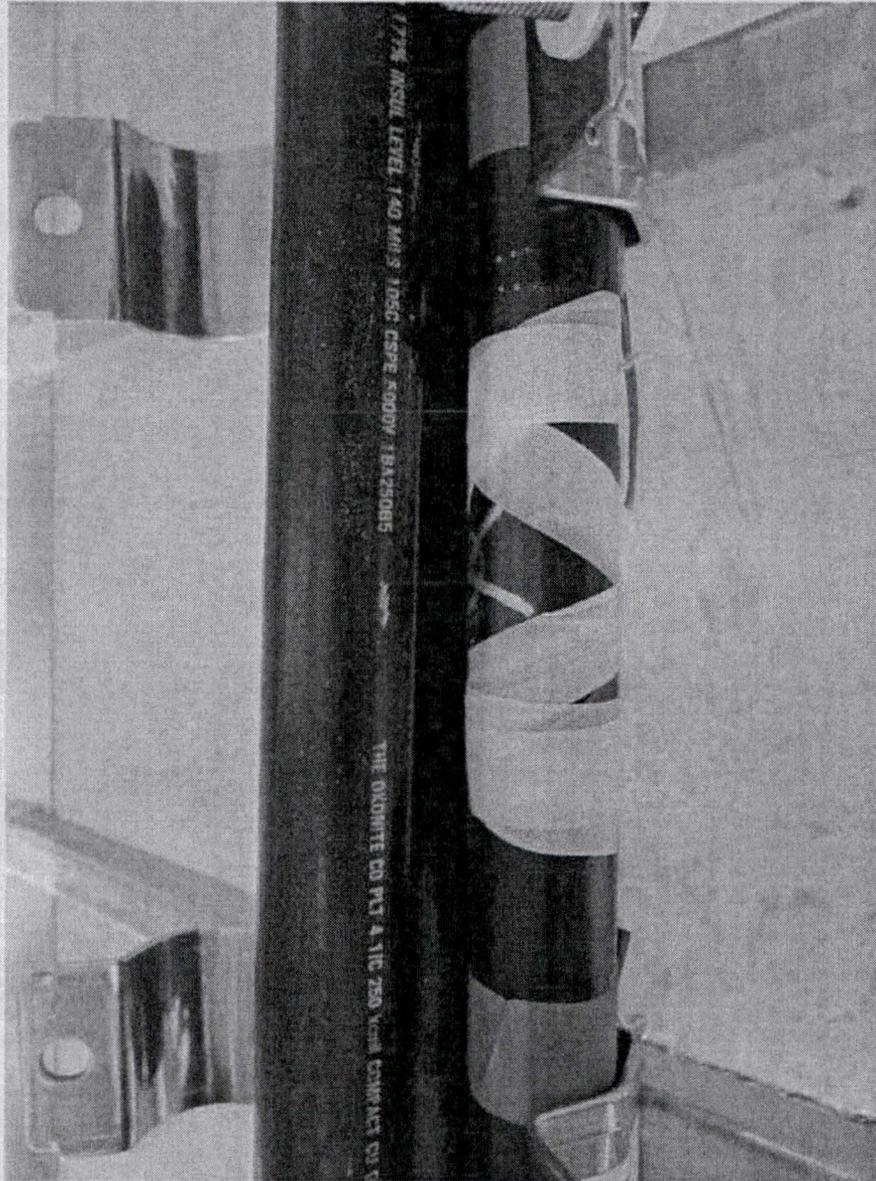
C-Phase Cable Jacket Flap Taped Back in Place and Installed in Triangular Bundle  
Fault Location Oriented Towards Adjacent B-Phase Cable
