EXAMINATION OF SECTIONS OF THE PRESSURIZER PORV
LINE SAFE-END FAILURE FROM THE
PALISADES NUCLEAR GENERATING STATION

TR-MCC-306

OCTOBER 1993

METALLURGICAL EXAMINATION REPORT - NON-PROPRIETARY
EXAMINATION OF SECTIONS OF THE PRESSURIZER PORV
LINE SAFE-END FAILURE
FROM THE PALISADES NUCLEAR GENERATING STATION
(TAC No. 87760)

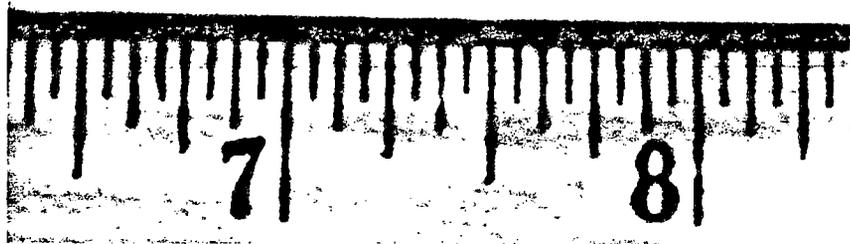
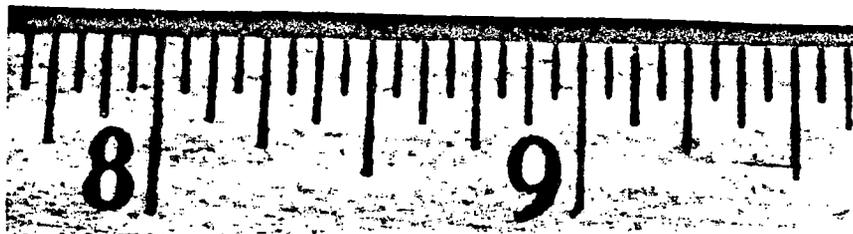
Figure 3-1. As-Received Weld Metal Sample.

Samples of weld metal and Inconel 600 base metal were taken in a region remote from the cracked region and sent to ABB Combustion Engineering Materials/Chemical Technology for chemical analysis. Photographs of these samples were taken and are shown in Figures 3-1 and 3-2.

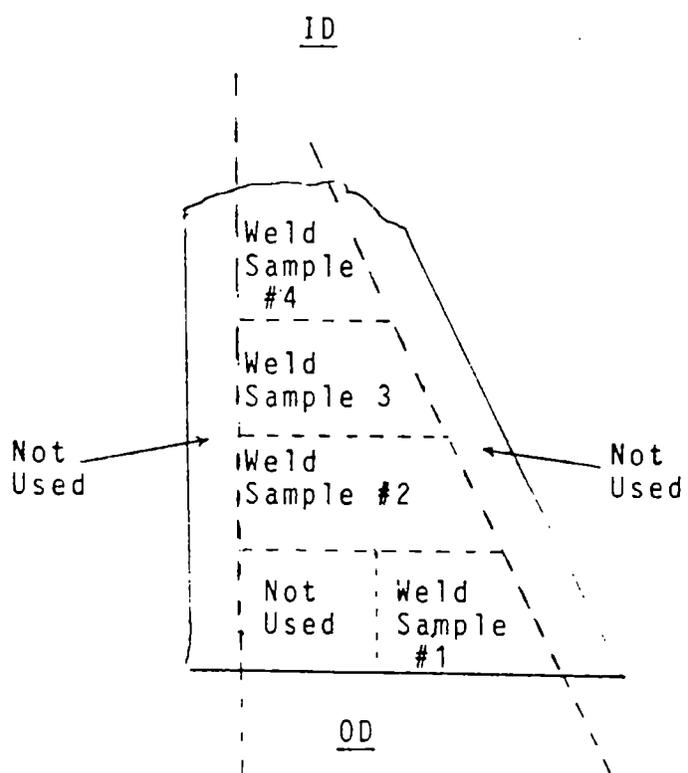
Figure 3-4. Sketch of Weld Sample Sectioning.

To produce 4 samples for analysis, drilling with a small diameter bit was attempted to produce chips but this approach proved difficult. It was decided to cut the weld into 4 sections using Al_2O_3 cutoff wheels and obtain chemical analysis on each. The sketch in Figure 3-4 approximates the weld sectioning. A 1/4 inch thick section was used and the likely high dilution areas were set aside as shown in the sketch. A new file was obtained and was successful in generating filings appropriate for analysis from each of the four cut samples.

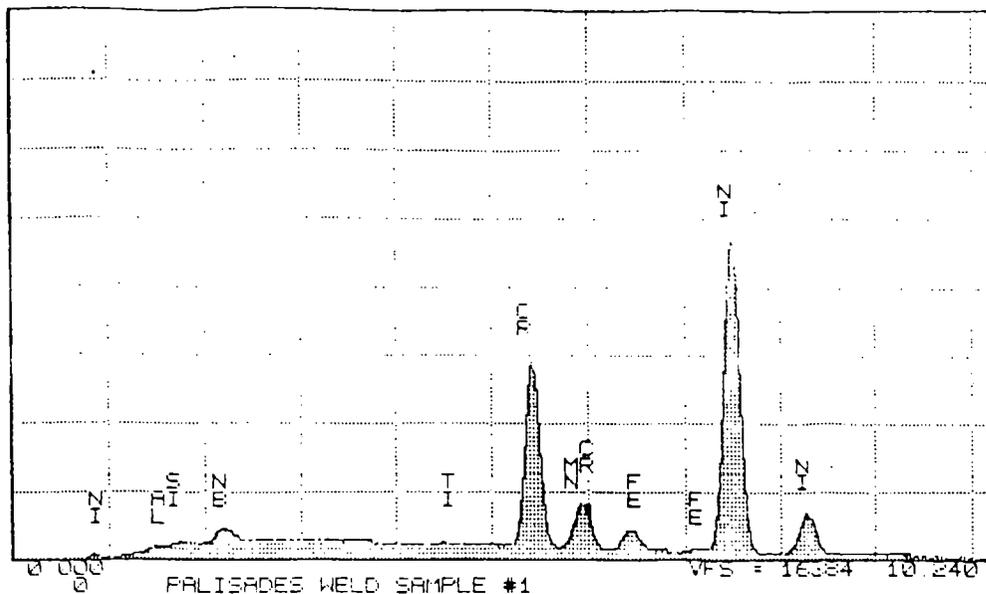
Figure 3-5. EDS Results from Weld Sample #1.

Element	K-ratio	Z	A	F	ZAF	Atom%	Wt%
Si-L	0.002	0.918	2.136	0.999	1.957	0.81	0.40
Nb-L	0.019	1.083	1.349	0.998	1.457	1.71	2.79
Ti-L	0.003	1.016	1.053	0.928	0.993	0.30	0.26
Cr-L	0.217	1.016	1.024	0.927	0.964	22.87	20.88
Fe-L	0.028	1.011	1.042	0.880	0.927	2.69	2.64
Ni-L	0.680	0.992	1.028	1.000	1.020	67.22	69.33
Al-L	0.002	0.945	2.768	0.999	2.615	1.09	0.51
Mn-L	0.034	1.032	1.015	0.900	0.943	3.31	3.19
						Total=	100.00%

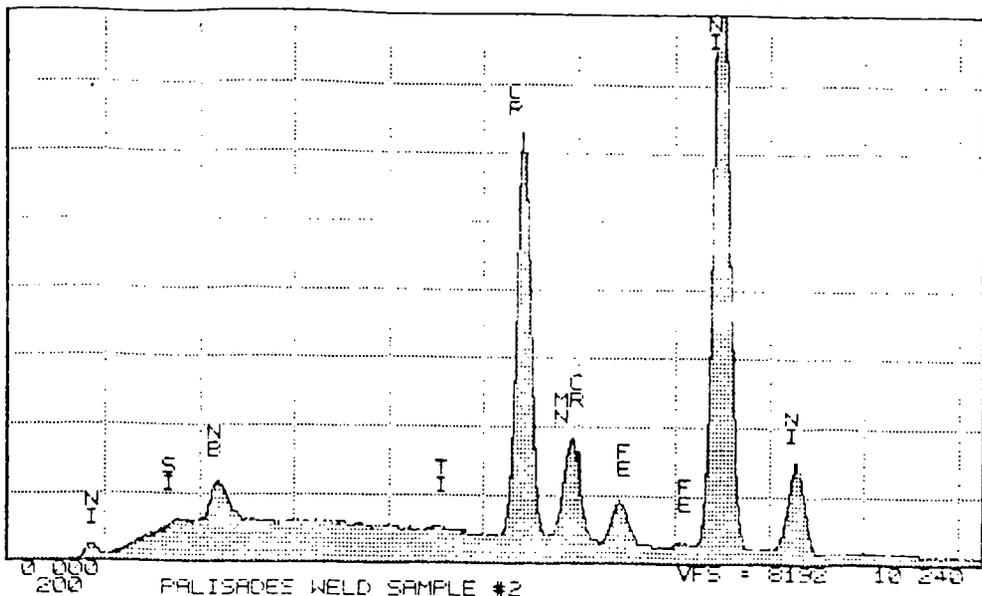
Figure 3-6. EDS Results from Weld Sample #2.

Element	K-ratio	Z	A	F	ZAF	Atom%	Wt%	
Si-K	0.002	0.917	2.124	0.999	1.944	0.73	0.36	
Nb-L	0.024	1.082	1.343	0.998	1.449	2.12	3.43	
Ti-L	0.003	1.016	1.053	0.928	0.993	0.37	0.31	
Cr-K	0.223	1.014	1.024	0.929	0.965	23.77	21.54	
Fe-K	0.028	1.010	1.044	0.883	0.931	2.63	2.56	
Ni-L	0.672	0.991	1.029	1.000	1.020	66.95	68.51	
Mn-L	0.035	1.031	1.015	0.902	0.944	3.43	3.28	
Total=							100.00%

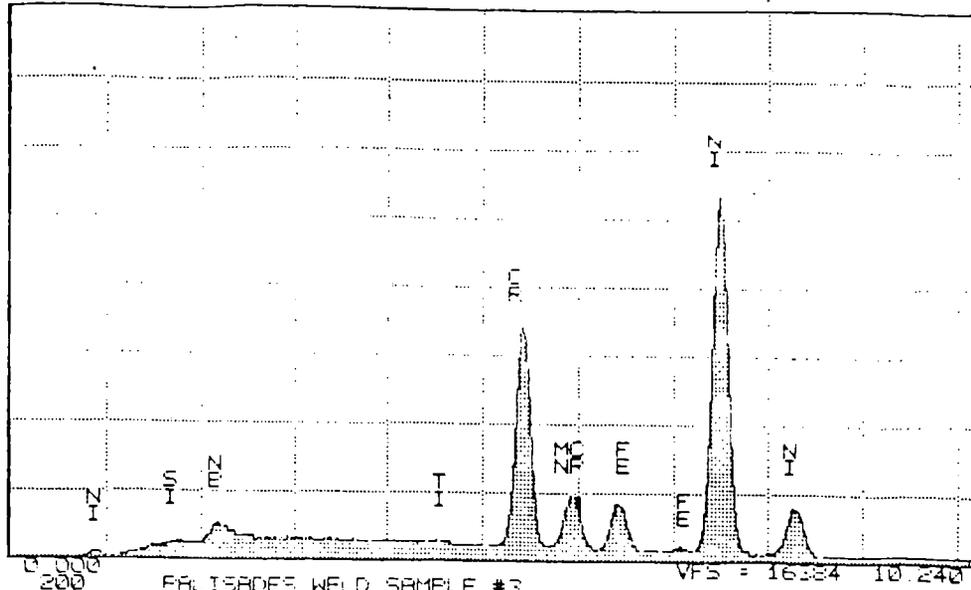
Figure 3-7. EDS Results from Weld Sample #3.

Element	K-ratio	Z	A	F	ZAF	Atom%	Wt%
Si-F	0.001	0.917	2.129	0.999	1.950	0.47	0.23
Nb-L	0.018	1.022	1.344	0.998	1.450	1.59	2.58
Ti-F	0.002	1.016	1.052	0.928	0.991	0.41	0.34
Cr-F	0.218	1.015	1.023	0.927	0.962	23.13	21.01
Fe-F	0.060	1.010	1.042	0.887	0.934	5.71	5.57
Ni-F	0.658	0.991	1.032	1.000	1.022	65.58	67.27
Mn-F	0.032	1.031	1.014	0.906	0.947	3.11	2.99
						Total=	100.00%

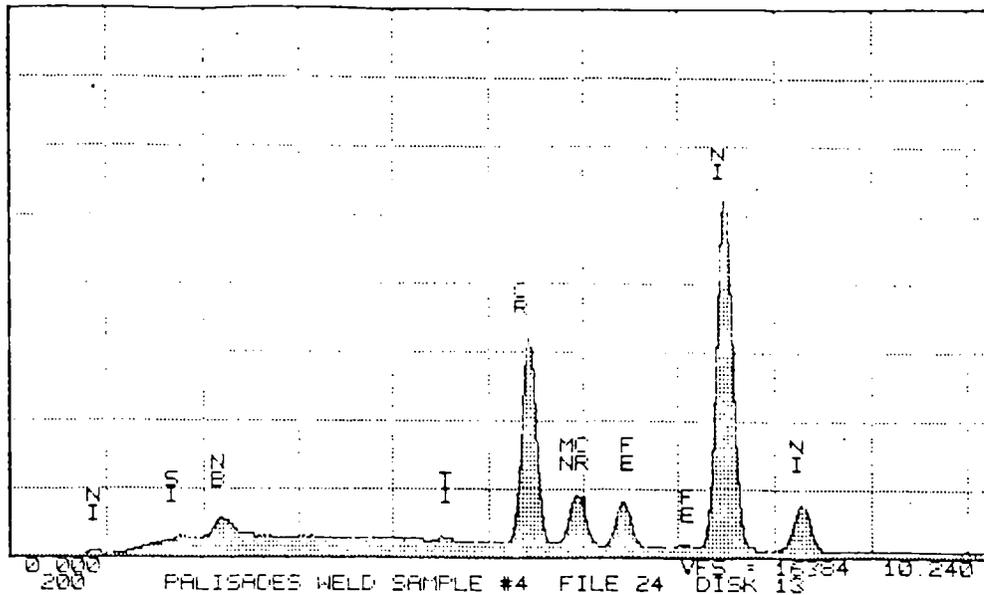
Figure 3-8. EDS Results from Weld Sample #4.

Element	K-ratio	Z	A	F	ZAF	Atom%	Wt%
Si-H	0.002	1.017	2.125	0.999	1.945	0.74	0.36
Nb-L	0.022	1.082	1.343	0.998	1.449	2.02	3.27
Ti-H	0.004	1.018	1.053	0.929	0.994	0.44	0.37
Cr-H	0.211	1.014	1.024	0.927	0.963	22.46	20.36
Fe-H	0.056	1.010	1.042	0.885	0.932	5.36	5.22
Ni-K	0.660	0.991	1.031	1.000	1.021	65.89	67.45
Mn-H	0.031	1.031	1.015	0.905	0.947	3.09	2.96
						Total=	100.00%

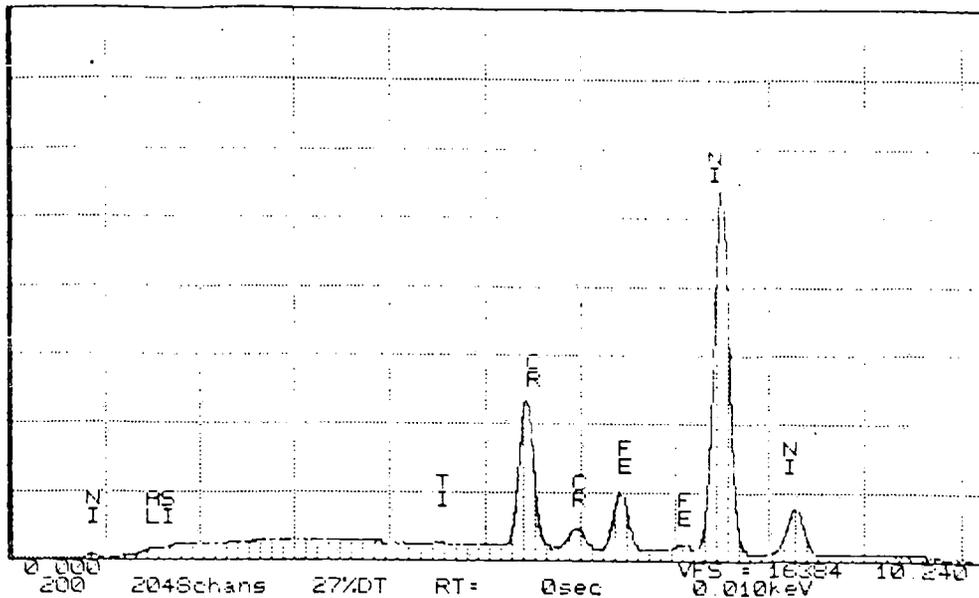
Figure 3-9. EDS Results from Base Metal Sample.

Samples from the base metal were similarly prepared and analyzed using the ICP and combustion techniques. The results of this analysis are tabulated in Table 3-2 along with the 1965 code requirements for SB-166 bar for comparison. The EDS results for the base metal are shown in Figure 3-9.

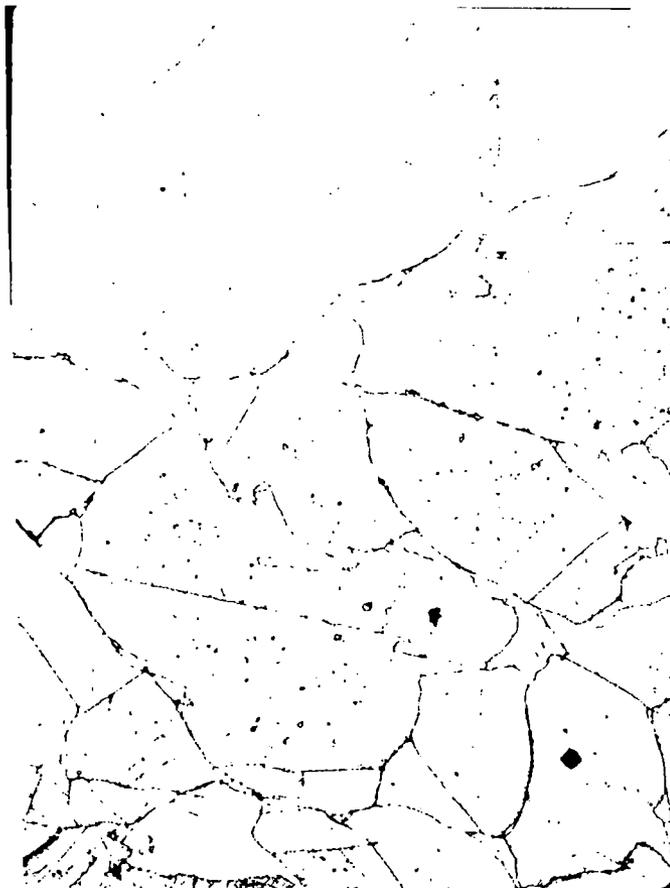
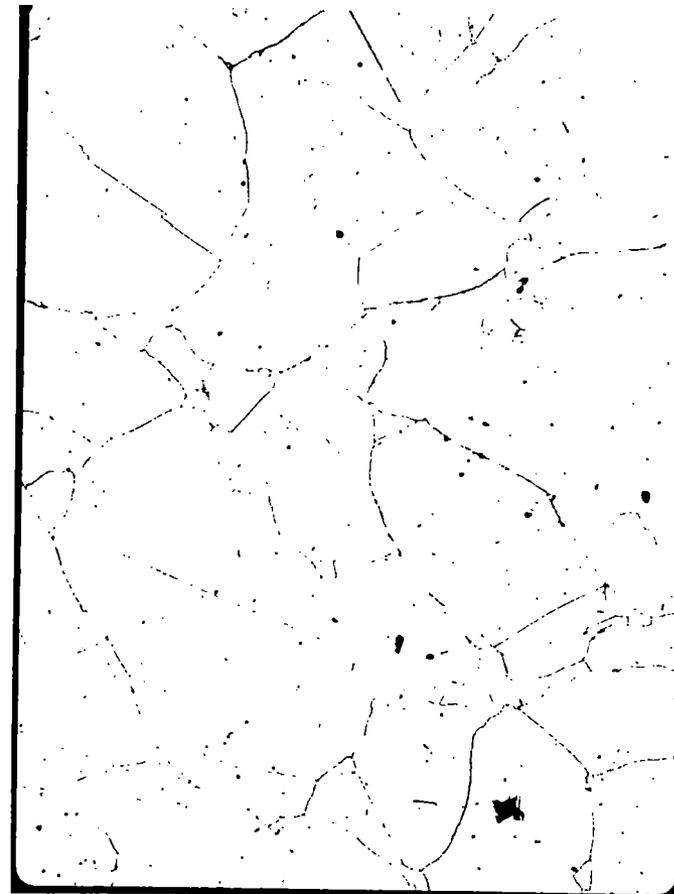
Figure 4-7. Dual Etch Metallography on Base Metal Near ID.

Dual etch metallography was performed on the HAZ and on the base metal. In each case a micrograph set was obtained near the ID surface, mid-wall and near the OD surface. These dual etch sets can be seen in Figures 4-7 through 4-12.

These photomicrographs show good correspondence between carbides and grain boundaries. The grains are very large, mostly ASTM size 00. The orthophosphoric acid etch photomicrograph shown in Figure 4-12 clearly shows the HAZ, a region having absolutely no intragranular indications. The HAZ is about 30 mils wide. The orthophosphoric acid etch revealed indications that appeared to line up in three directions. These are not carbides but rather are etch pits due to stress relaxation. The structure is similar to that of a failed SONGS-3 pressurizer nozzle, having large grains and numerous intergranular carbides.

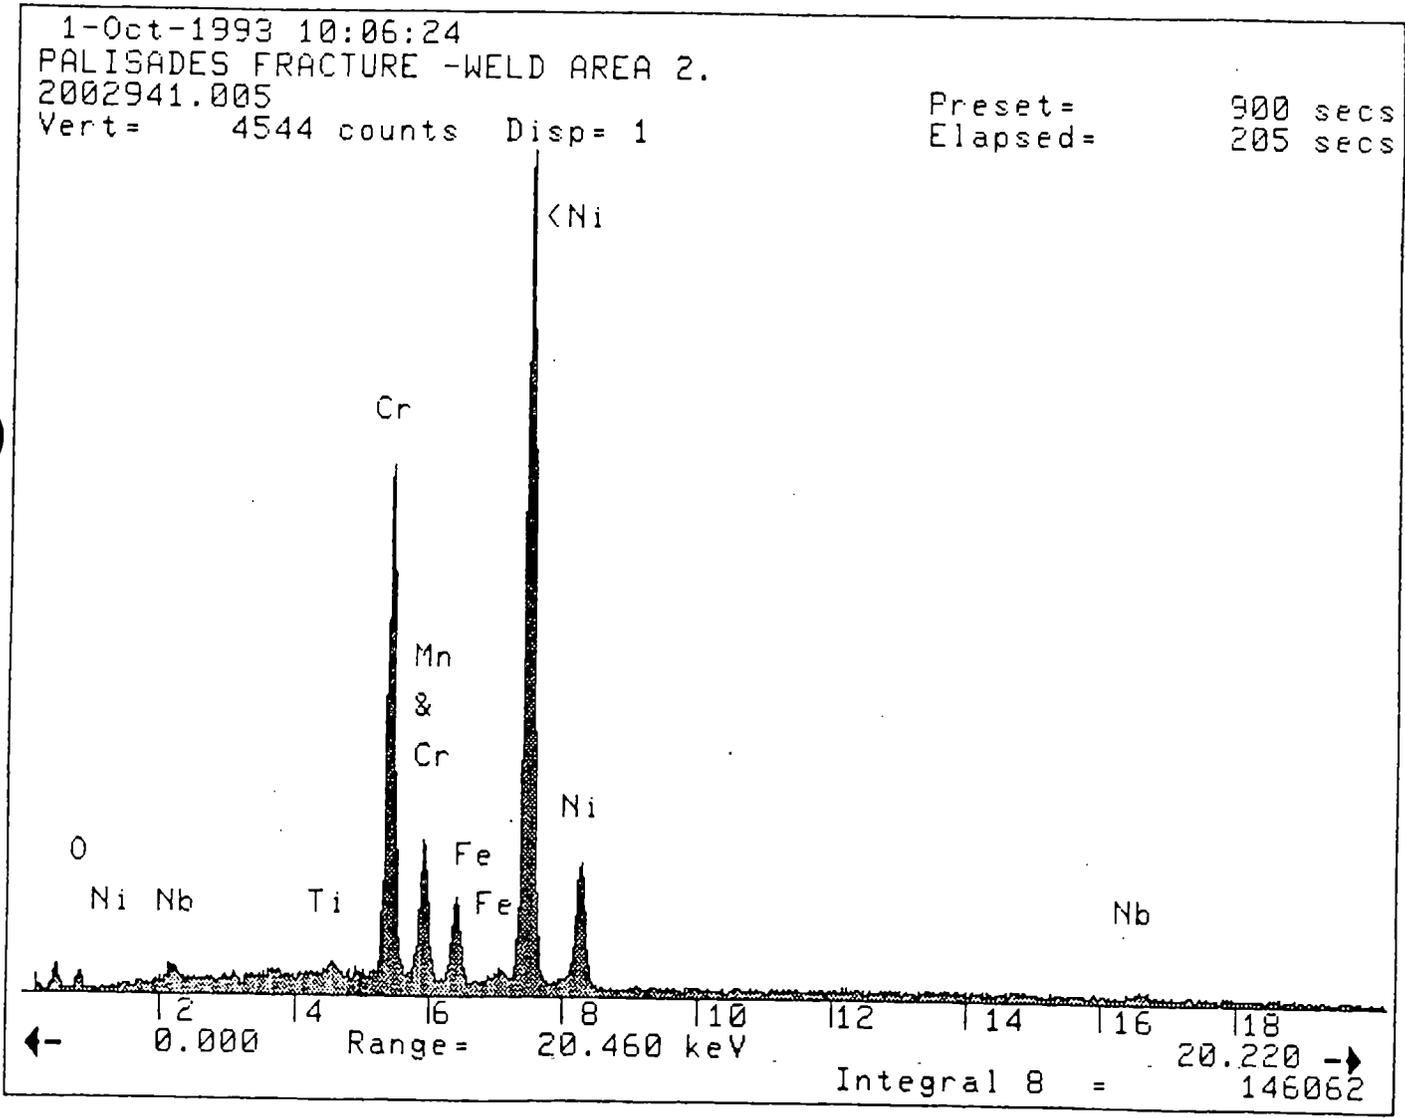
A metallographic mount identified as #3 was sent to ABB/CE for examination. The section includes what appears to be an ID repair weld. A low magnification SEM view of the repair weld is shown in Figure 5-1. EDS spectra were recorded in areas as noted on the micrograph in Figure 5-1. These spectra are shown in Figures 5-2 through 5-6 respectively. Table 5-1 summarizes the major elements in each of these EDS spectra. Table 5-1 shows that the repair weld has a composition between that of the original weld and the stainless steel. This difference in composition explains why this weld region etched differently than the other material.

Figure 5-2. Original Weld EDS Spectra, Near ID.

LOCATION	NICKEL	CHROMIUM	IRON
Figure 5-2 Original Weld	58.91	24.51	4.91
Figure 5-3 316 S/S	15.09	16.08	62.88
Figure 5-4 Original Weld	65.10	22.10	3.98
Figure 5-5 Repair Weld	41.93	17.54	32.38
Figure 5-6 Repair Weld	43.05	17.64	28.43

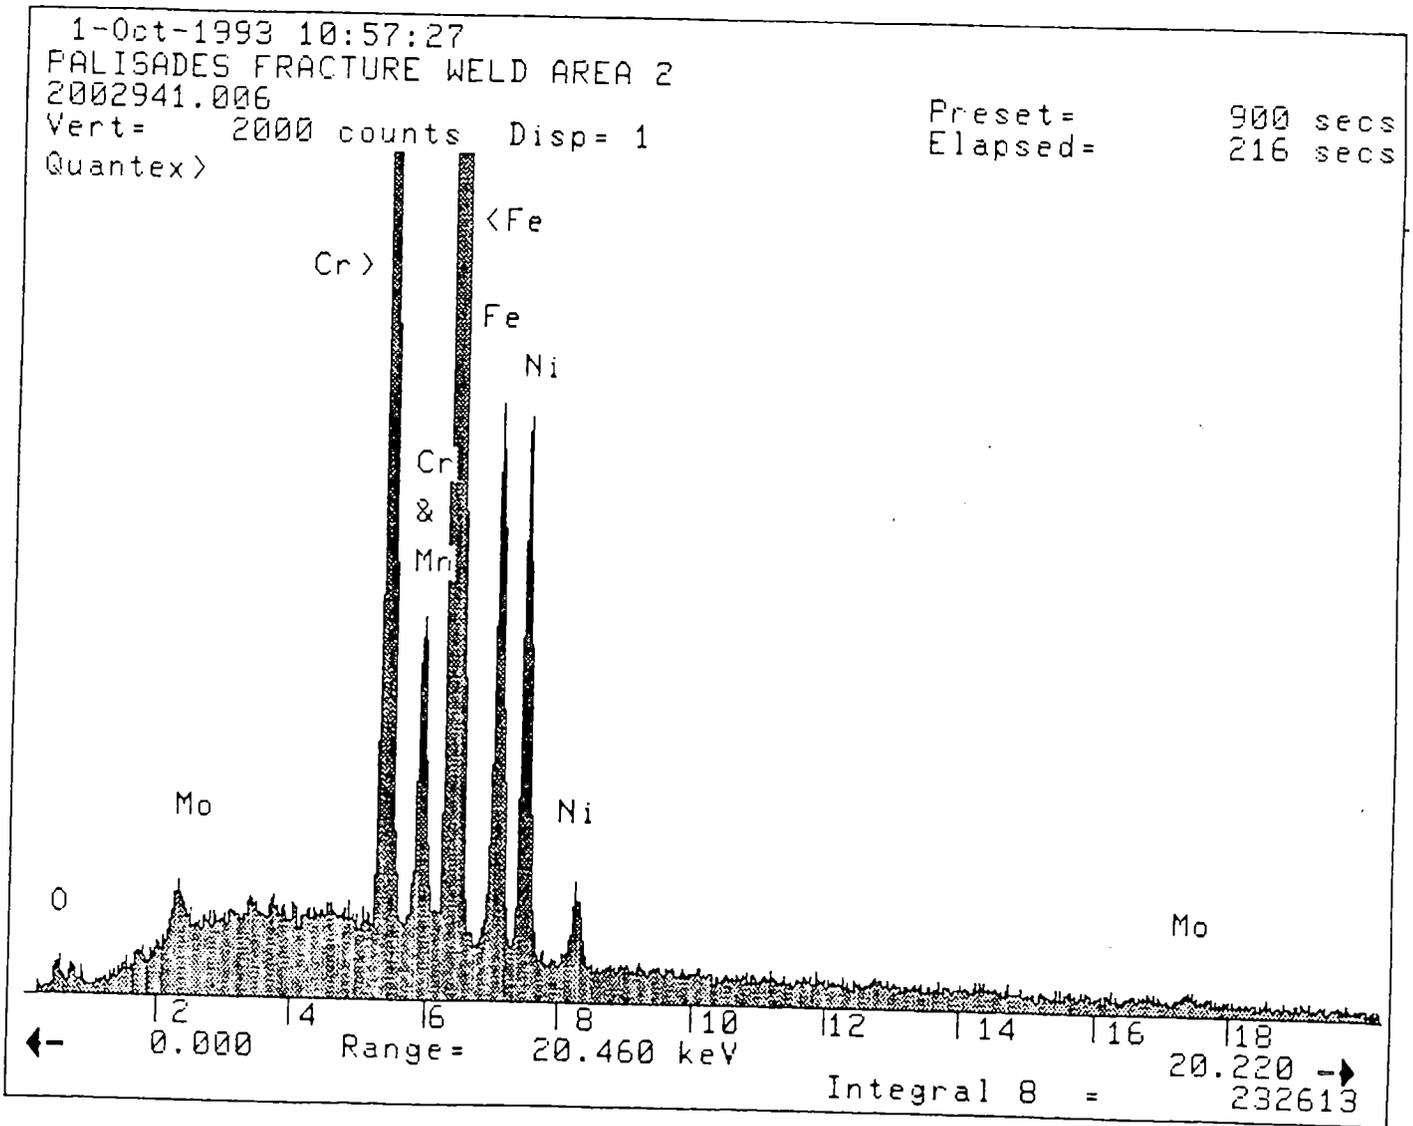
Figure 5-3. Stainless Steel EDS Spectra, Near Weld.

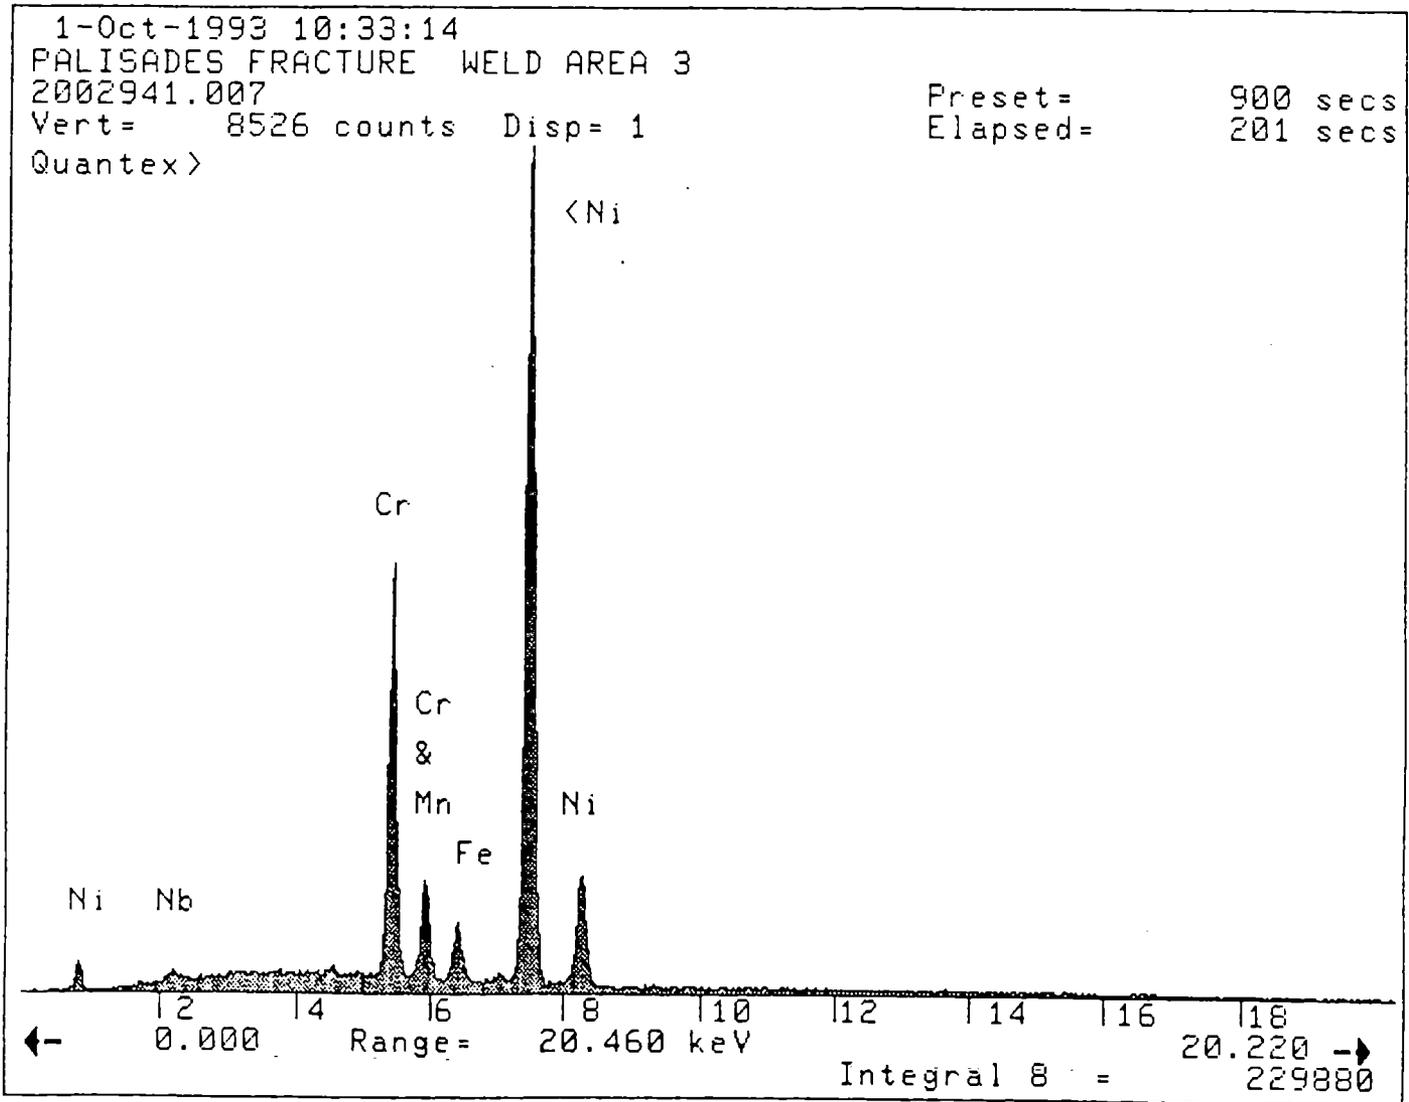
Figure 5-4. Original Weld EDS Spectra, Near Stainless Steel.

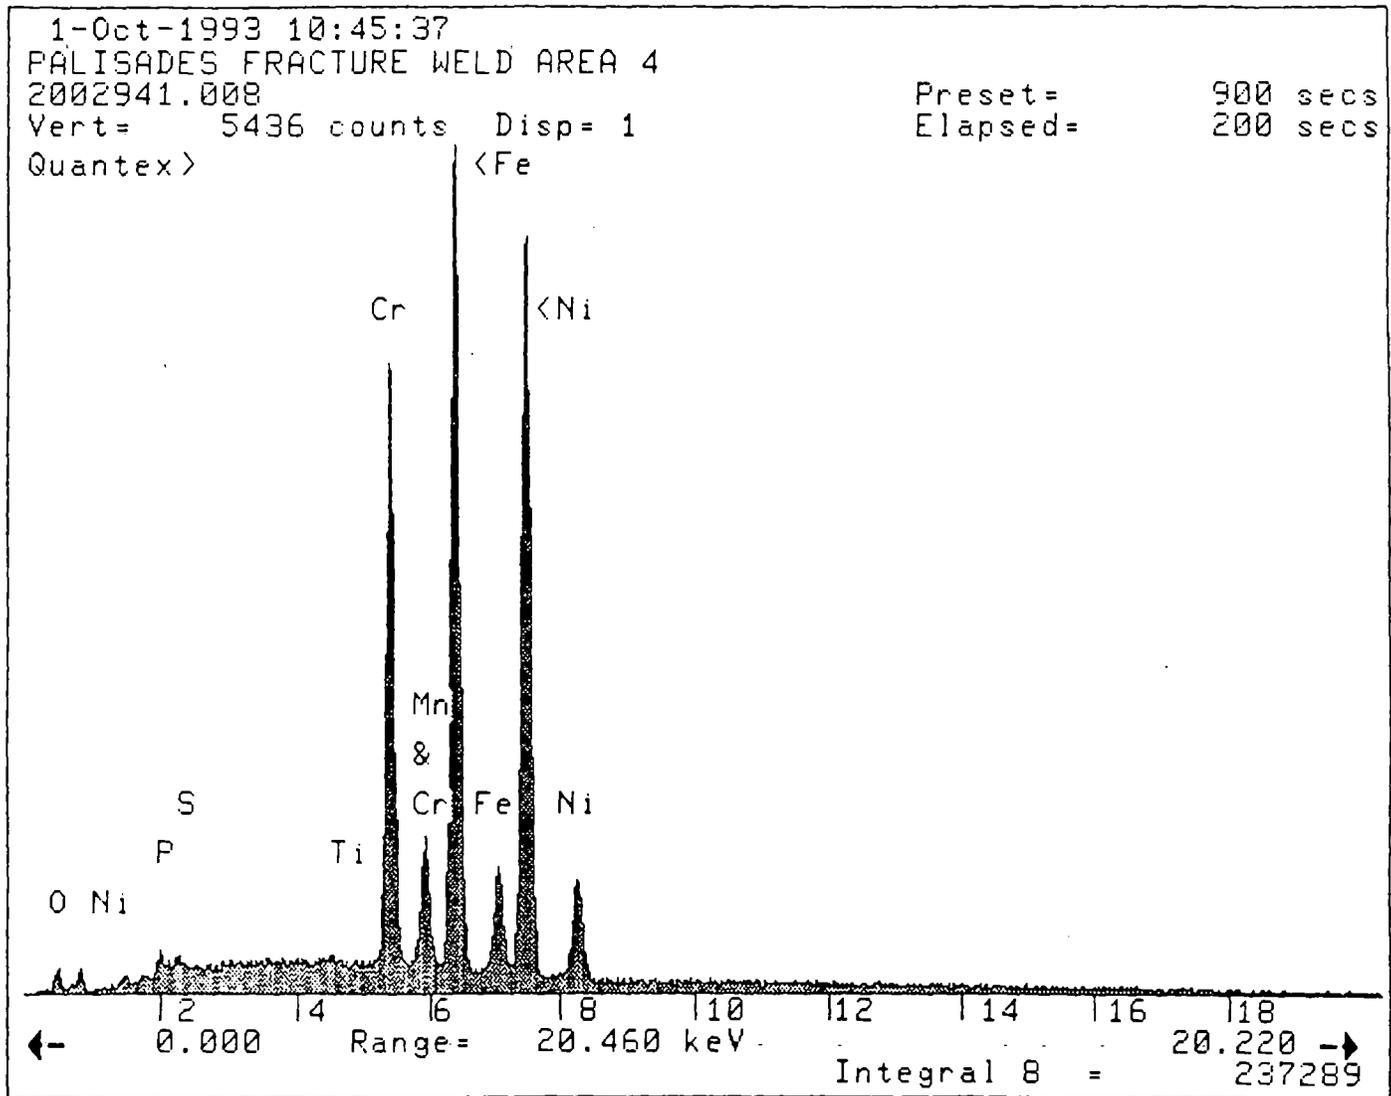
Figure 5-5. Repair Weld Near ID and Original Weld.

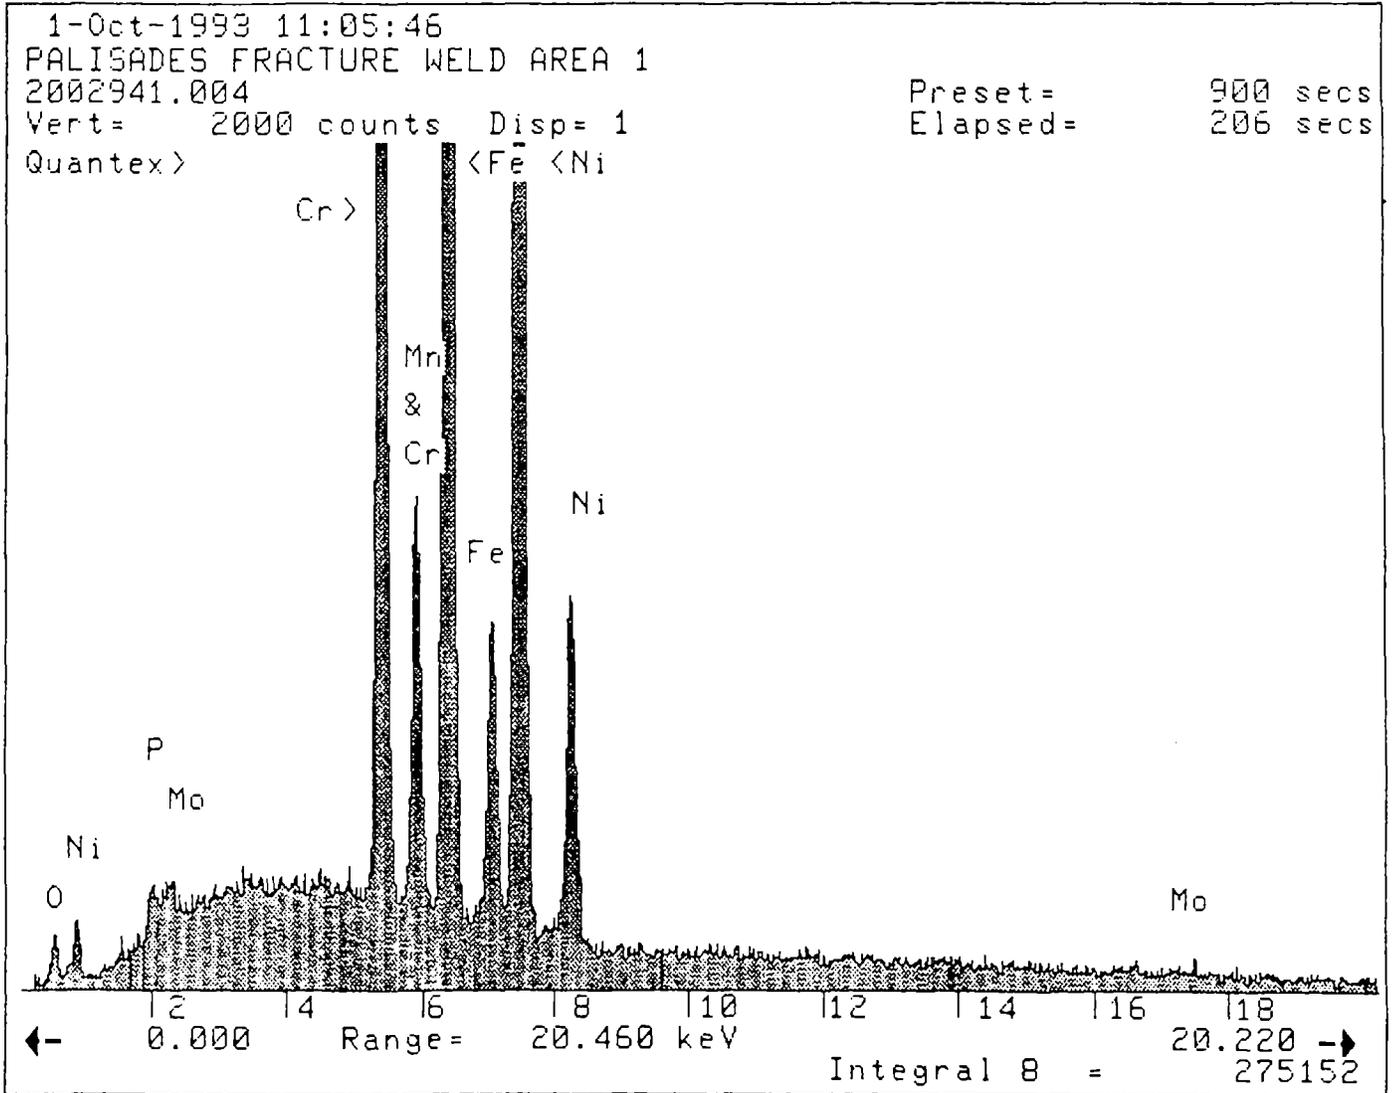
Figure 5-6. Repair Weld Near Stainless Steel.
