U. S. NUCLEAR REGULATORY COMMISSION
REGION I

Docket and Report Nos. 50-272/88-02
50-311/88-02 Licensee Nos.: DPR-70
DPR-75

Facility: Salem Nuclear Generating Station,
Units 1 and 2

Dates: January 4-7, 1988

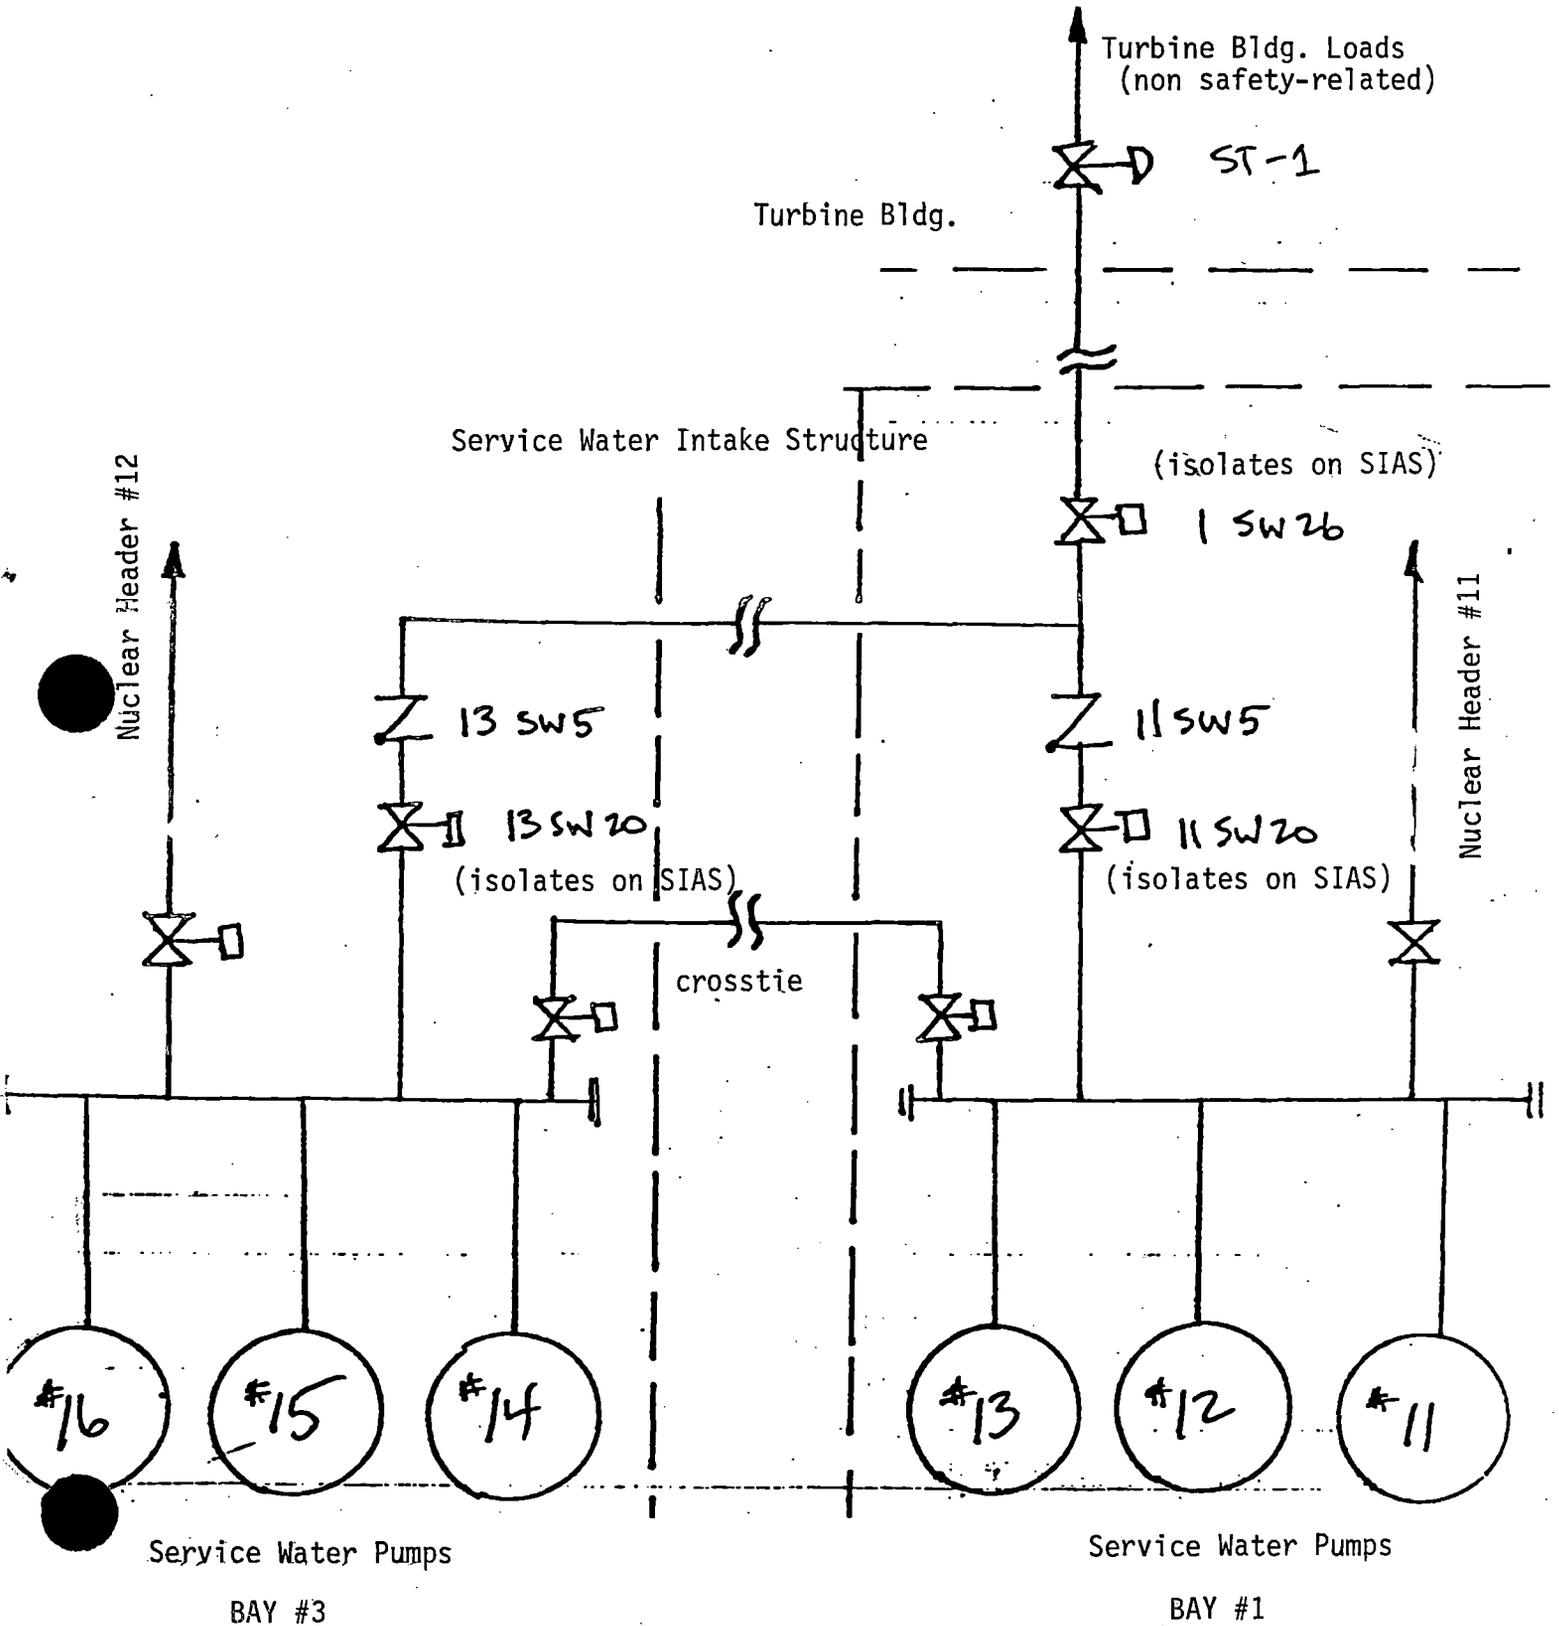
FIGURE 3
PRATT VALVE DETAILS

body seat groove so that the seat ring will slightly overlap the lining. Figure 3 depicts the existing Pratt valve seating details.

PM Valve 13SW20 was removed. The rubber seat ring was found to be torn from its normal position over about 18% of the pipe's circumference.

PM Replaced valve 13SW20.
