U. S. NUCLEAR REGULATORY COMMISSION

Report No. 50-272/89-11
50-311/89-10

Facility: Salem Nuclear Generating Station - Units 1 and 2

Inspection Summary:
Inspection 50-272/89-11; 311/89-10 on May 1, 1989 - June 5, 1989

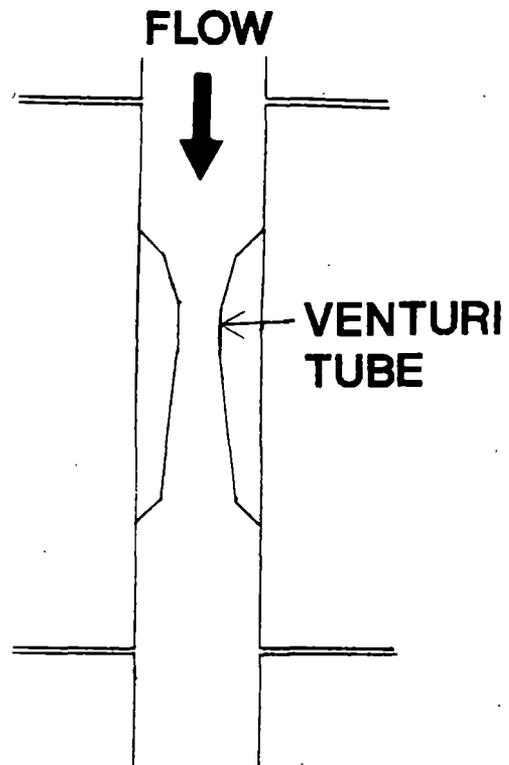
(4)

CALIBRATE BY SETTING
100% FLOW TO MEASURED
VALUE

HAVE RECALIBRATED THE
SYSTEM APPROXIMATELY
ONCE PER CYCLE PRIOR
TO CYCLE 8

12 STM. GEN. STEAM FLOW
