U.S. NUCLEAR REGULATORY COMMISSION
REGION I INSPECTION REPORT

Report No. 50-272/89-27

Facility Name: Salem Unit No: 1

NRC ENFORCEMENT CONFERENCE

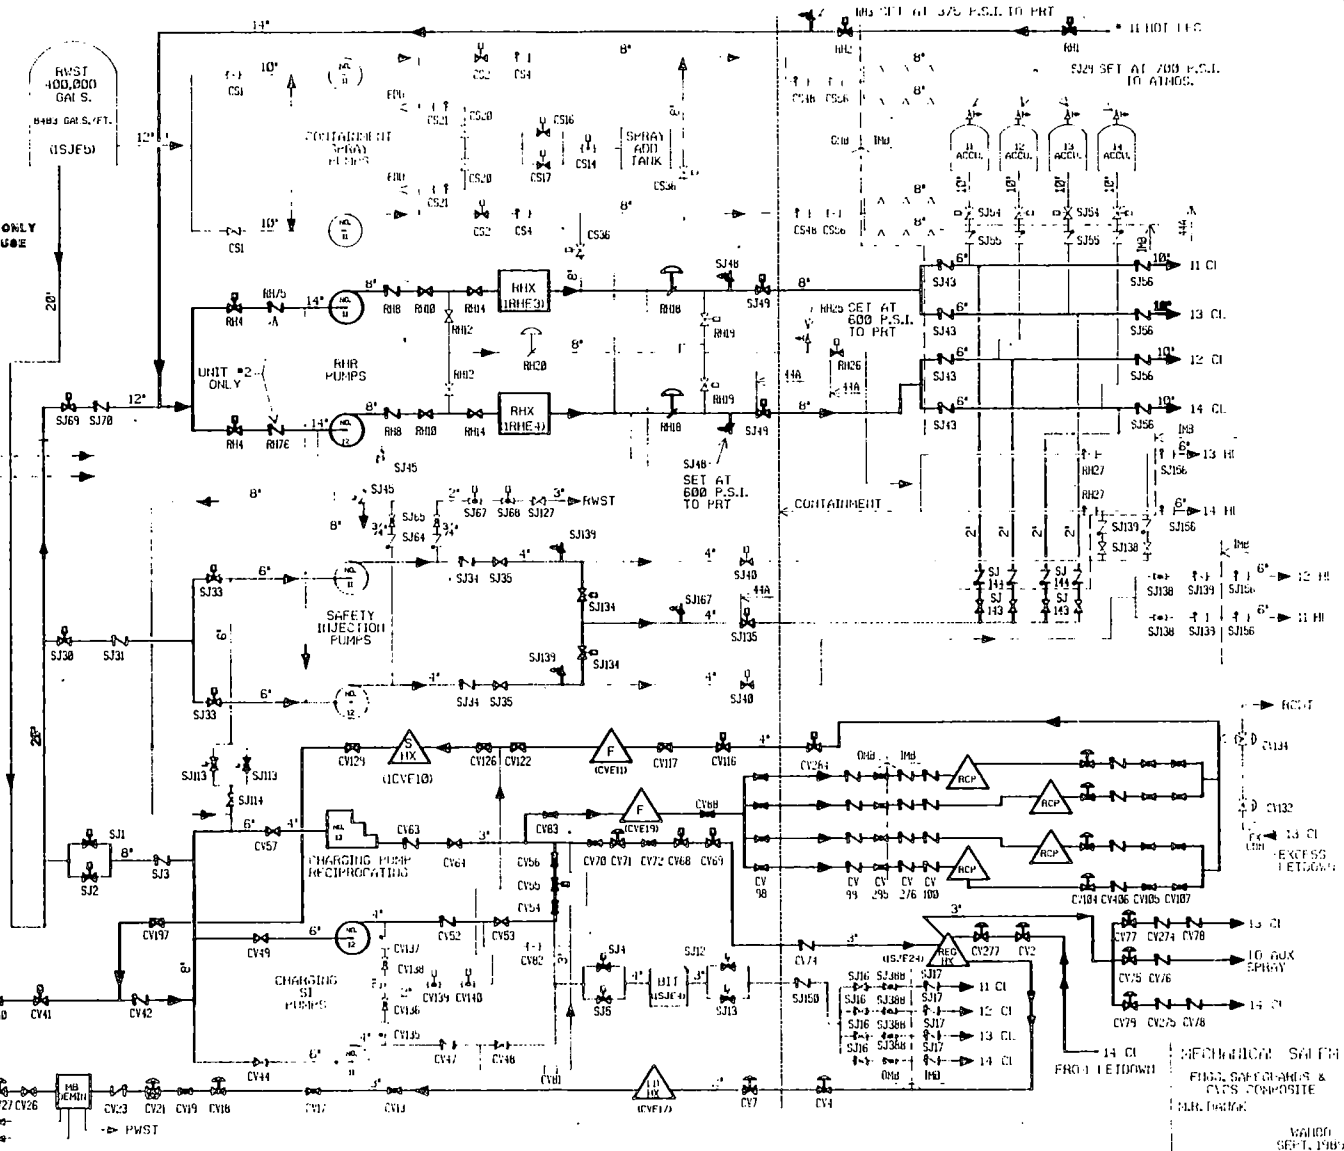
FRIG-1 (COLD) RECHARGE SAFETY
 FRIG-2 SAFETY-CHARGE &
 CV'S COMPOSITE
 H.C. DRAWING

- FAILURE TO IDENTIFY THAT DCR 1EC-2295 FOR UNIT 1 AND 2EC-2295 FOR UNIT 2 CONTAINED A USQ BY INTRODUCING A POTENTIAL SINGLE FAILURE WHICH COULD HAVE JEOPARDIZED THE ABILITY OF THE ECCS SYSTEMS TO PERFORM THEIR SAFETY FUNCTION DURING A LOCA

- * TAGGED SJ49 MOTOR BREAKERS IN OPEN POSITION TO ELIMINATE SINGLE FAILURE CONCERN.
- * REVISED OPERATOR LOGS TO REQUIRE VERIFICATION OF SJ49 OPEN POSITION, EACH SHIFT.
- * CONDUCTED BRIEFINGS WITH SHIFT PERSONNEL.
- * REVISED EOP'S TO ENSURE SJ49'S ARE POWERED-UP FOR SWITCHOVER TO RECIRCULATION.

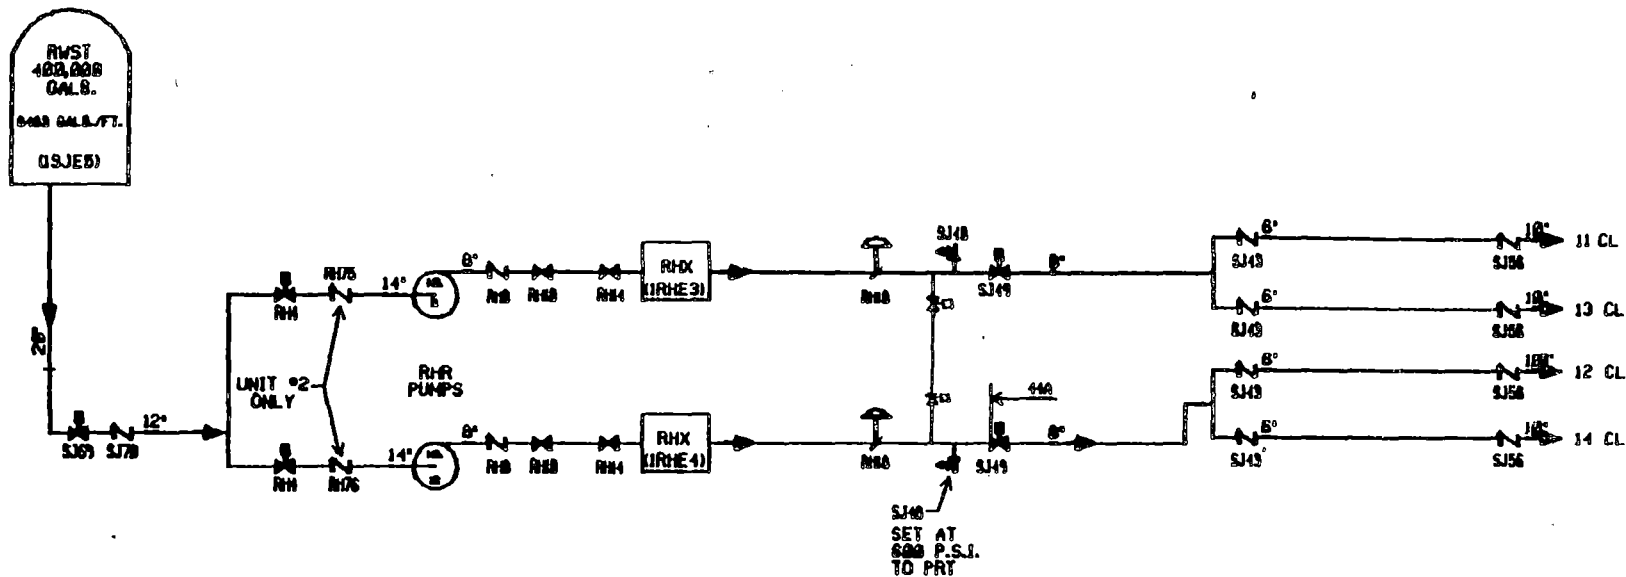
RHR - INJECTION MODE

- * LIMITING BREAK IS LOCA WITH CD = 0.4
- * LIMITING SINGLE FAILURE = CLOSURE OF ONE SJ49
- * ALL PUMPS INCLUDING BOTH RHR PUMPS ARE RUNNING
- * EVALUATION ASSUMES RHR FLOW TO ONE COLD LEG
- * CALCULATED TOTAL FLOW TO ONE LOOP 2864 GPM AT 25 PSIA
RCS PRESSURE (BY WESTINGHOUSE)
- * CALCULATED PCT PENALTY DUE TO SI DEGRADATION IS 29 F.
(BY WESTINGHOUSE)
- * NO ADDITIONAL PCT PENALTY FROM ASYMETRIC FLOW DELIVERY
(BY WESTINGHOUSE)
- * CALCULATED NEW PCT: $2091 + 29 = 2120$ F.
- * NEW PCT REMAINS LOWER THAN 2200 F
- * MINIMAL SAFETY SIGNIFICANCE

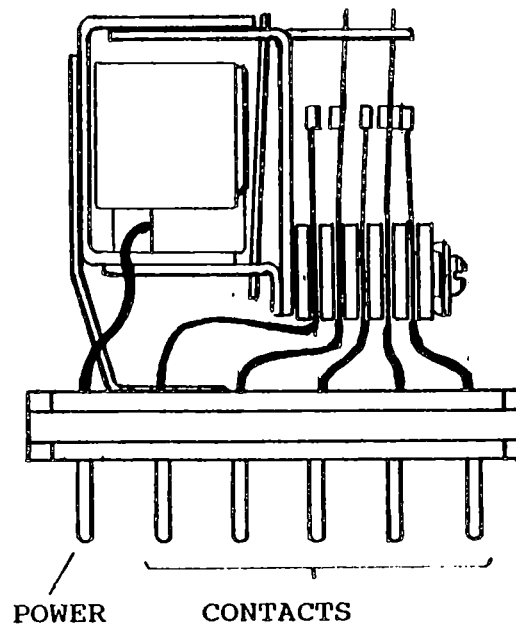
HEAVY-DUTY PLUG-IN RELAY FAMILY

- COMBINED PROBABILITY OF LARGE LOCA AND RANDOM SINGLE FAILURE OF CONTROL CIRCUIT (2.5×10^{-11})
