U. S. NUCLEAR REGULATORY COMMISSION
REGION I

REPORT/DOCKET NOS. 50-272/94-80
50-311/94-80

FACILITY: Salem Nuclear Generating Station

INSPECTION DATES: April 8-26, 1994

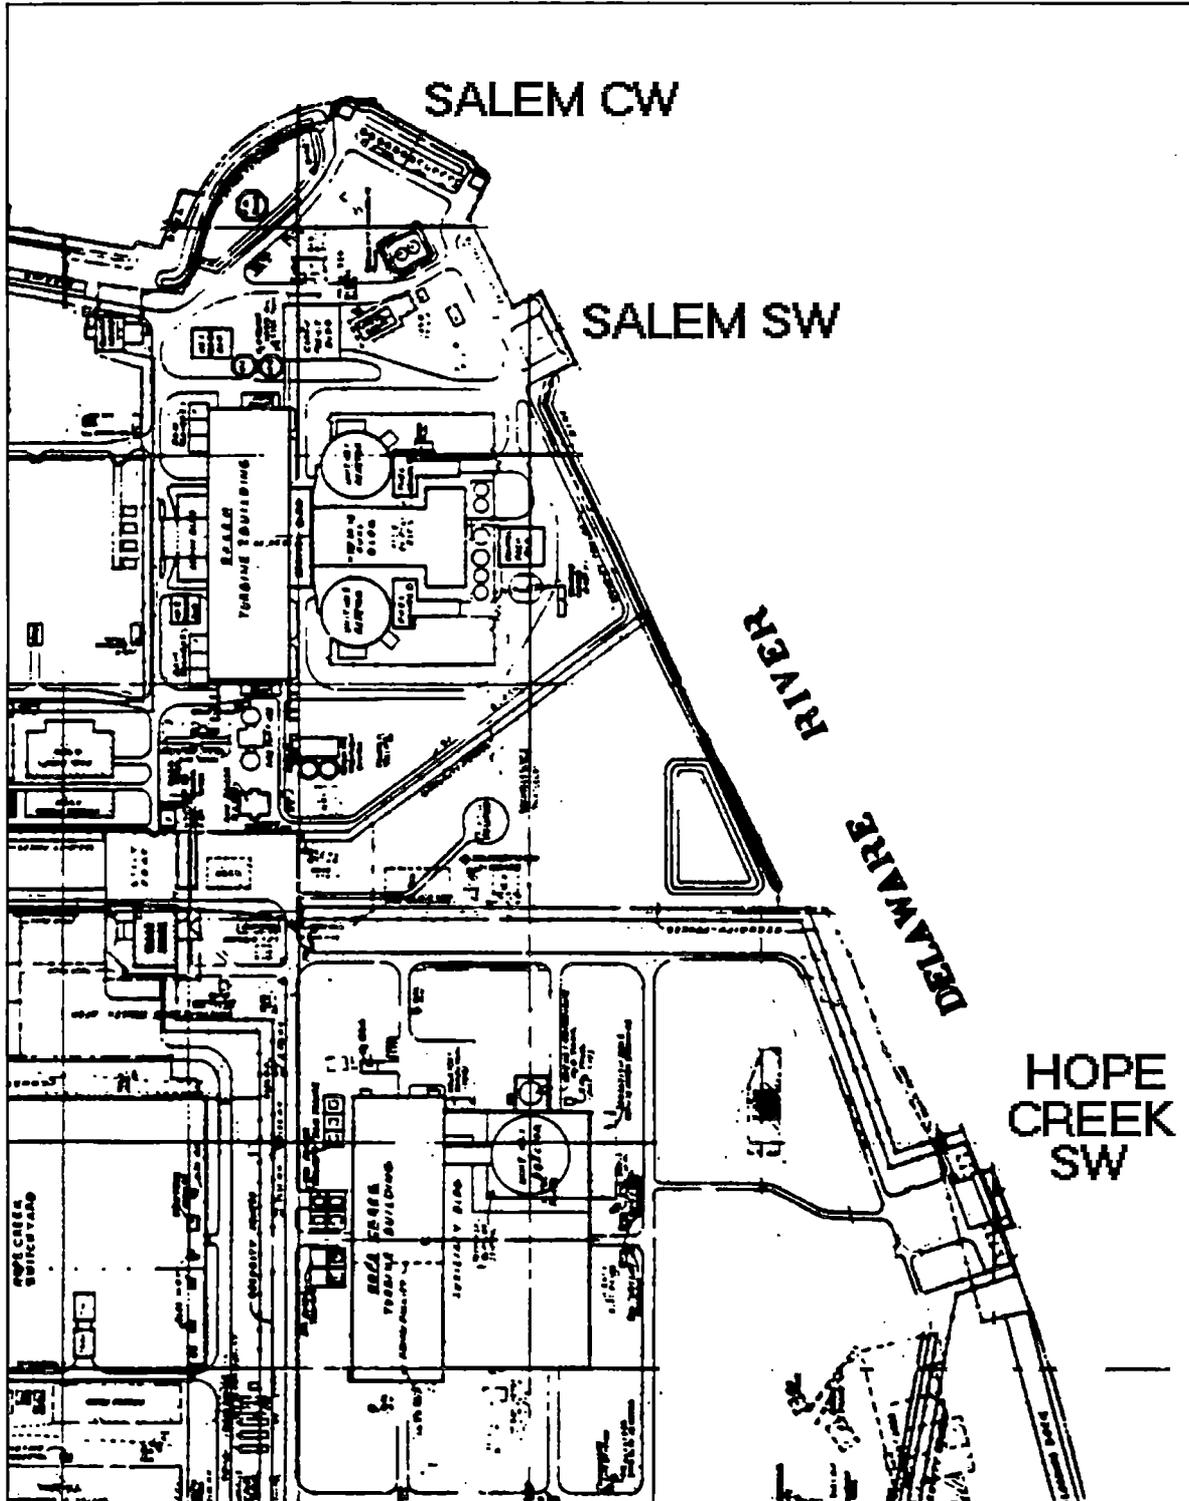
Figure 3. Relative Location of Water Intake Structures

Salem and Hope Creek have three water intake structures positioned as shown in Fig. 3 in Attachment 7.

Salem's SW intake is about 100 yds upstream (north) of the CW intake and Hope Creek's SW intake is about 3/8 mile upstream of the Salem SW intake. Water entering each intake structure passes through a trash rack, a moving screen, a pump, and, for SW, a filter. These are shown in Figs. 4 - 6 in Attachment 7. The bottom of both SW intakes is at about the river bottom, about 30 feet below surface grade. The CW intake bottom is 50 ft. below grade and the river bottom is dredged to that depth for the width of the intake structure and for a distance of 100 ft. from shore.
