WCAP-9638

METALLURGICAL INVESTIGATION OF  
CRACKS IN THE STEAM GENERATOR  
FEEDWATER LINES OF SURRY STATION NO. 1

L. Albertin  
G. V. Rao  
T. R. Mager

December 1979

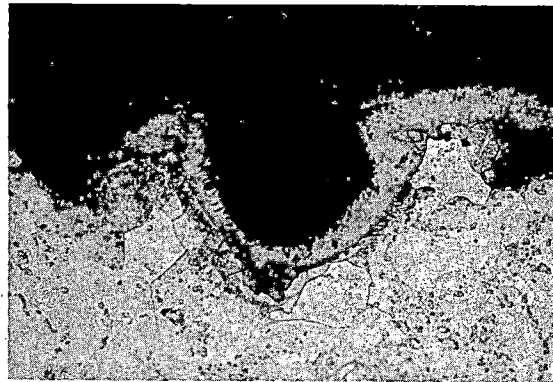
**Figure 2-12. Surface Oxidation and Small Oxide Protrusions Found in Reducer B, Section 108 Degrees**

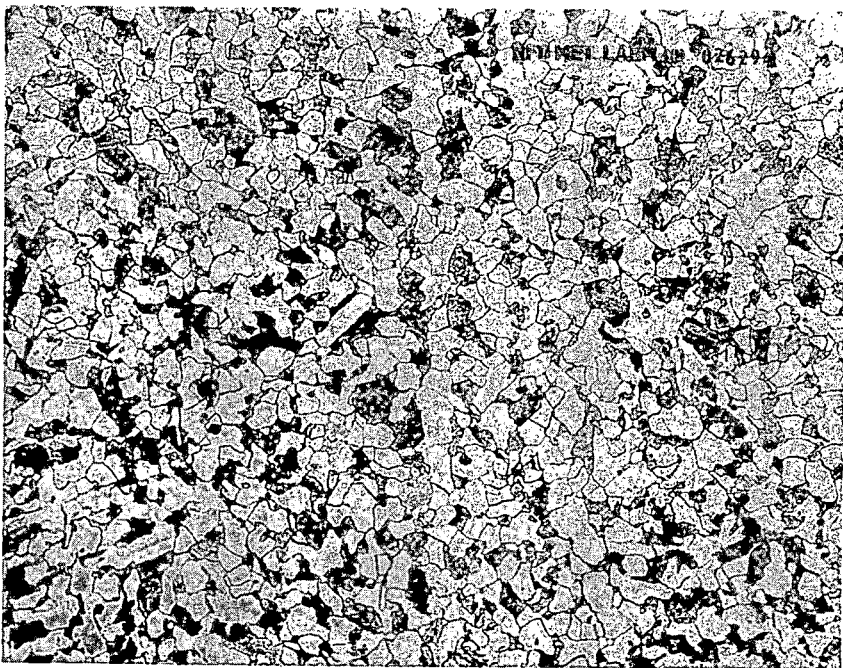
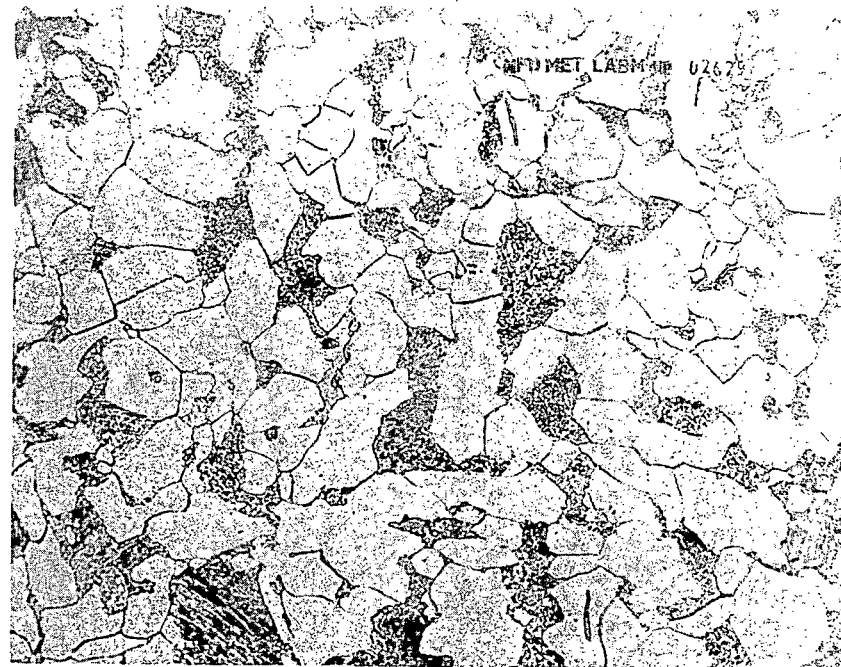
Light microscopy was conducted to study the size, morphology and distribution of ferrite and pearlite phases. Figure 2-13 illustrates the typical light micrographs and shows the distribution of pro-eutectoid ferrite and pearlite phases with some banding of pearlite in the major working direction.

Figure 2-13. Light Optic Micrographs Showing the Size and Distribution of Ferrite and Pearlite Phases. (Reducer Material, Loop B)

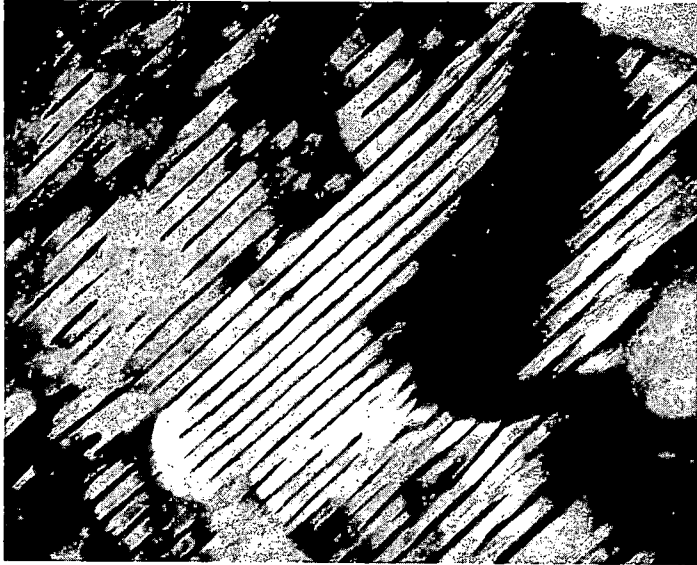
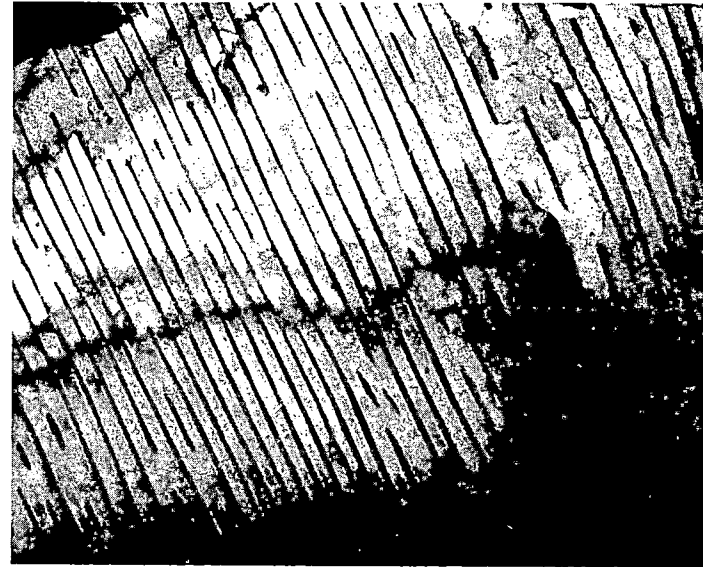
The fine structure of the ferrite and pearlite phases was studied by thin foil transmission electron microscopy. Figures 2-14 and 2-15 illustrate the substructures within ferrite and pearlite phases, respectively. No abnormal features are seen. The interlath spacing of pearlite lamellae is estimated to be approximately 0.20 microns.

Figure 2-15. Thin Foil Transmission Electron Micrographs of the Reducer (Loop B) Material Showing the Fine Structure and Interlath Spacing of the Pearlite Phase

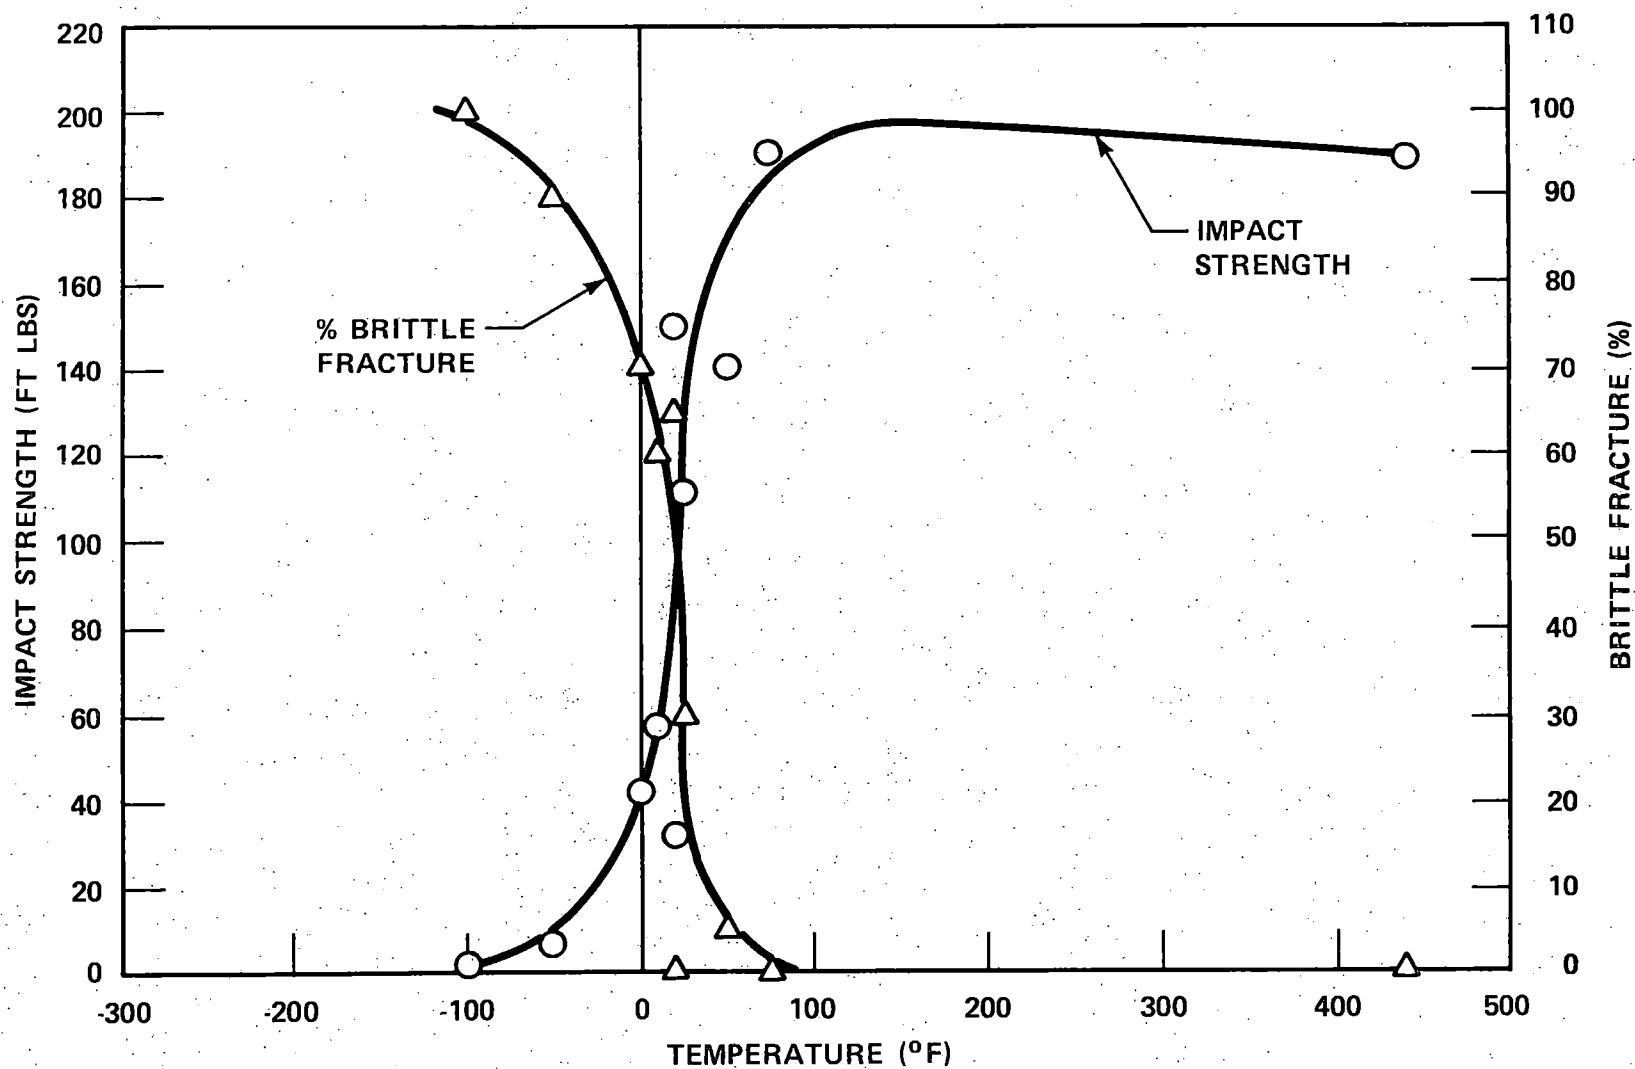
Ten Charpy impact specimen blanks were cut from Reducer B, location 121°, in such a way that the notch plane in the Charpy specimens would correspond to the crack plane of the field fracture. Machined specimens were then tested at various temperatures to determine the ductile-brittle behavior of the steel. The results are shown in figure 2-32.

Figure 2-32. Charpy V-Notch Properties of Reducer B Material in the Test Temperature Range of 100 to 440°F
