SHEARON HARRIS NUCLEAR POWER PLANT
FAULT INVESTIGATION

PROGRESS REPORT

EBASCO SERVICES INCORPORATED

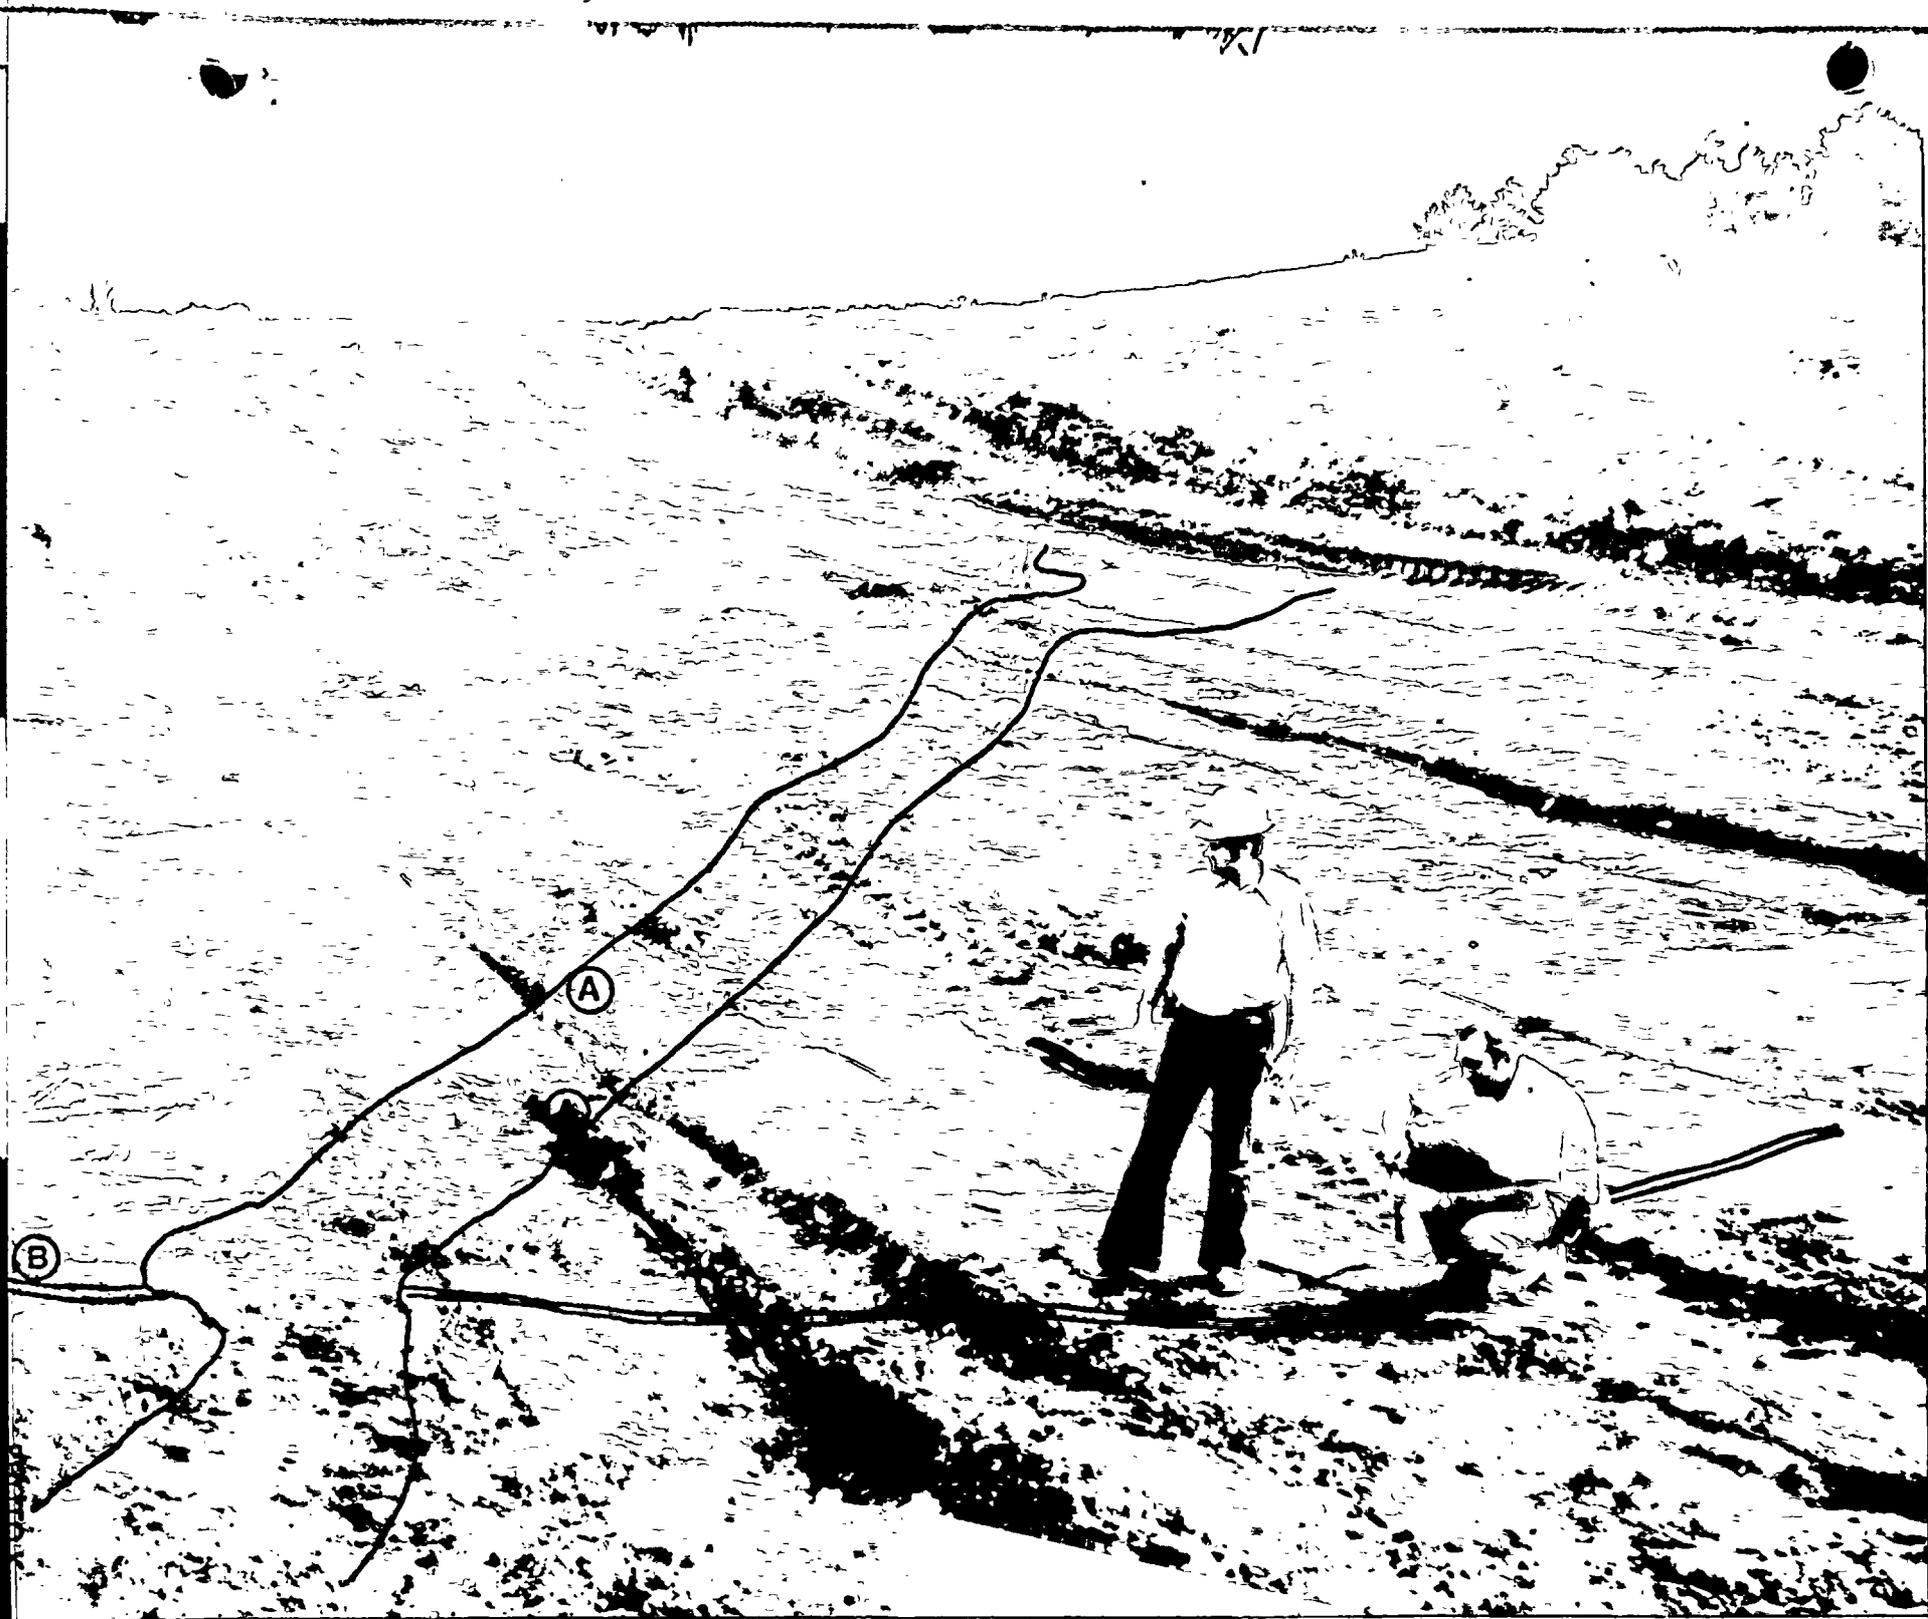
C54-493
Photo K Caption

West Dike 3S intersects West Dike 3 at a point several hundred feet northerly from the intersection of the fault with the two dikes. Sedimentary beds crossing West Dike 3S are not offset. At elevation 249, the outcrop of the intersection of West Dike 3S and the fault was such that West Dike 3S, if any apparent offset could be seen at all, was out of line only a few inches. This is seen on Plate 5 and in Photo K. Subsequent excavation to elevation 239 revealed relative change in location of all key elements of this exposure as shown on Plate 6 and in Photos L through P. Analysis of these changes indicates that they could not have been produced by fault offset if the dike was planar at the fault as it is elsewhere. That is, had fault movement occurred after intrusion of the dike, the dikes configuration as now seen would not be expected.

View south along diabase West Dike 3S taken at elevation 249 at the intersection with the fault. The fault is identified by line segments (B). Line segments (A) represent the boundaries of West Dike 3S. At this elevation there is the suggestion of an apophysis of the diabase into the faulted material in the south limb. Left lateral offset, if any, could be interpreted to be a few inches. The straight alignment of West Dike 3S suggests that the dike is either vertical or exhibits essentially constant dip. There is no evidence of shearing in the diabase in this exposure.

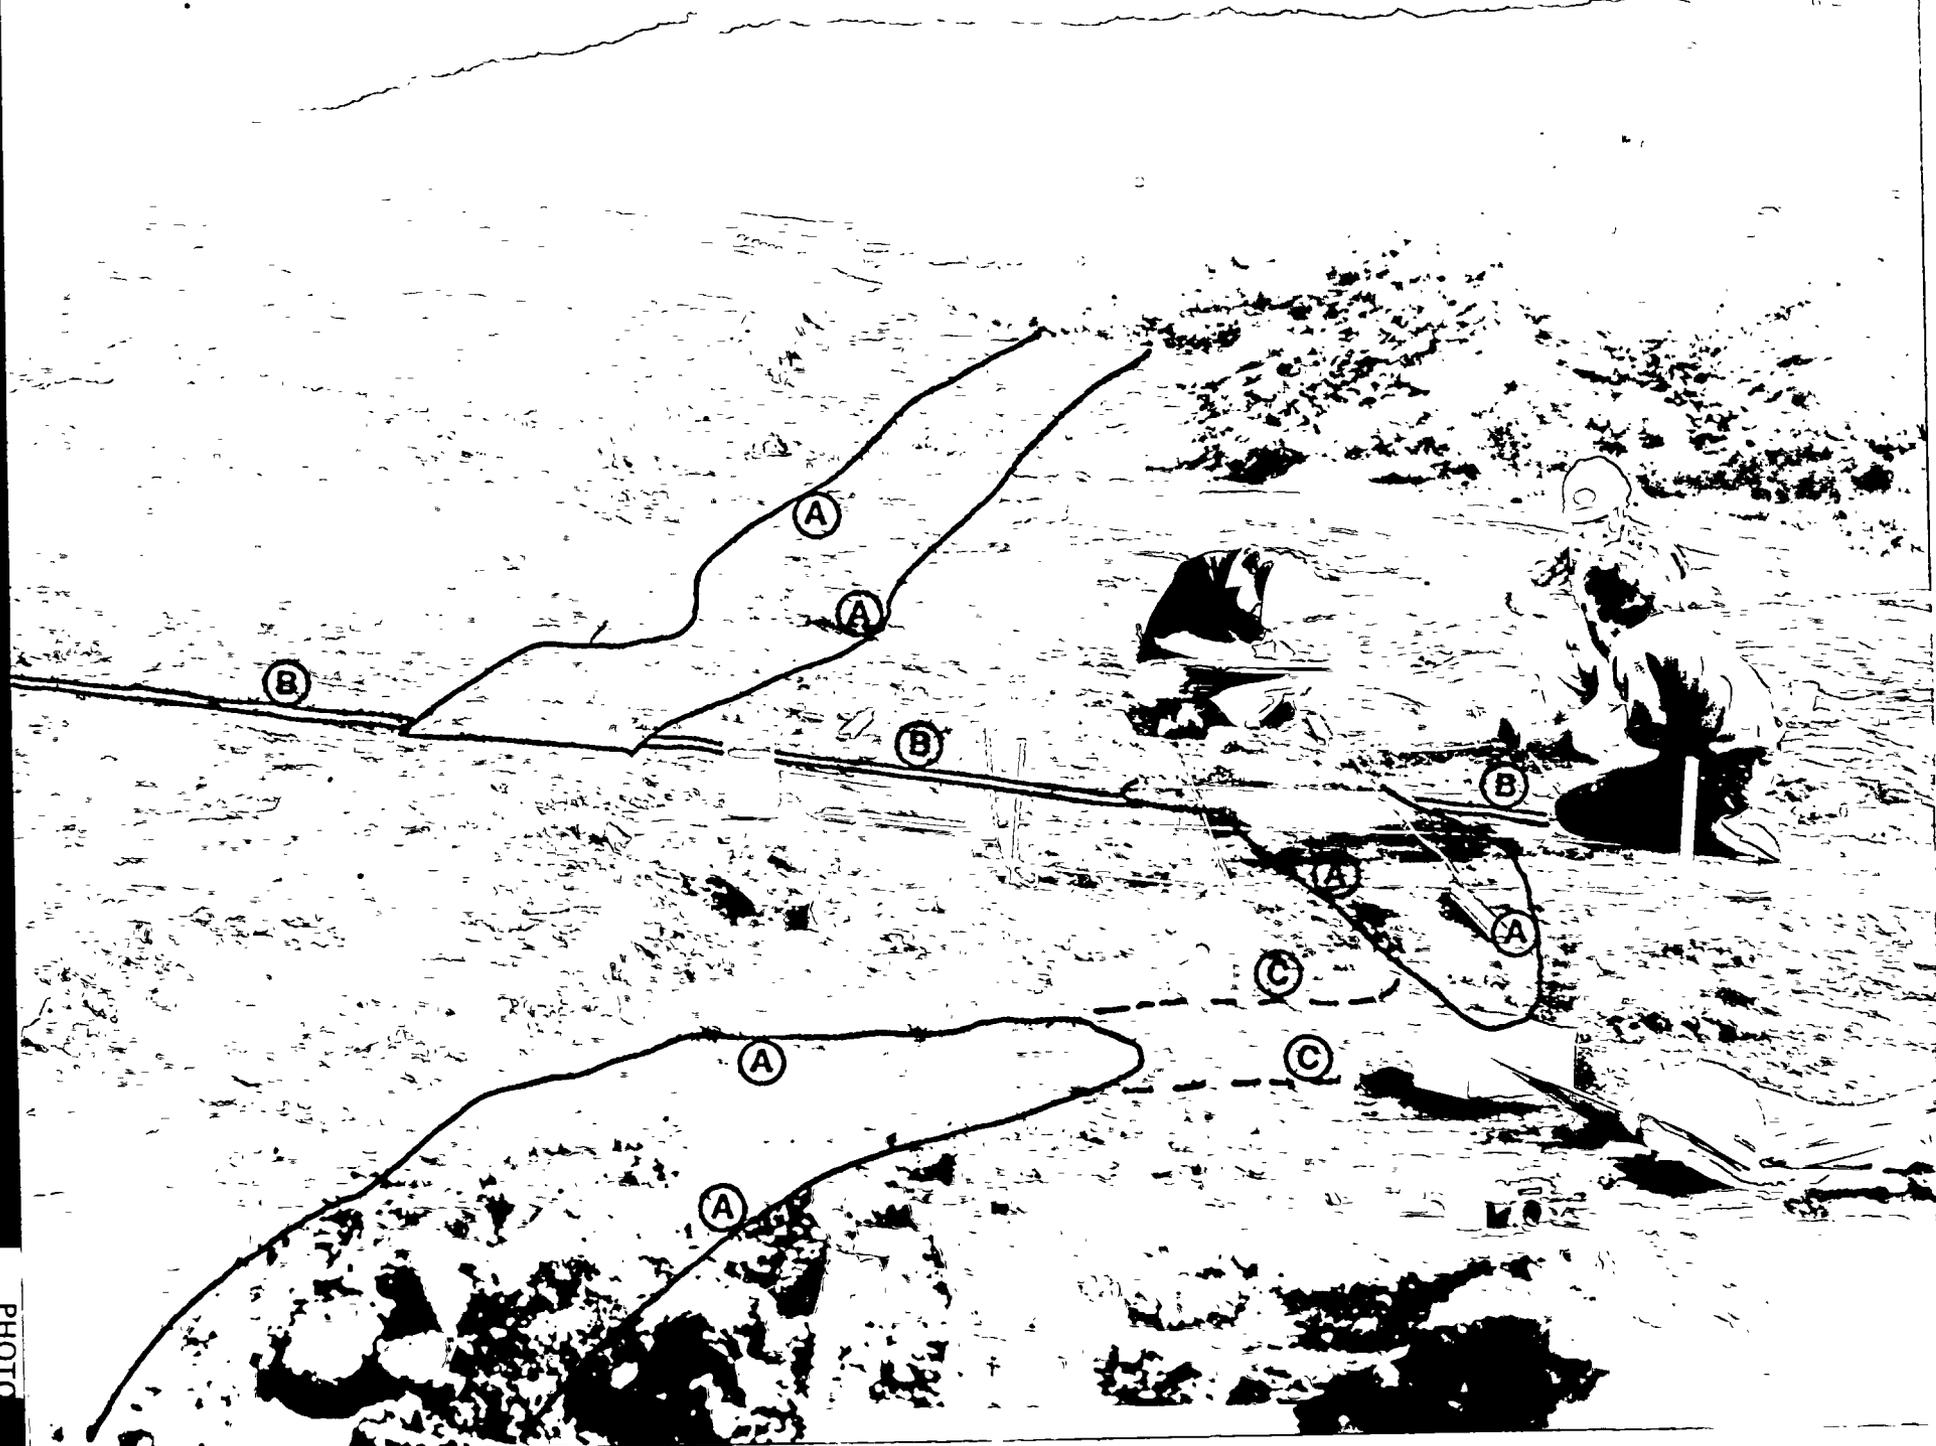
C54-487
Photo L Caption

The outcrop of the intersection of West Dike 3S and the fault at elevation 239 offers strong evidence that West Dike 3S was intruded subsequent to movement on the fault. This exposure is seen in attached Photos L through P and on Plate 6. As can be seen in the photos and drawings diabase of West Dike 3S overlaps the sheared clay of the fault zone. The two apophyses of diabase seen at the end of the northern limb of this exposure appear to offer com-

View southward along West Dike 3S, at elevation 239. Compare this photo to Photo K. Line segments (A) represent the limits of the diabase dike. Line segments (B) represent the trace of the fault. Line segment (C) represents the limits of the zone of alteration between the two northern segments of West Dike 3S. Compare with Photo Q.
