Legacy
Management

2018 Annual Site Inspection and
Monitoring Report for Uranium Mill Tailings
Radiation Control Act Title II Disposal Sites

December 2018

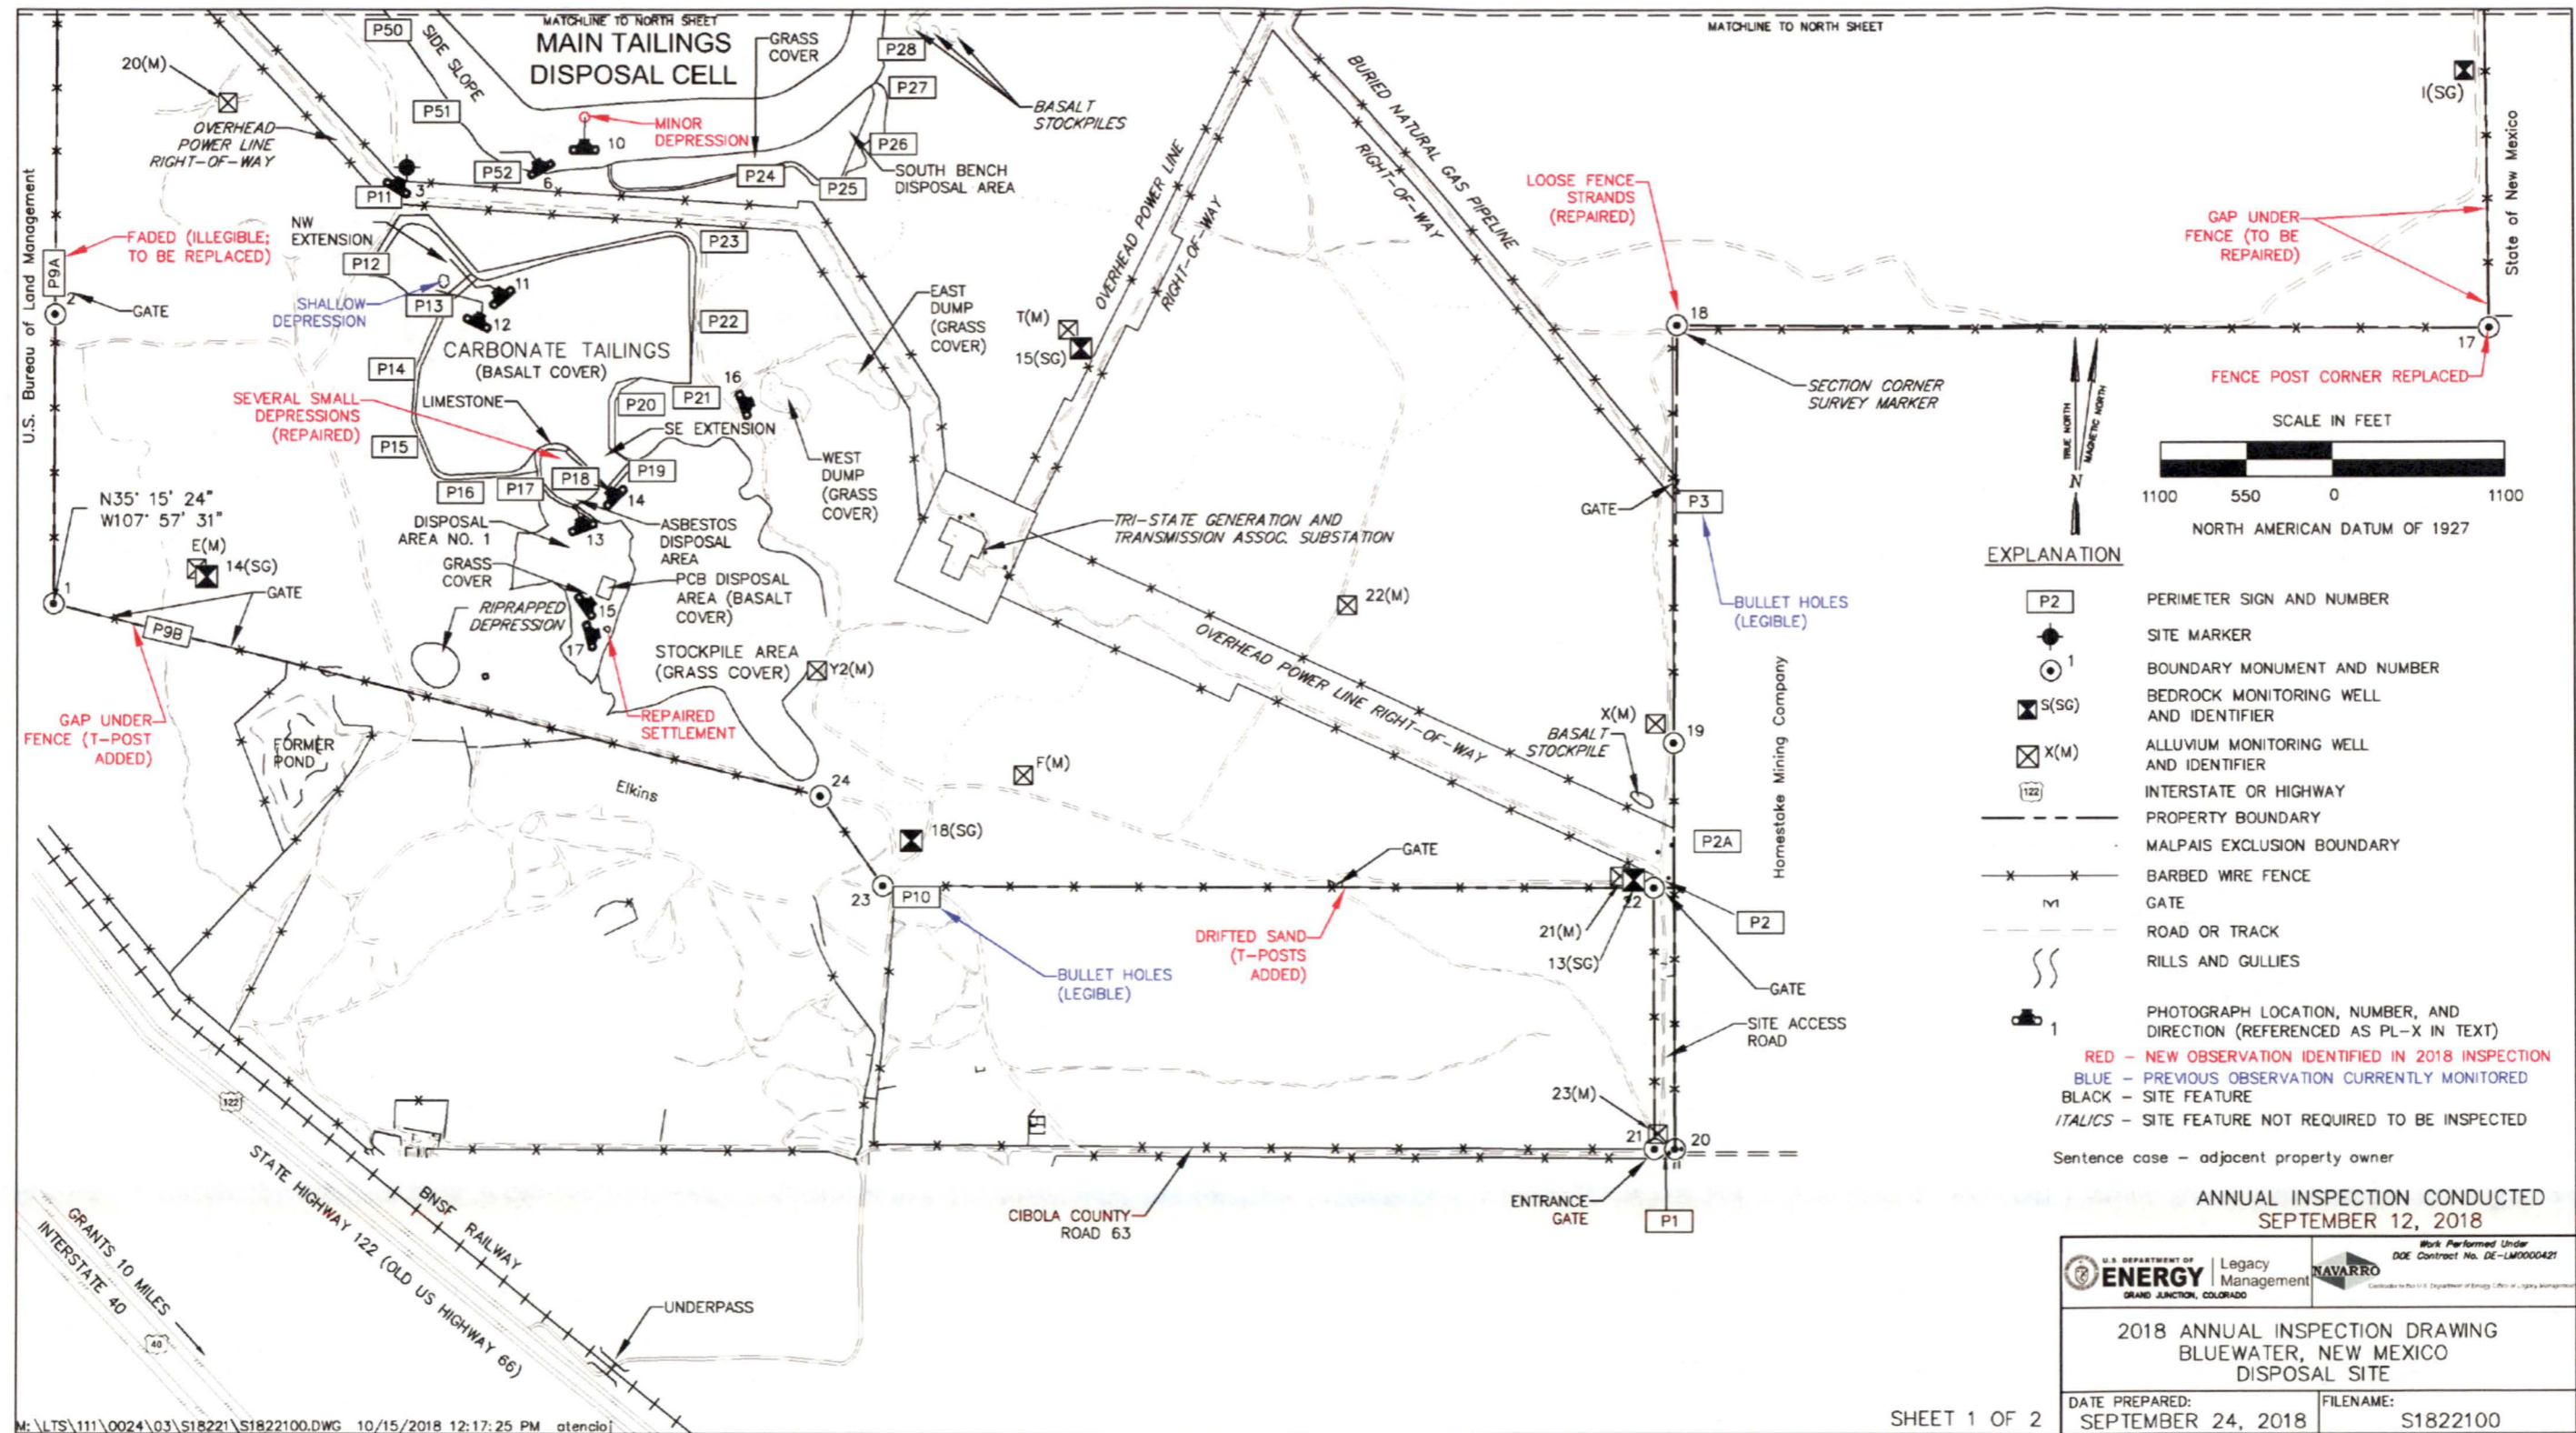
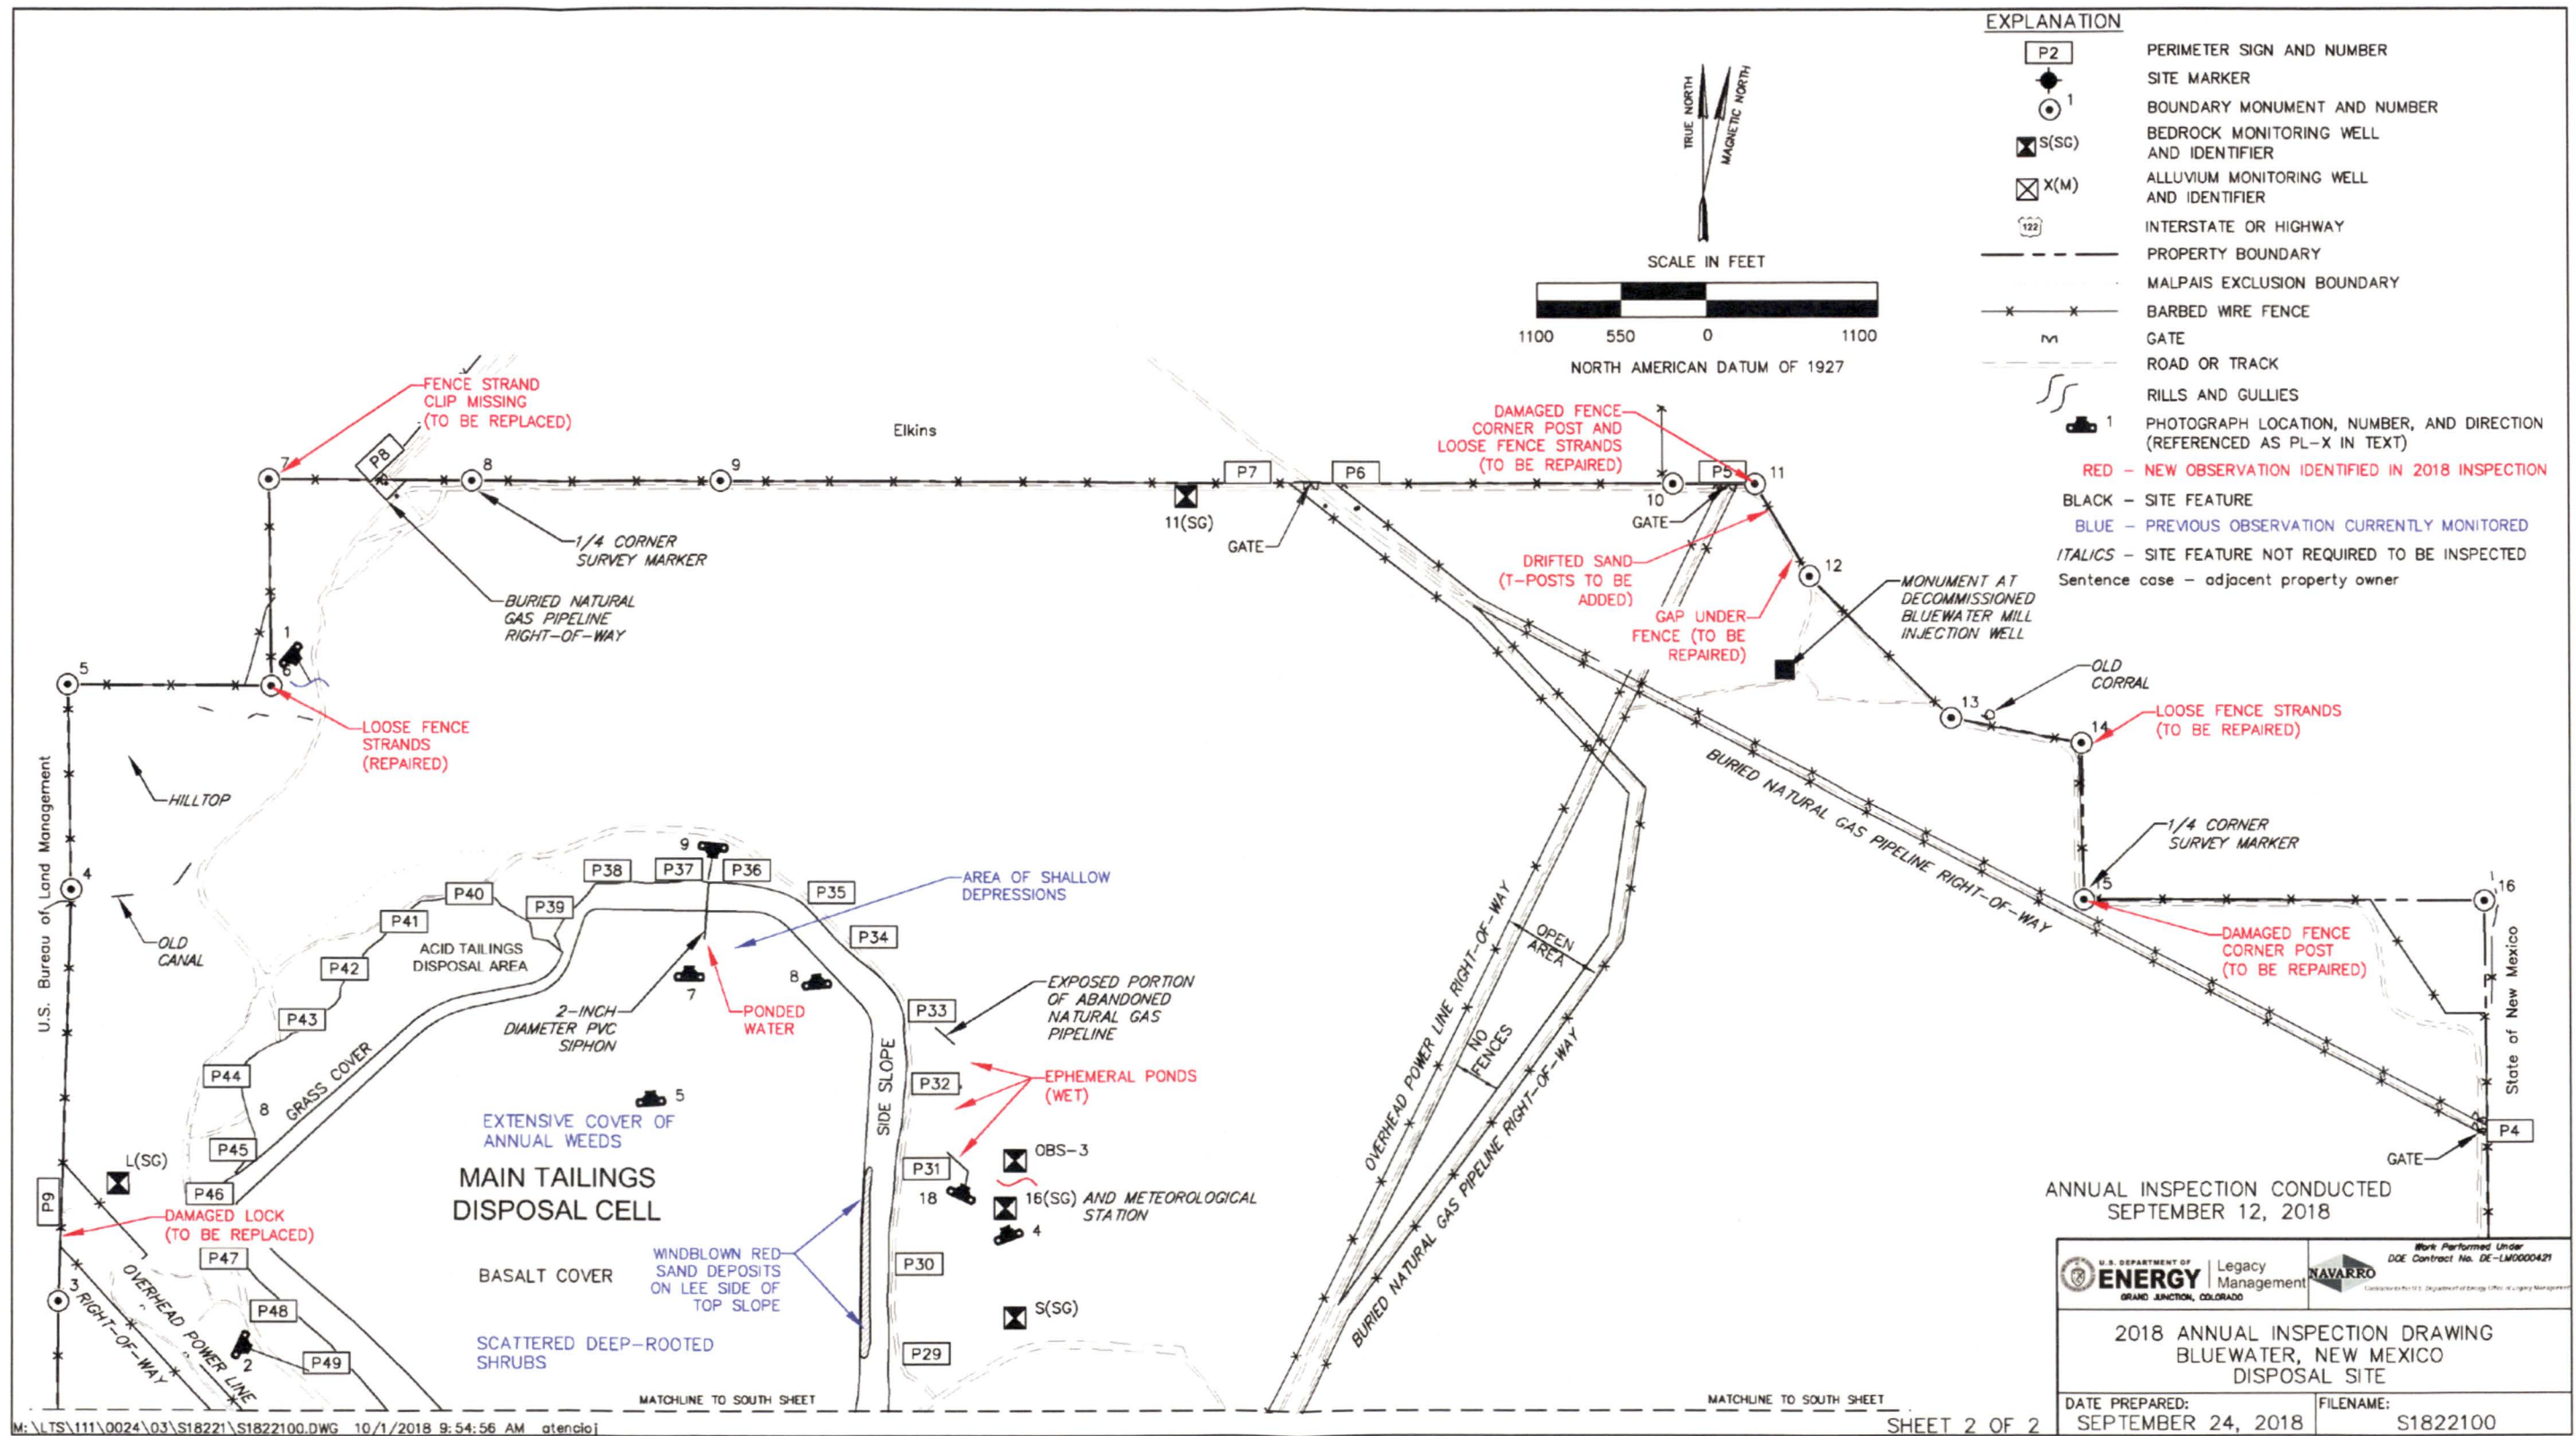
Figure 1-1 and Figure 1-2 show the locations of site features in black, including the surveillance features and inspection areas. Site features that are present but not required to be inspected are shown in italic font. Observations from previous inspections that are currently monitored are shown in blue text, and new observations identified in the 2018 annual inspection are shown in red. Inspection results and recommended maintenance activities associated with site surveillance features are included in the following subsections. Photographs to support specific observations are identified in the text and in Figure 1-1 and Figure 1-2 by photograph location (PL) numbers. The photographs and photograph log are presented in Section 1.9.

A four-strand barbed-wire fence encloses the site to facilitate land management by LM, which retains a local subcontractor to periodically check the site perimeter fence and remove trespassing cattle. Minor fence repairs are conducted as needed. Numerous sections of the fence are in remote areas of the site and cannot be observed from site access roads. The entire perimeter fence was inspected on April 25, 2018. Before the inspection, on April 23–25, 2018, a south section of the perimeter fence was repaired by adding additional T-posts and wire to eliminate gaps caused at some locations by erosion and deposition. At the corner where boundary monument BM-17 is located, the old wooden-post corner was replaced with an angle-iron corner post and braces set in concrete. Additional fence repair needs and a damaged lock on a perimeter gate are noted in Figure 1-1 and Figure 1-2; repairs are planned for 2019.

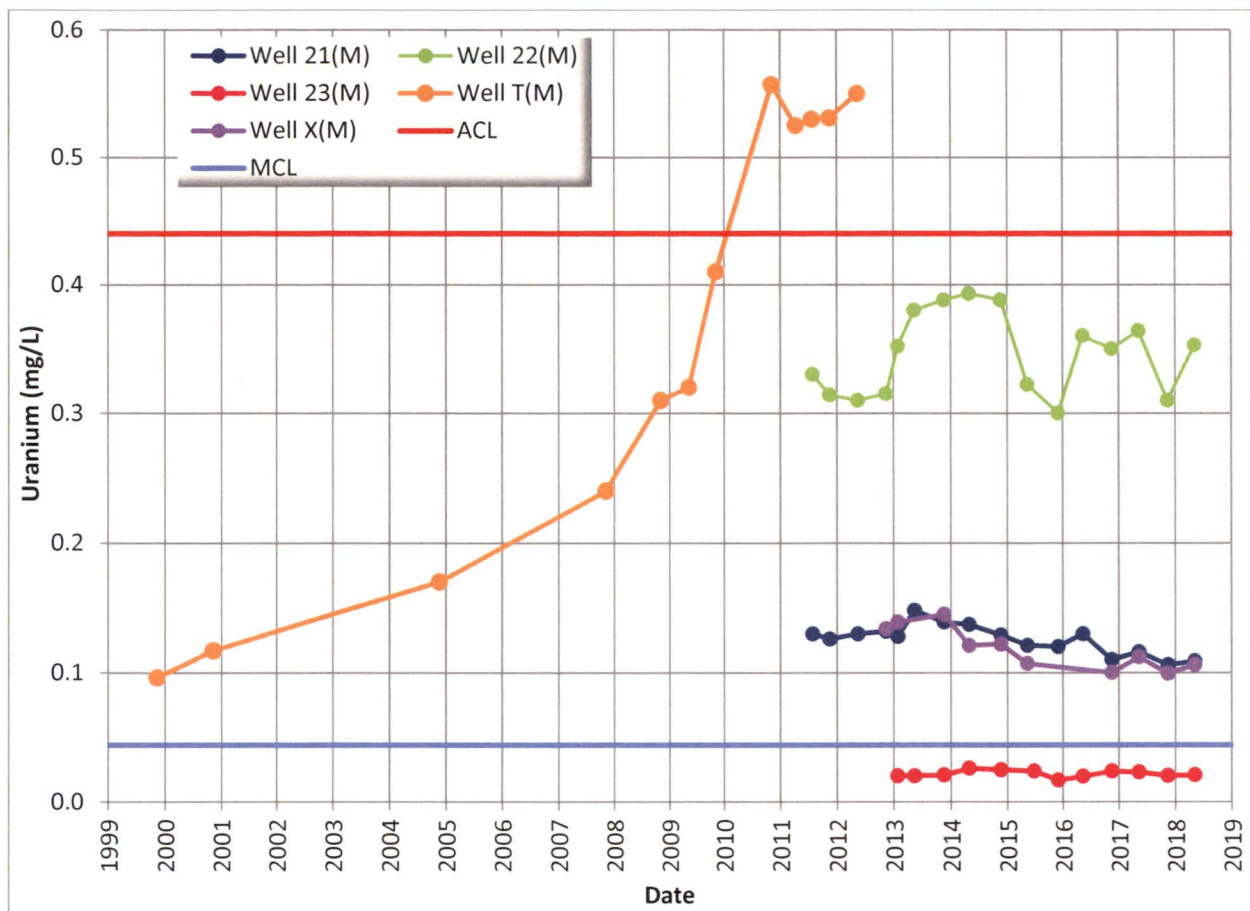
Figure 1-4 shows historical uranium concentrations measured at POC well T(M) and five additional wells screened in the alluvial aquifer. As this figure shows, the uranium concentration at well T(M) trended upward since LM began monitoring the well in 1999, and the November 2010 concentration of 0.557 mg/L was the first of five uranium concentrations that exceeded the ACL of 0.44 mg/L. LM notified NRC of the exceedance upon receiving the 2010 results from the laboratory. Well T(M) dried up following a May 2012 sampling as a result of drought and continuing declines of water levels in the well, and the well has since remained dry. Well 21(M) in the southeast corner of the site and POE well X(M) near the site's east boundary show a slightly decreasing trend in uranium concentration since 2013 (Figure 1-4). However, the elevated uranium concentrations at these two wells in recent years indicate that alluvial groundwater with uranium concentrations exceeding the New Mexico groundwater standard (0.03 mg/L) is discharging from the site toward the southeast.

NRC requested that LM evaluate the performance of the main tailings disposal cell to assess whether seepage losses from the cell between 2005 and 2010 had increased above previous losses to the extent they were responsible for the elevated uranium concentrations measured at POC well T(M) (see Figure 1-4) before it dried up. An assessment of the disposal cell cover and an accompanying evaluation of the water balance for the main tailings disposal cell (including the 2013 radon study referred to in Section 1.4.2.1) concluded that the increase in uranium concentrations in well T(M) could not be attributed to a compromise of the disposal cell's performance and that there was no surge of tailings-fluid seepage from the main tailings cell since it was closed (DOE 2014). It was further concluded that water levels in well T(M) decreased so much during the early 2000s that they were at or below the contact between the alluvium and underlying Chinle Formation from 2008 to 2012. The simultaneous increase in uranium concentration was attributed to the declining water level and the influence of contaminated groundwater migrating through and interacting with weathered Chinle Formation materials, with the resulting fluids obscuring the water chemistry of groundwater in nearby portions of the alluvial aquifer that remained saturated (DOE 2014).

Figure 1-4. Uranium Concentrations in Alluvial Aquifer POC Well T(M) and Downgradient Wells at the Bluewater, New Mexico, Disposal Site

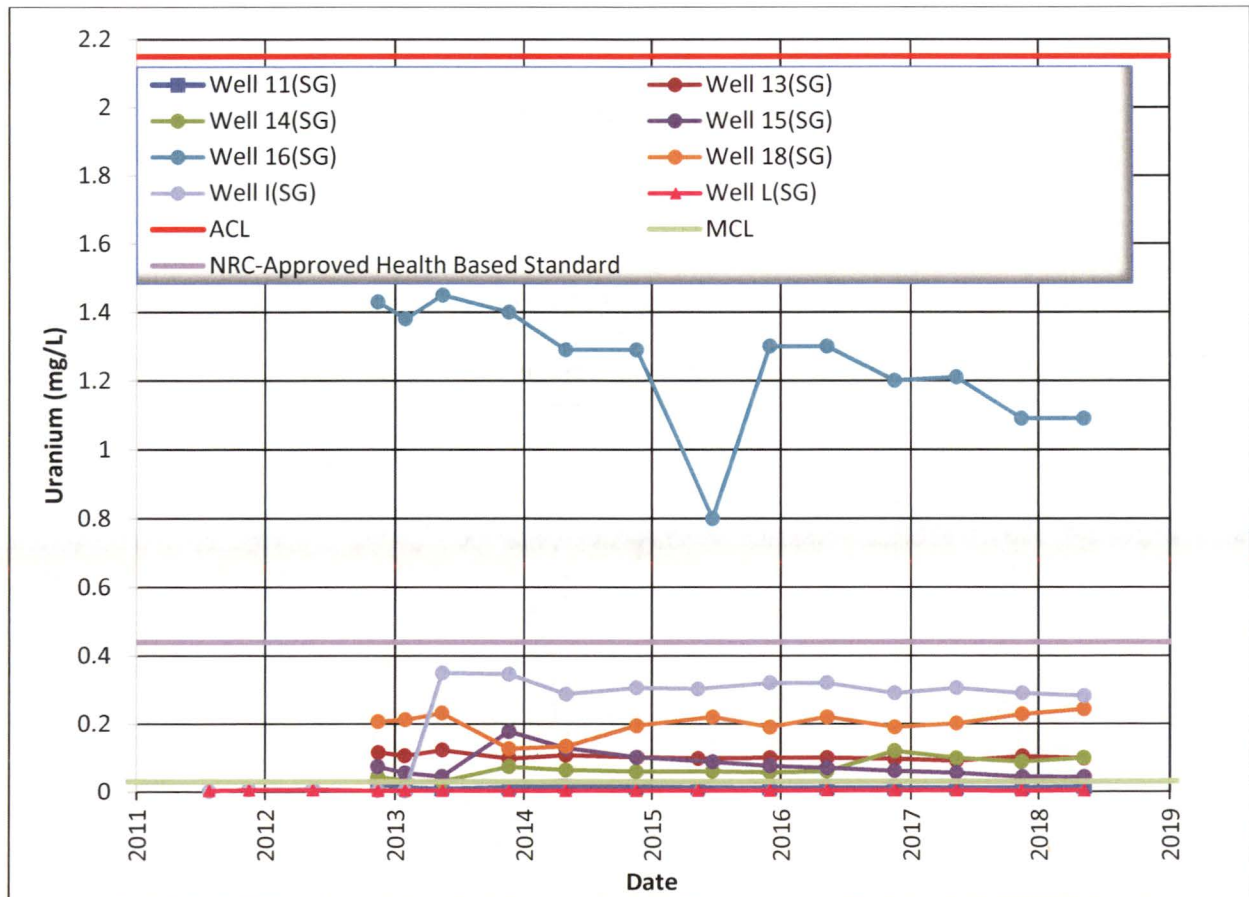
Uranium concentrations in the SAG aquifer are shown in Figure 1-5. Uranium concentrations in well I(SG) before 2013 are not shown because they were erroneously low due to an incorrect sampling depth in the well. Uranium concentrations at POC wells OBS-3 and S(SG) are not shown in Figure 1-5 because the well screens are encrusted with iron scale that has resulted in erroneously low uranium concentrations since LM began sampling the wells.

Figure 1-5. Uranium Concentrations in the San Andres/Glorieta Aquifer at the Bluewater, New Mexico, Disposal Site

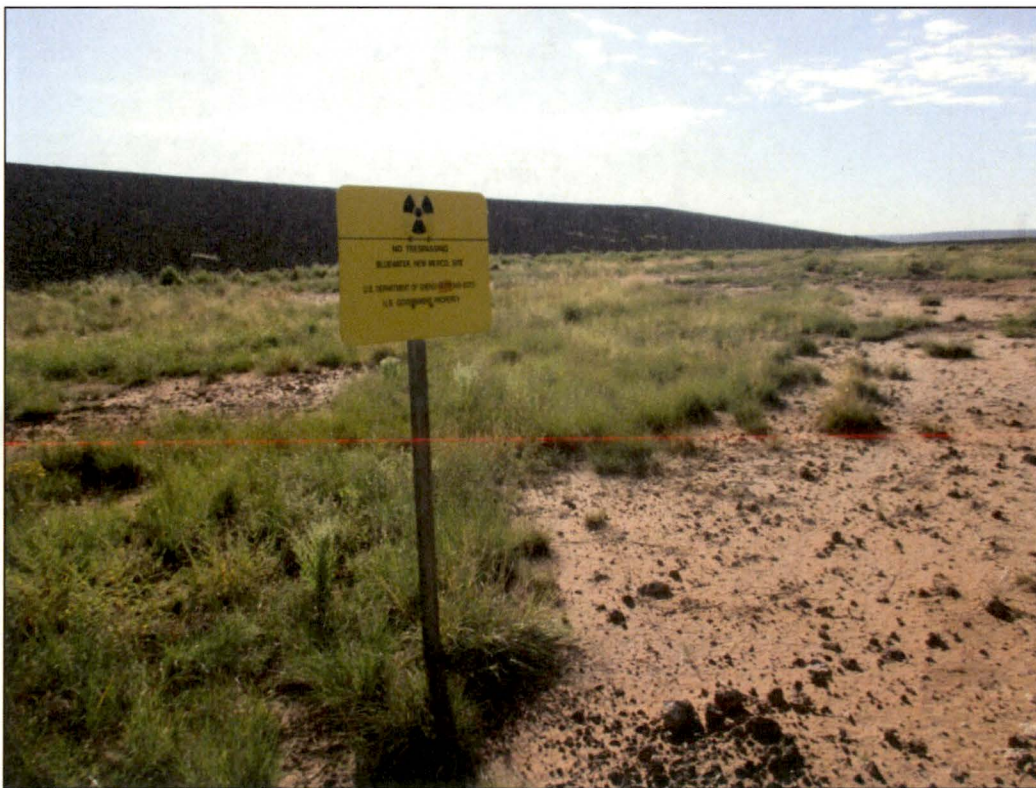
PL-2. Perimeter Sign 49; Southwestern Side Slope in Background

Fifty-five perimeter signs (warning and no-trespassing signs) are mounted on steel posts along the site boundary and around the main and carbonate tailings disposal cells (PL-2). Perimeter signs P3 and P10 have gunshot damage but are legible. Perimeter sign P9A is faded and will be replaced. No other maintenance needs were identified.

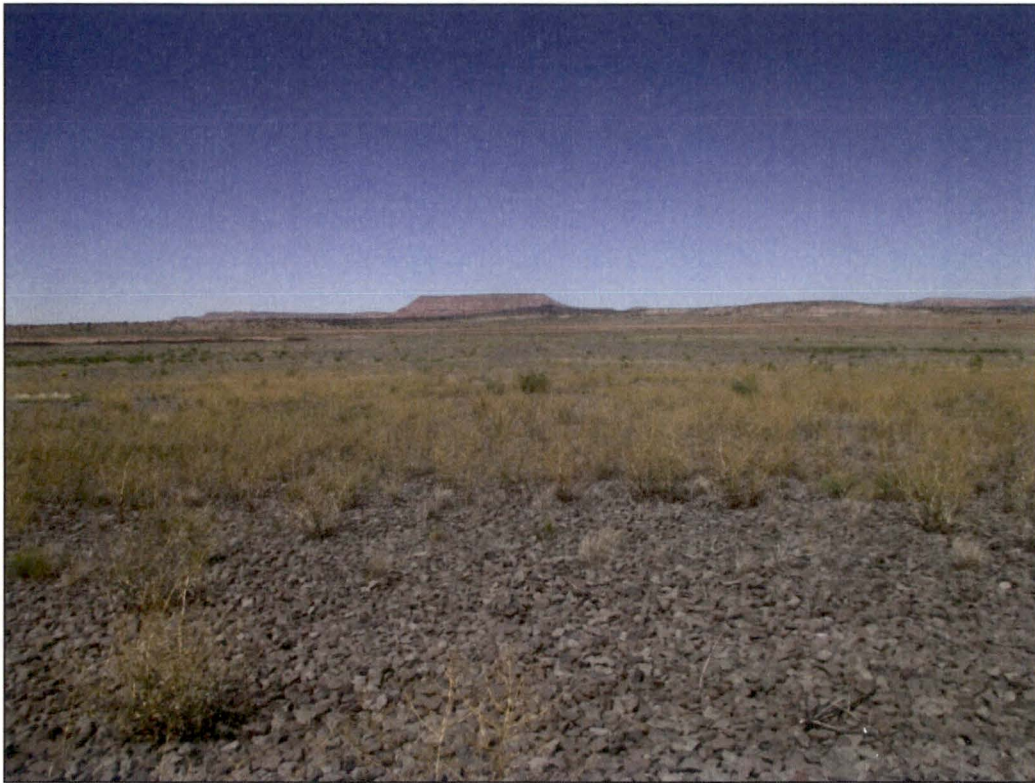
PL-5. Vegetation on Main Tailings Disposal Cell Top Slope

Plant encroachment (by annual weeds, perennial grasses and forbs, and scattered perennial shrubs) continues on the main tailings disposal cell top and side slopes (PL-5, PL-6). Siberian elm saplings on the top slope are managed to prevent the establishment of trees that could damage the main tailings disposal cell cover materials; none were observed during the inspection.

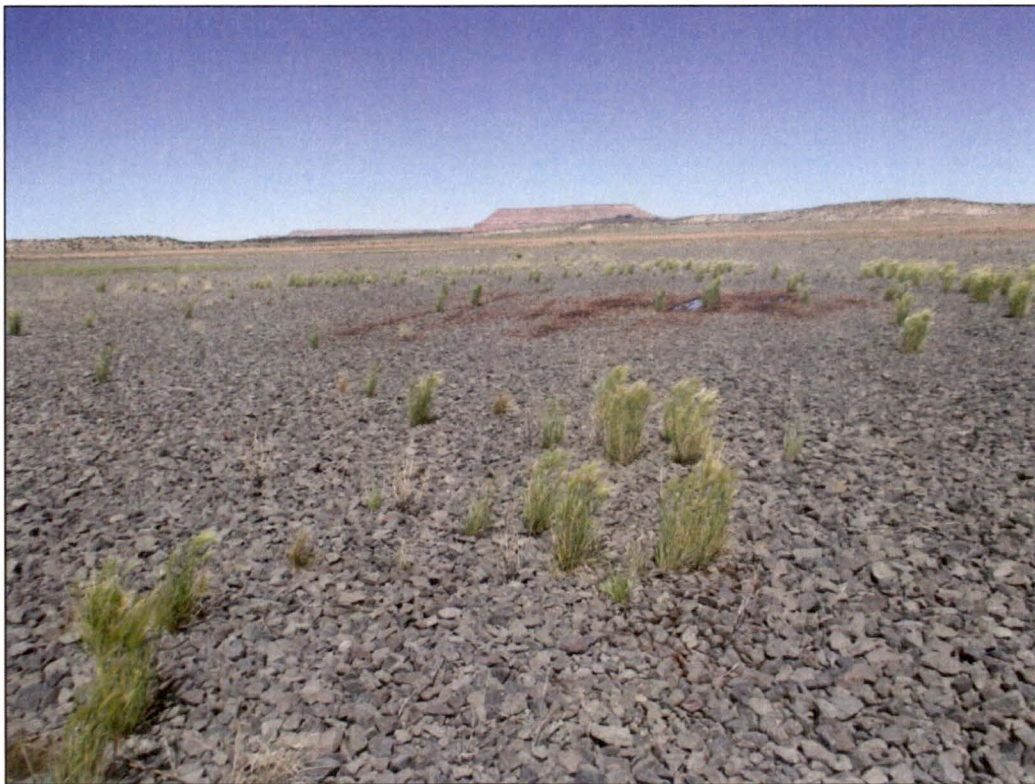
materials if the pond surface reaches an elevation high enough to spill over the north side slope of the disposal cell. Water would start to spill at the lowest point along the north edge of the top slope, and that could initiate erosion at that location. In 2018 LM developed a conceptual design to repair the depressions, regrade the north portion of the top slope, and construct a spillway on the north side slope to ensure positive drainage. In 2019, LM will continue to work on the design and coordinate with NRC regarding its concurrence.

NRC requested that LM evaluate the performance of the radon barrier because of a concern that the ponded water could be degrading the main tailings disposal cell performance (i.e., releasing radon and allowing percolation of water through the cover materials and into the encapsulated tailings). Radon flux measurements were collected in July 2013 on top of the radon barrier in the area of depressions. All radon measurements were below the detection limit, indicating that the radon barrier in that portion of the main tailings disposal cell was performing as designed. Based on the integrity of the radon barrier and the persistence of ponded water, dissipation of the ponded water was determined to be most likely due to evaporation rather than percolation through the cover materials.

PL-8. Ponded Water on Main Tailings Disposal Cell Top Slope

- **Bluewater, New Mexico:** In 2018 LM developed a conceptual design to repair depressions on the main tailings disposal cell, regrade the north portion of the top slope, and construct a spillway on the north side slope to ensure positive drainage. In 2019, LM will continue to work on the design and coordinate with NRC regarding its concurrence.

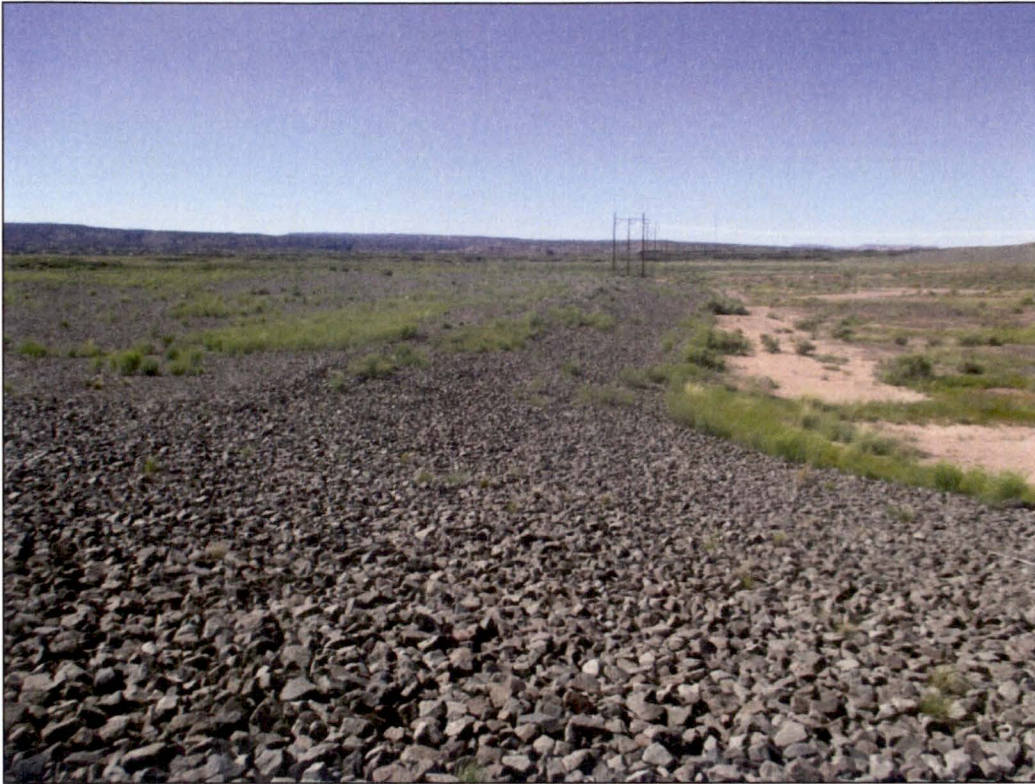
PL-11. Northeastern Side Slope of Northwestern Extension of Carbonate Tailings Cell

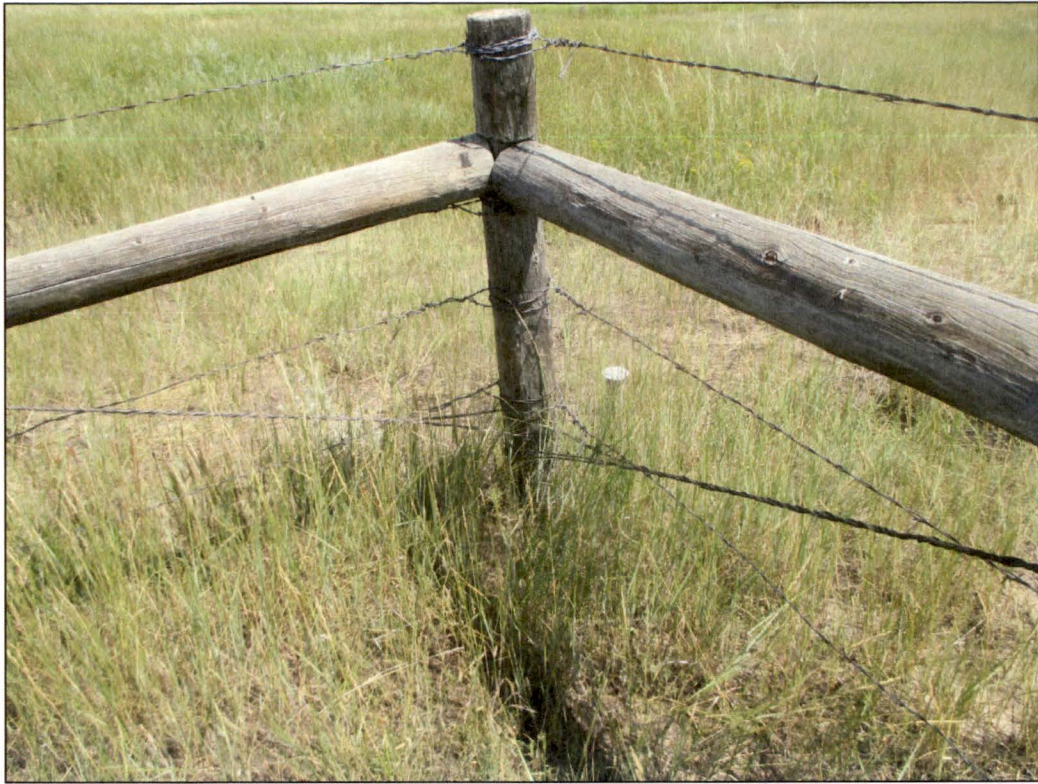
There are four boundary monuments, each at a corner of the property (PL-7). All boundary monuments were inspected, and no maintenance needs were identified.

PL-7. Boundary Monument BM-2

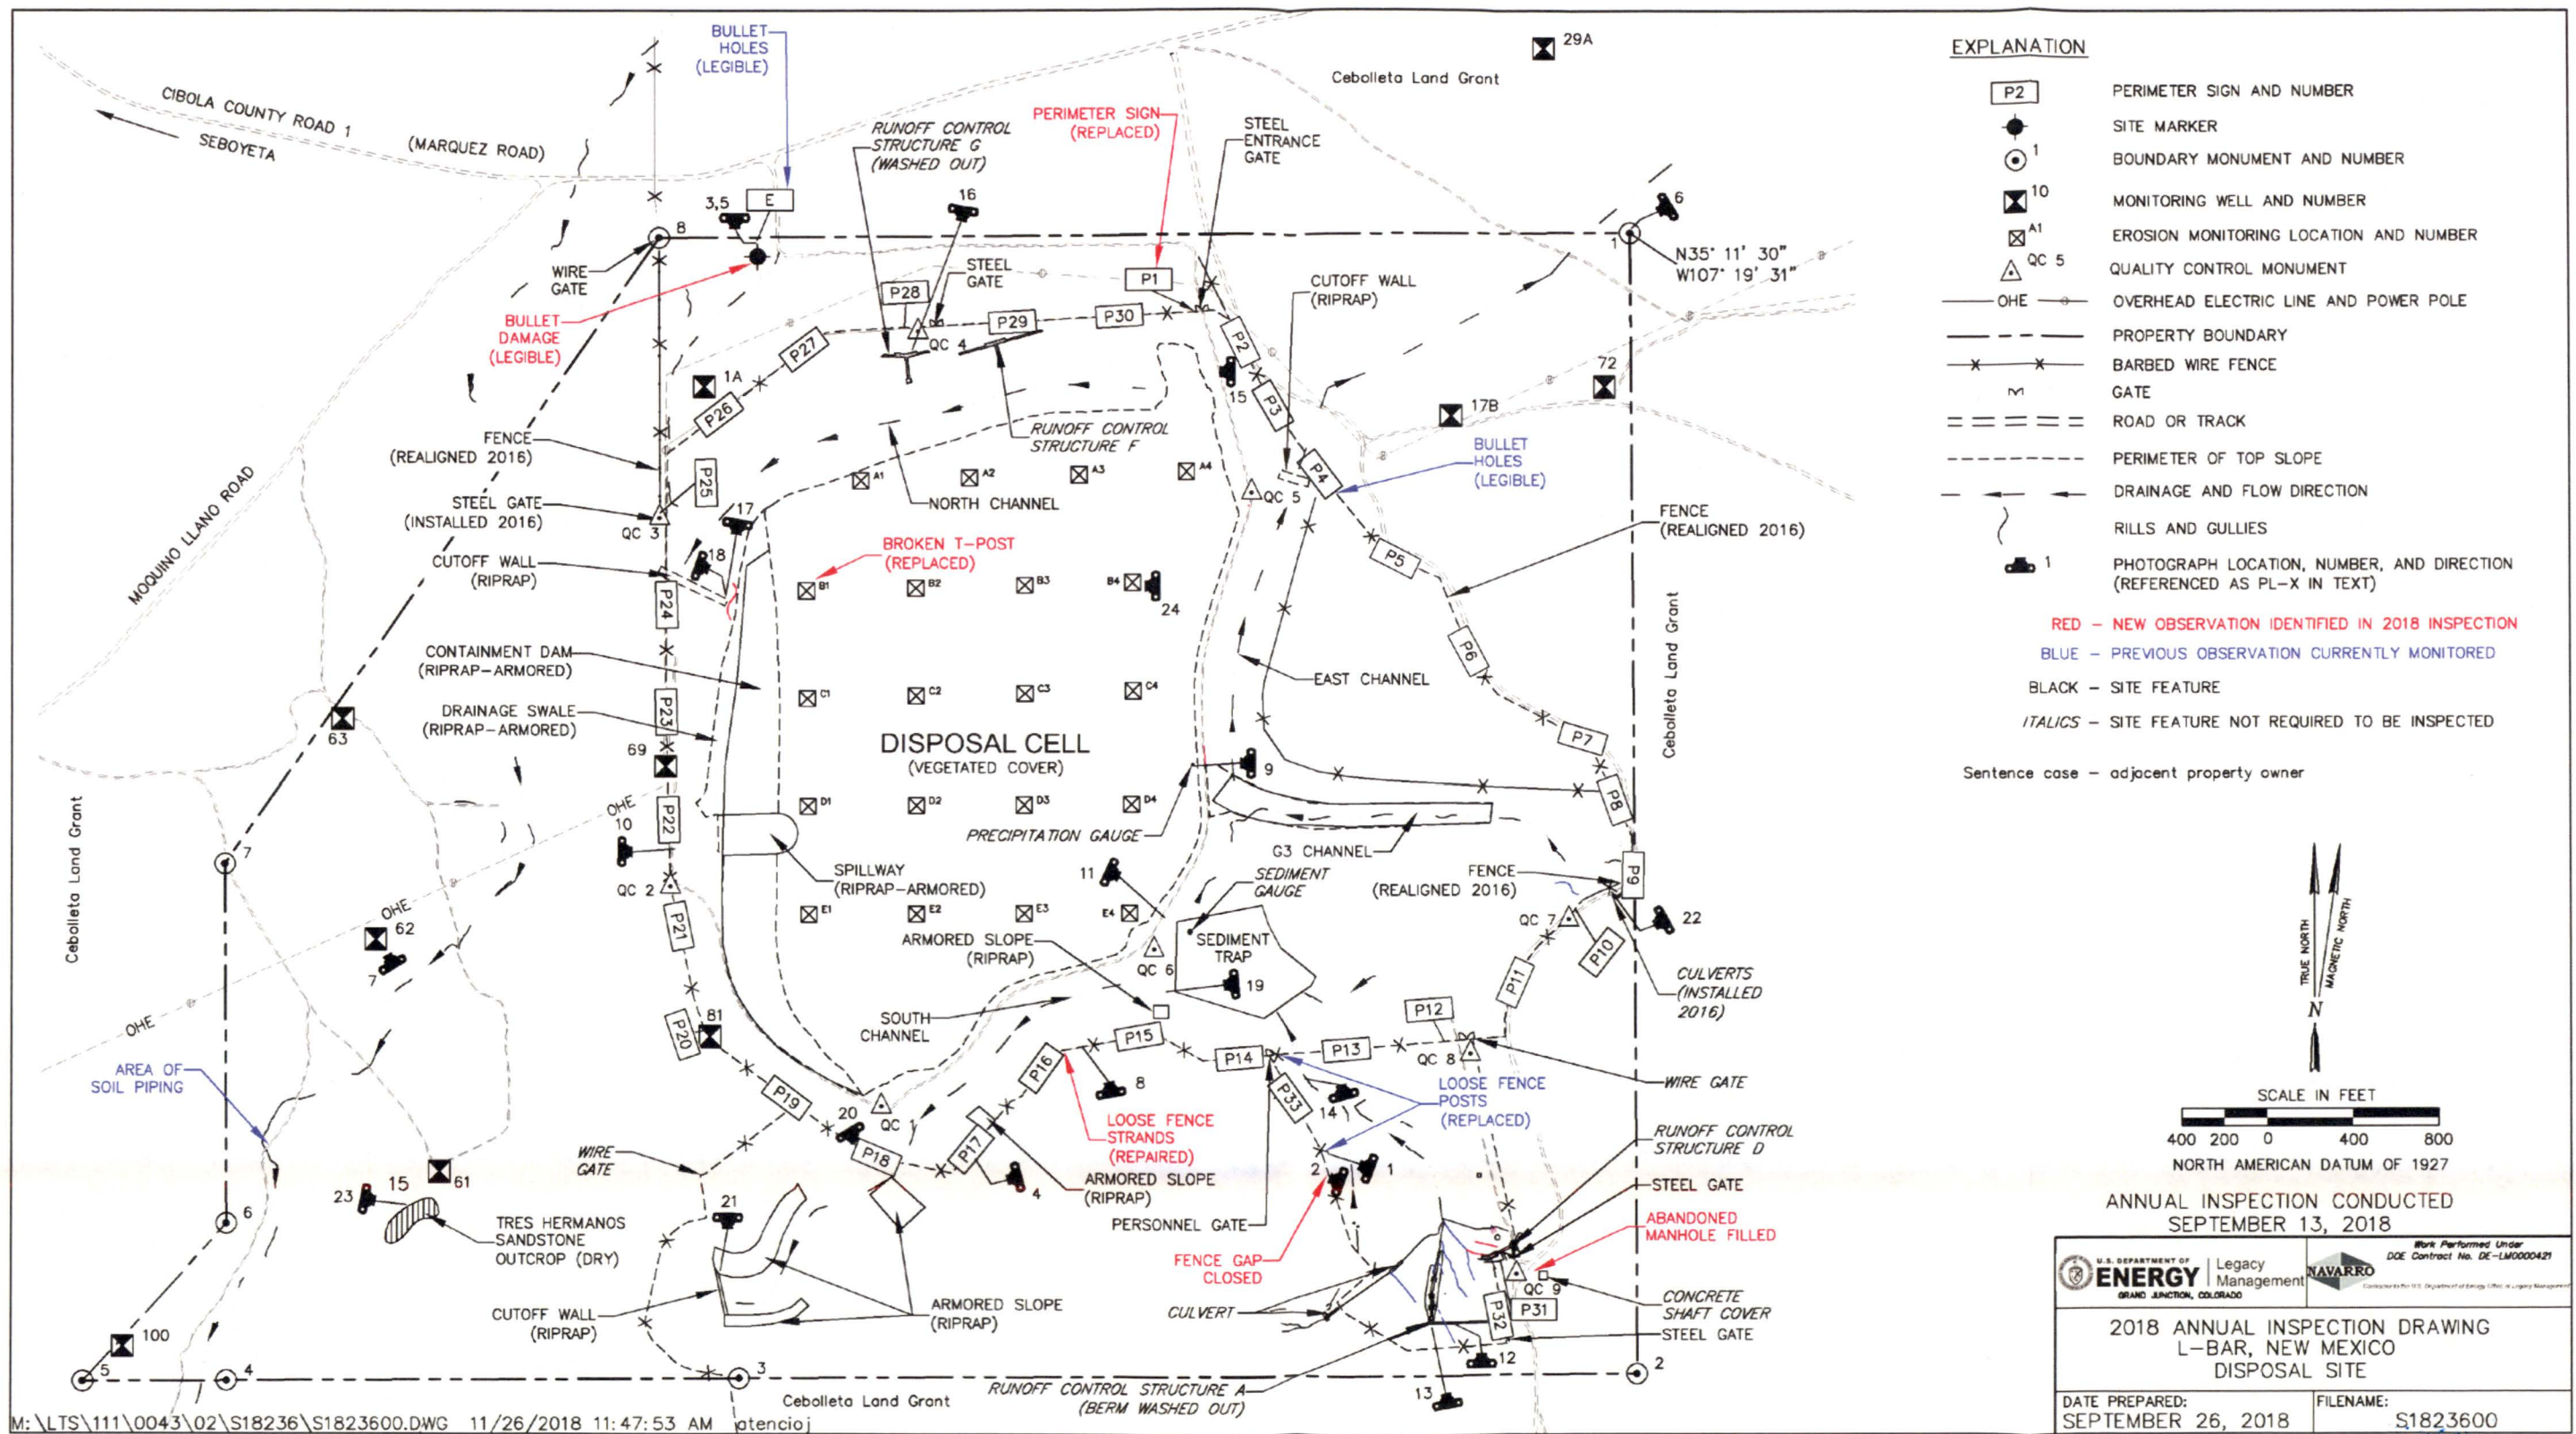
Figure 3-1. 2018 Annual Inspection Drawing for the L-Bar, New Mexico, Disposal Site

A tributary channel (G3) was constructed to divert runoff from a smaller watershed into the east channel (Figure 3-1). Gullies have formed along the side slopes of the G3 channel. The erosion and sediment deposition are not impairing the function of the channel.

A Tres Hermanos Sandstone unit of the Mancos Shale crops out in the southwest corner of the site (Figure 3-1). This unit is reported to be hydraulically connected to contaminated groundwater under the disposal cell, and the outcrop is considered a potential evapotranspiration area. The outcrop was dry at the time of the inspection (PL-23), and there is no evidence that seepage has occurred. This location will continue to be monitored for seepage and recommended for sampling if seep water is present.

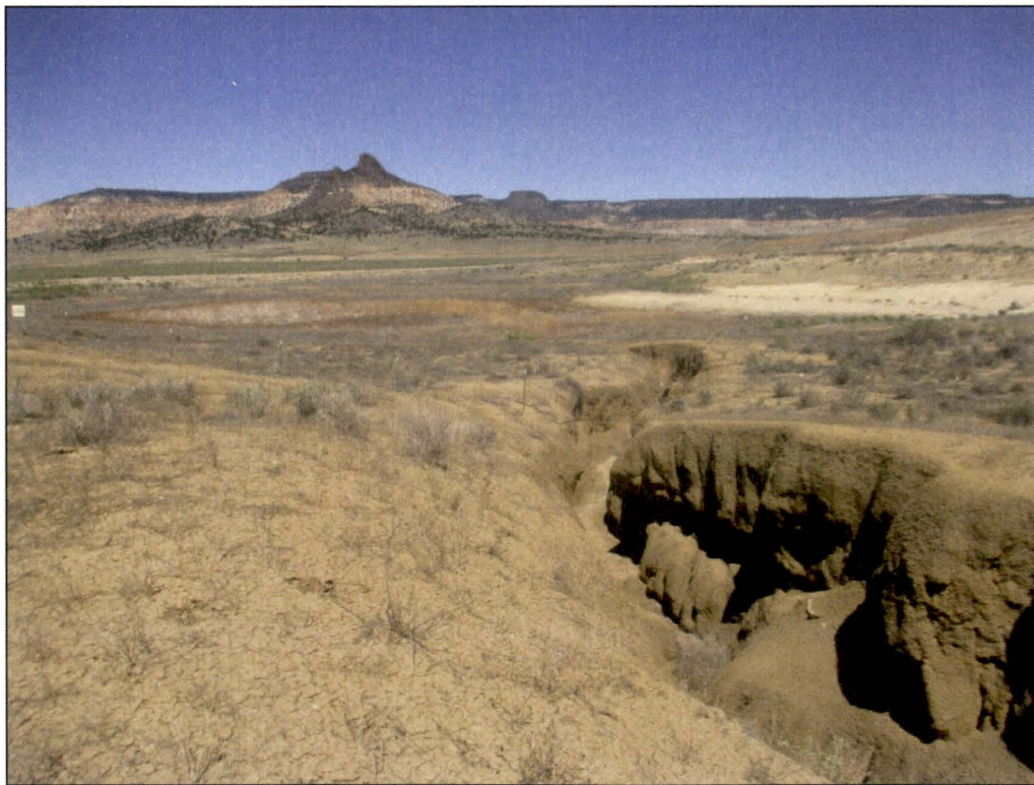
PL-13. Soil Piping Along Inlet of Runoff Control Structure A

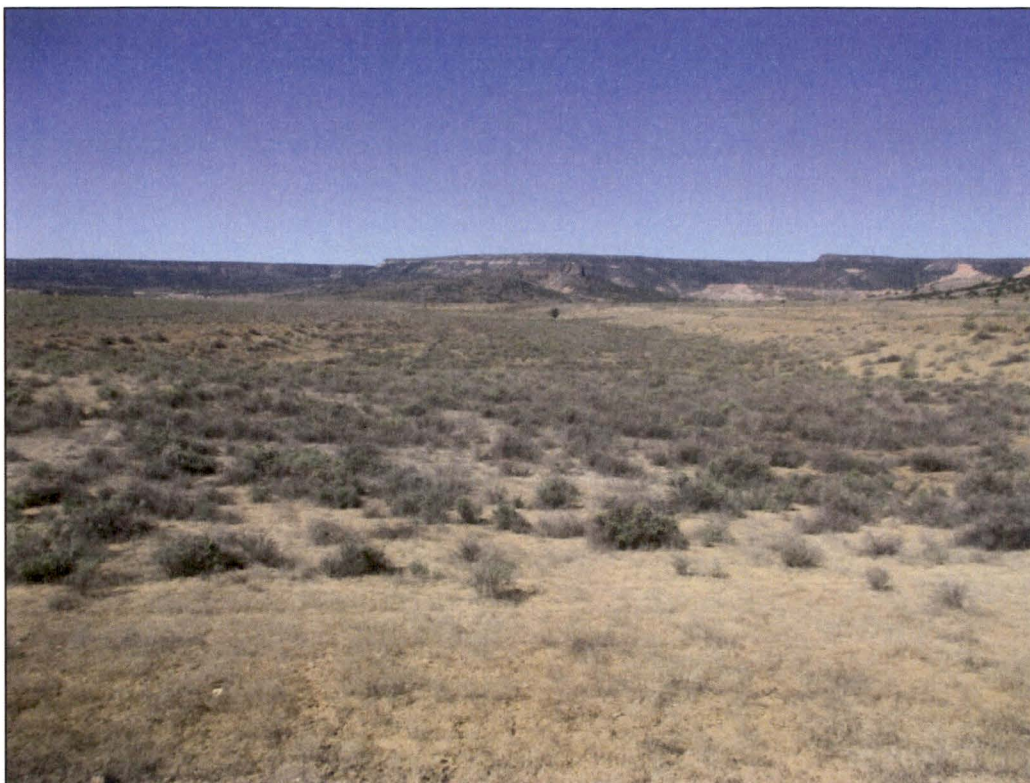
PL-14. Gully Upgradient of Sediment Trap

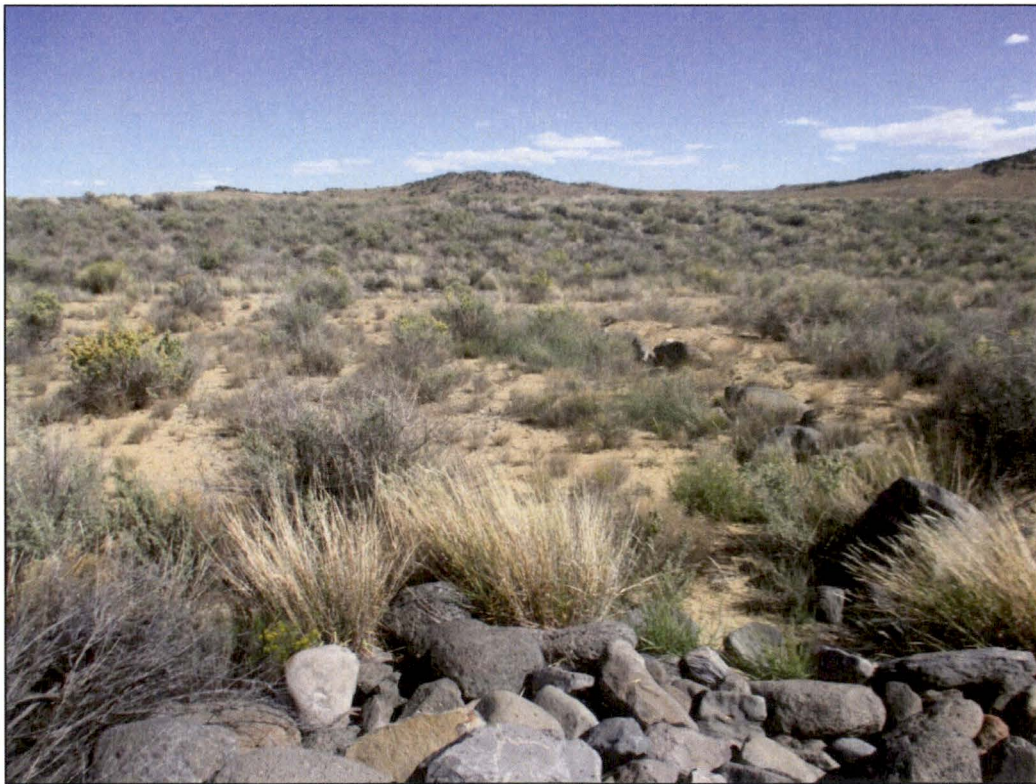
PL-17. Erosion East of Riprap Cutoff Wall at Outlet of North Channel

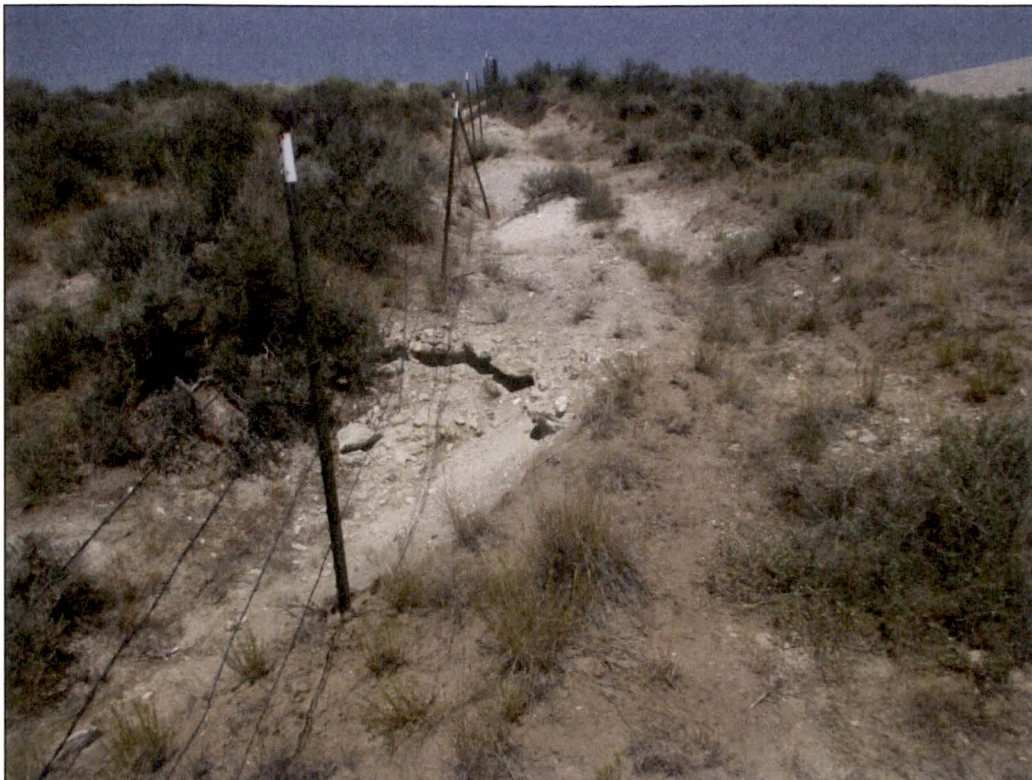
PL-1. Erosion Near Southwest Corner of Perimeter Fence
