Legacy
Management

2018 Annual Site Inspection and
Monitoring Report for Uranium Mill Tailings
Radiation Control Act Title II Disposal Sites

December 2018

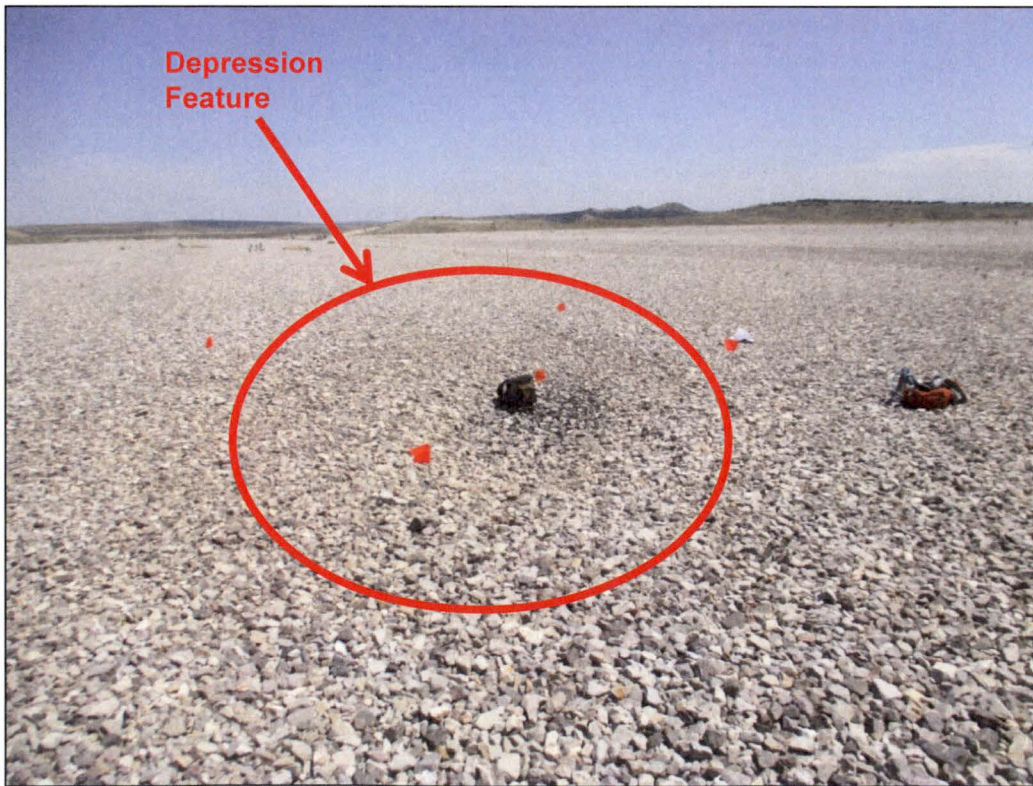
The disposal cell is on the reclaimed site of a former heap leach processing area. The top slope of the riprap-armored disposal cell occupies about 60 acres of the site. The top of the disposal cell showed no signs of significant erosion, settling, or other modifying processes that would affect the cell’s integrity. However, a small, shallow depression (Depression No. 1) was observed just north of Diversion Channel No. 1 during the initial annual inspection in 2010 (PL-6). This depression—approximately 26 feet long, 17 feet wide, and 1 foot deep in the center—appears to be the result of settlement of the underlying materials since completion of the disposal cell.

Depression No. 1 is slightly longer and wider than measurements noted during the 2017 annual inspection. A second smaller and shallower depression (Depression No. 2)—approximately 10 feet long, 5 feet wide, and less than 6 inches deep in the center—was first noted just west of the first depression during the 2016 annual inspection. Depression No. 2 appeared during the 2018 annual inspection to be approximately the same size as previously observed. A third, smaller depression (Depression No. 3) was also observed for the first time during the 2018 annual inspection and measures approximately 1 foot long, 1 foot wide, and 9 inches deep (PL-7). This depression is directly northwest of Depression No. 2.

No standing water was observed in any of the depressions during the inspection; however, standing water was observed in the depressions during a site visit in April 2018. The depressions currently do not threaten the integrity or performance of the disposal cell. No maintenance needs were identified.

PL-6. Depression No. 1 on Top Slope of Disposal Cell

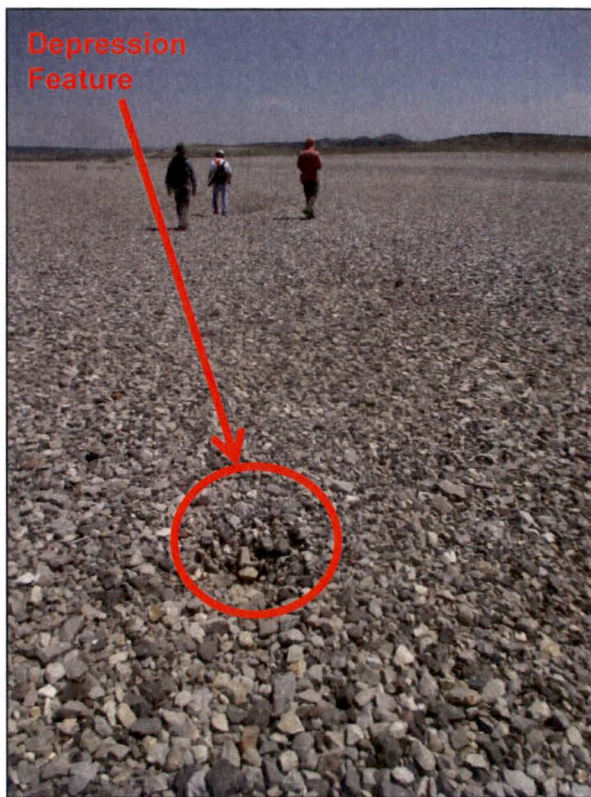
PL-7. Depression No. 3 on Top Slope of Disposal Cell

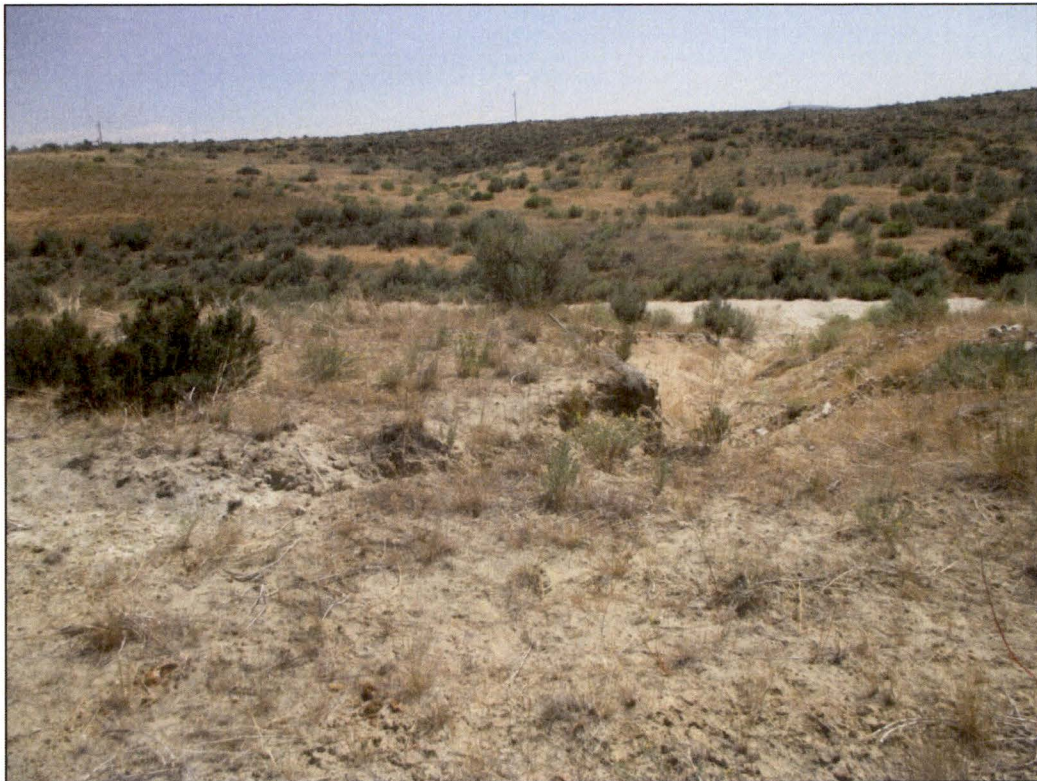
PL-17. Gully West of Diversion Channel No. 2

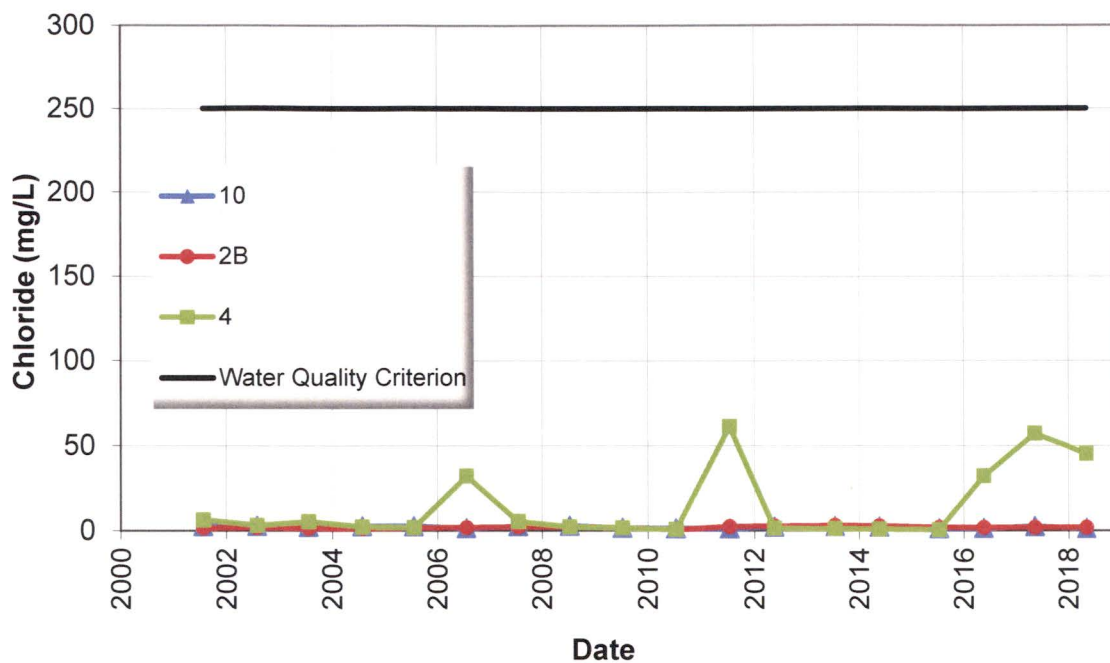
Figure 5-3 and Figure 5-4 show concentrations of chloride and sulfate, respectively, in the three monitoring wells since 2001. Occurrences of slightly elevated chloride levels in well 4 correspond with the higher sulfate levels measured at the same location. Water elevations for each of the monitoring wells are shown in Figure 5-5. These elevations are preliminary and are based on a survey of the elevation of the monitoring wells conducted in August 2018. Groundwater occurs in two hydrostratigraphic units: (1) the alluvium that lies on top of the bedrock surface and (2) the conductive bedrock, including weathered bedrock in the upper portion and unweathered or competent bedrock below. Monitoring well 10 is completed in the alluvium, and wells 2B and 4 are completed in the bedrock.

Figure 5-3. Chloride Concentrations at the Sherwood, Washington, Disposal Site

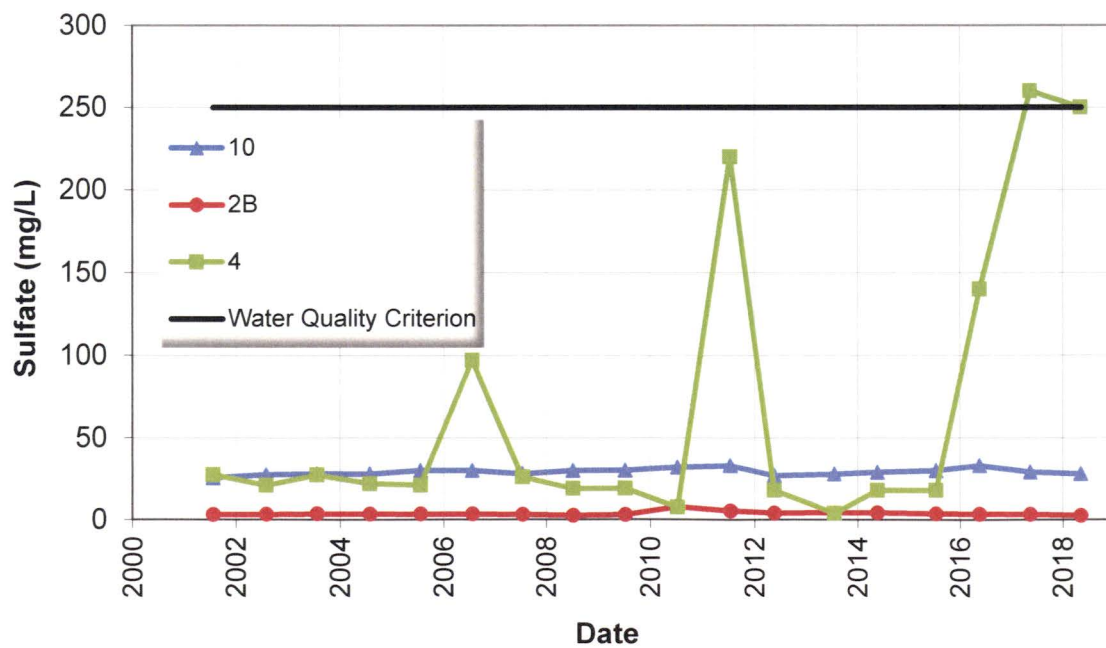
Table 5-3 presents the May 2018 sampling results. Groundwater constituent concentrations continue to be less than the action levels for confirmatory sampling in monitoring wells 2B and 10; however, sulfate concentration exceeded the action level in monitoring well 4 in 2017 and met it in 2018.

A borehole camera was used to evaluate conditions in the three monitoring wells, specifically to determine if there were any well issues that could have caused the exceedance in monitoring well 4. The video showed that the inlet of the dedicated bladder pump used for low-flow sampling was buried in debris at the bottom of the well. The well will be cleaned and redeveloped before sampling in 2019.

Figure 5-4. Sulfate Concentrations at the Sherwood, Washington, Disposal Site

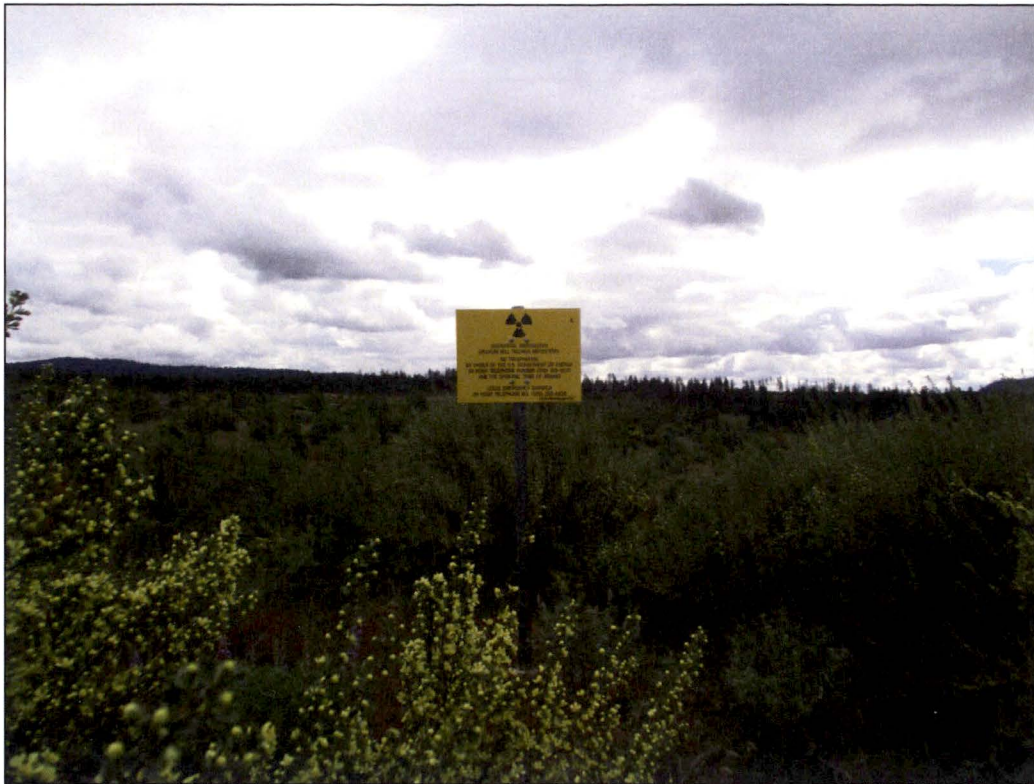
There are six warning or perimeter signs, attached to steel posts set in concrete, positioned along the site boundary at likely access points around the site (PL-1). In the past, some signs have become illegible due to fading or vandalism (including bullet damage). However, no maintenance needs were identified.

PL-1. Perimeter Sign P6

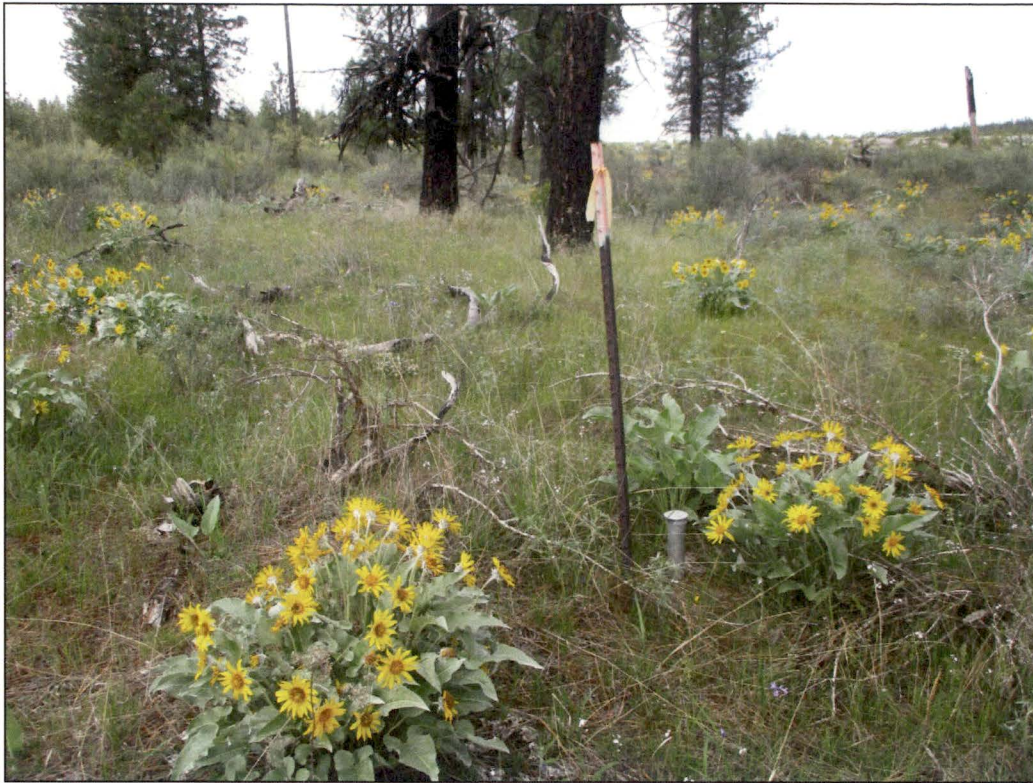
Six boundary monuments set in concrete define the site boundary. Because surrounding vegetation has made it difficult to locate some of the monuments, metal T-posts were installed at each monument location. All boundary monuments were inspected (PL-3). No maintenance needs were identified.

PL-3. Boundary Monument BM-3

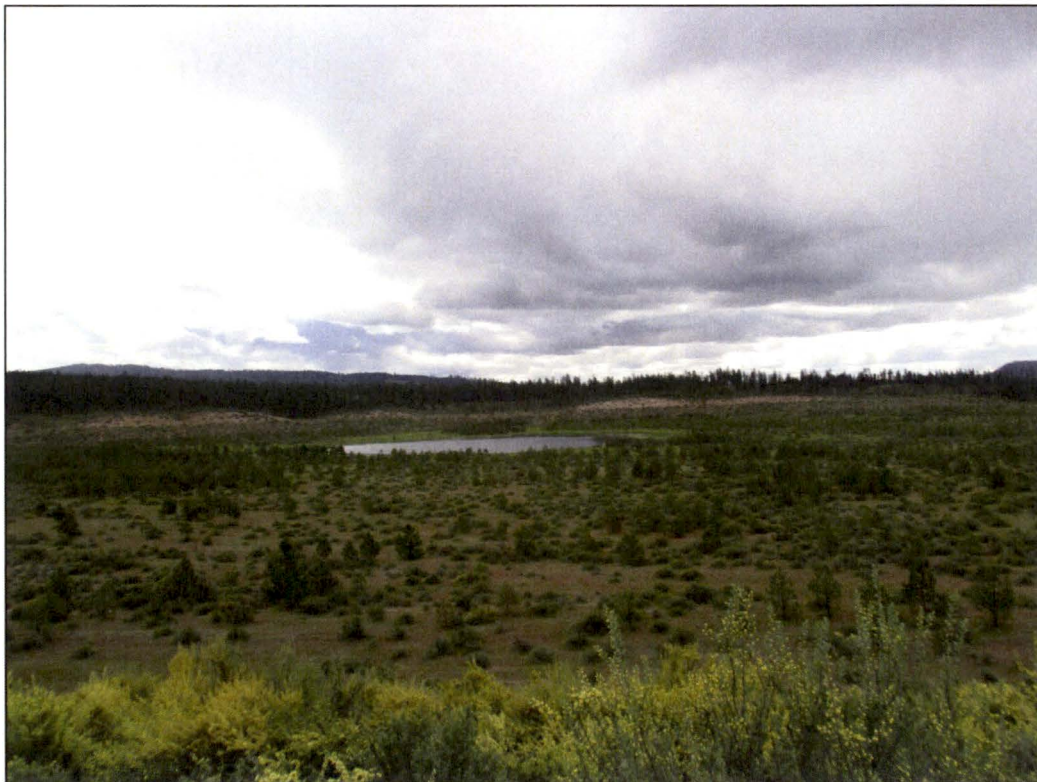
PL-6. Pond 1 on Disposal Cell Cover

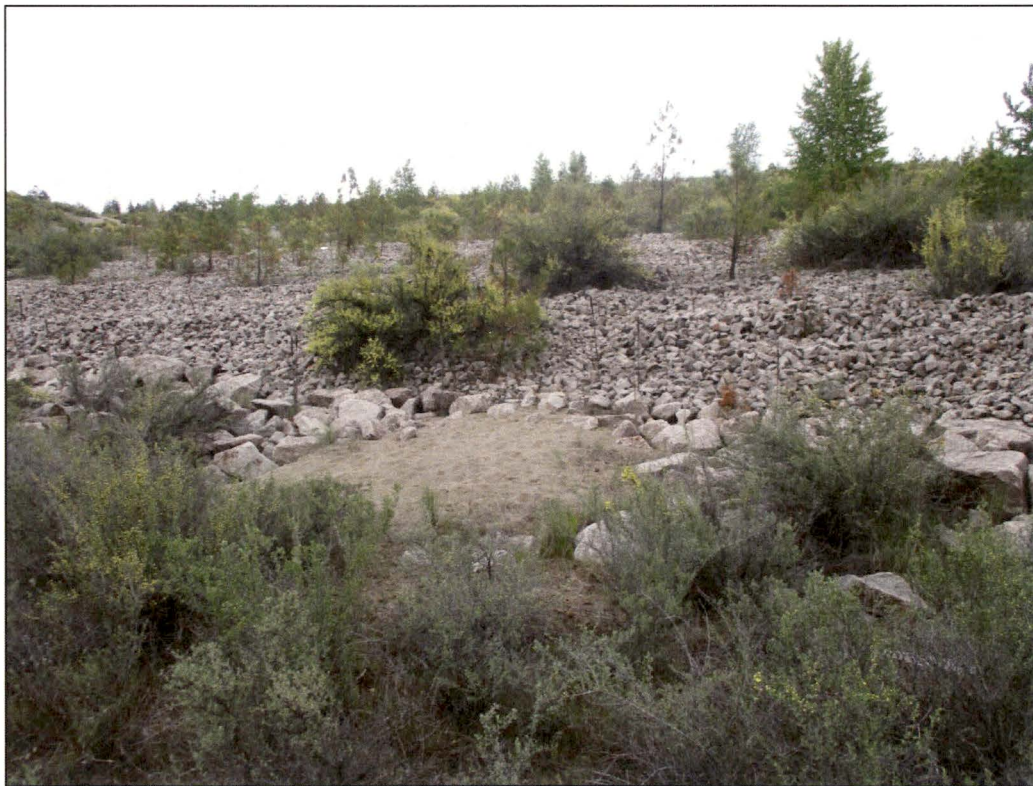
During the 2016 annual inspection, one area at the base of the rock-covered containment dam face was found to have a fan of sand that had washed out from underneath the rock cover (PL-8). A follow-up inspection of the erosion feature was performed on October 4 and 5, 2016. The protective rock cover adjacent to the area of erosion was removed, and the underlying material was examined. The sandy material that was eroded from the embankment was the same as natural undisturbed material nearby. During reclamation, this area of the mill site was used as a source for fill material used to contour the area below the toe of the containment dam. Review of original reclamation and as-built drawings showed that the toe of the containment dam is upslope from the area of erosion. This was confirmed during the investigation conducted before the 2017 annual site inspection and subsequent engineering evaluation, when several small holes were dug upslope to determine the edge of the actual embankment. It was determined that the washout area was in a portion of the dam defined as the outslope in the construction completion report and does not impact the containment dam (Figure 5-1).

The erosion feature was examined during the 2017 and 2018 annual site inspections, and the extent of the erosion had not increased. However, the area will be visually monitored during future inspections and by periodic aerial high-resolution topographic surveys. Repair options will be evaluated and implemented, in consultation with NRC, if the erosion area increases such that the containment dam could be affected. A report was transmitted to NRC on March 12, 2018, describing the 2016 follow-up inspection and 2017 engineering evaluation (DOE 2018b).

PL-8. Sand Washout Watch Area at Base of Outslope

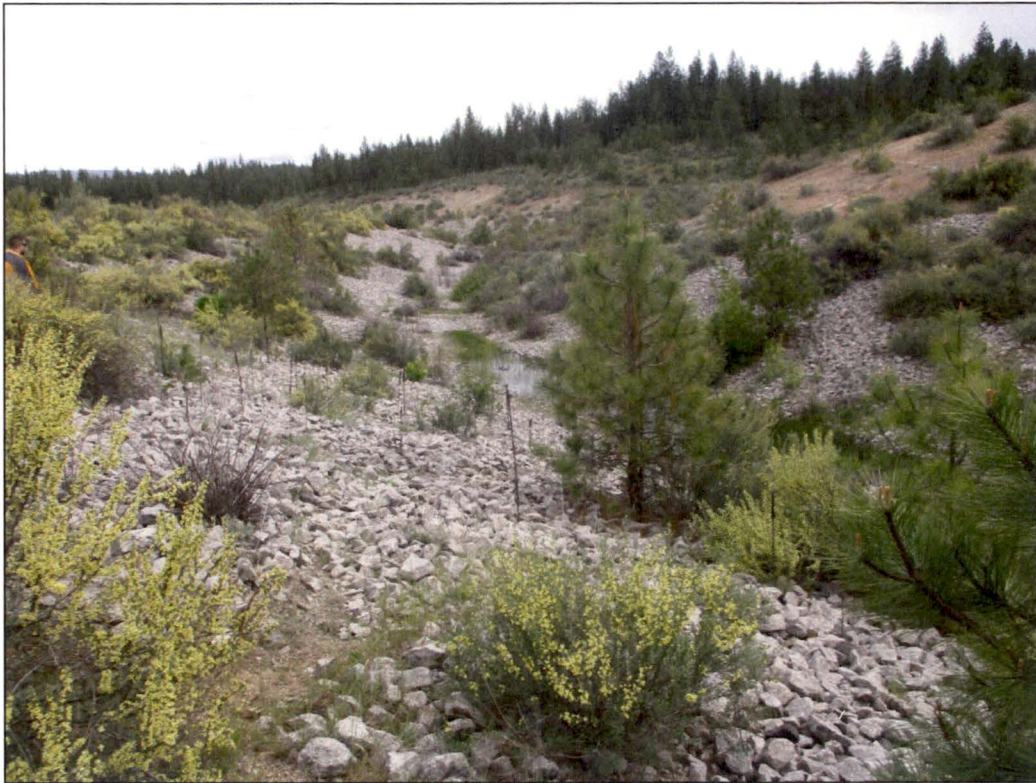
A riprap-armored diversion channel surrounds the disposal cell and diverts runoff away from the disposal cell surface. The diversion channel (PL-9) was designed to allow trees to grow and stabilize the surfaces, and their presence in the diversion channel is not expected to hinder the diversion channel's ability to convey design flows. The intrusion of volunteer plants, including trees, is evident in most areas of the diversion channel. Sediment deposition is found in places on the west leg of the diversion channel but does not interfere with the diversion channel's design function. Upslope areas that have contributed to the sedimentation have stabilized with vegetation. Wildlife and horse trails cross the diversion channel at numerous locations and have displaced the diversion channel riprap in several places (PL-10). These disturbances will be visually monitored for erosion but are not in areas that would impact the disposal cell.

PL-9. Vegetation in East Diversion Channel

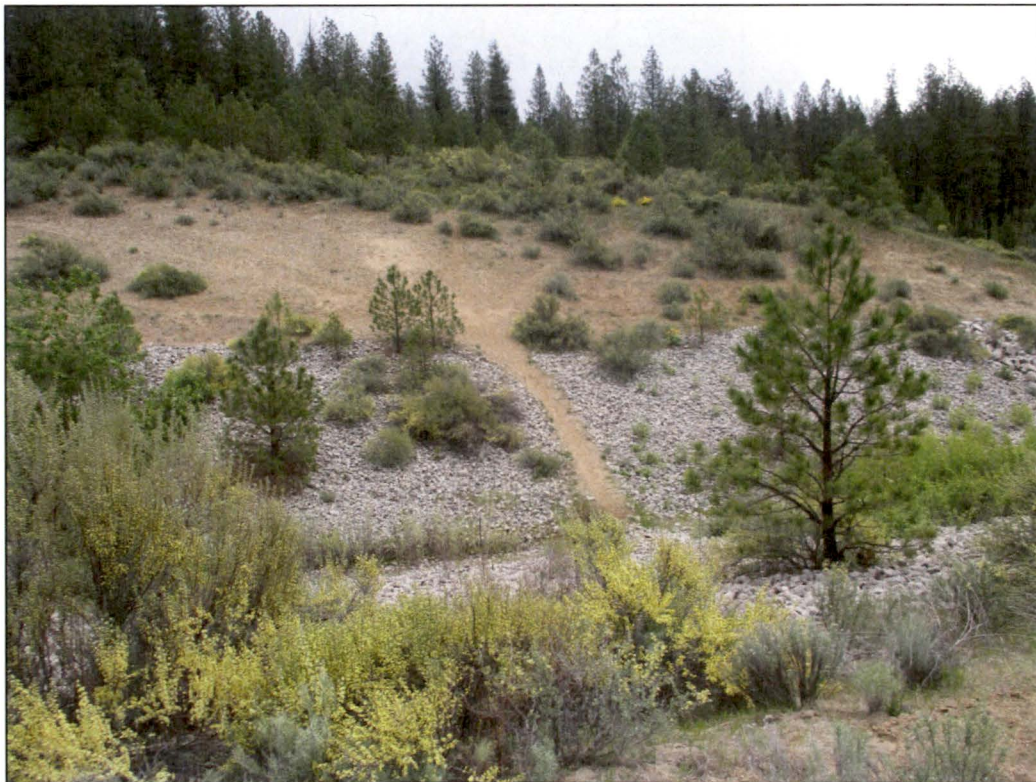
PL-10. Protective Rock Armor Displaced by Animal Trails

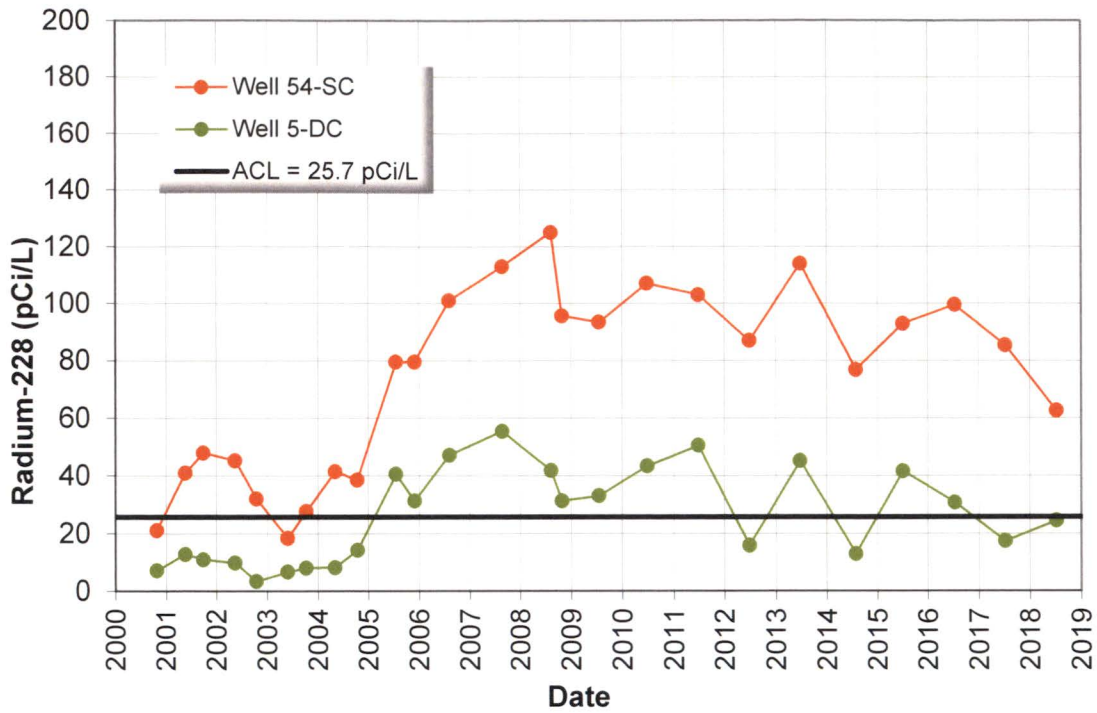
The concentration of cadmium in well 5-SC remained below the ACL since 2005. Radium-228 continued to exceed the ACL in well 54-SC but continues to be below the ACL in well 5-DC (Figure 6-3). Additionally, the ACL for ²²⁶Ra continues to be exceeded in well 110-DC (Figure 6-4).

Figure 6-3. Radium-228 Concentrations in Wells 5-DC and 54-SC Since Completion of the Disposal Cell at the Shirley Basin South, Wyoming, Disposal Site

Although the ^{228}Ra concentration is elevated in well 54-SC, it is lower than the highest concentration measured in this well in the early 1990s during site groundwater remediation activities. Radium-228 is a decay product of thorium-232 (^{232}Th), which is highly immobile. Because the half-life of ^{228}Ra is relatively short, ^{232}Th sources must be near monitoring wells 5-DC and 54-SC. LM attributes the elevated ^{226}Ra and ^{228}Ra in the site wells to natural mineralization in the sand units, rather than concluding it is evidence of diminished disposal cell performance or contaminant plumes migrating offsite (DOE 2011). Both the upper and main sand aquifers at the site were dewatered during mining and remediation and are still recovering. Consequently, periodic increases in some constituent concentrations in the groundwater, such as radium-228, may represent a reestablishment of equilibrium of groundwater with naturally occurring constituents in the sand units (Figure 6-3 and Figure 6-4) (DOE 2011).

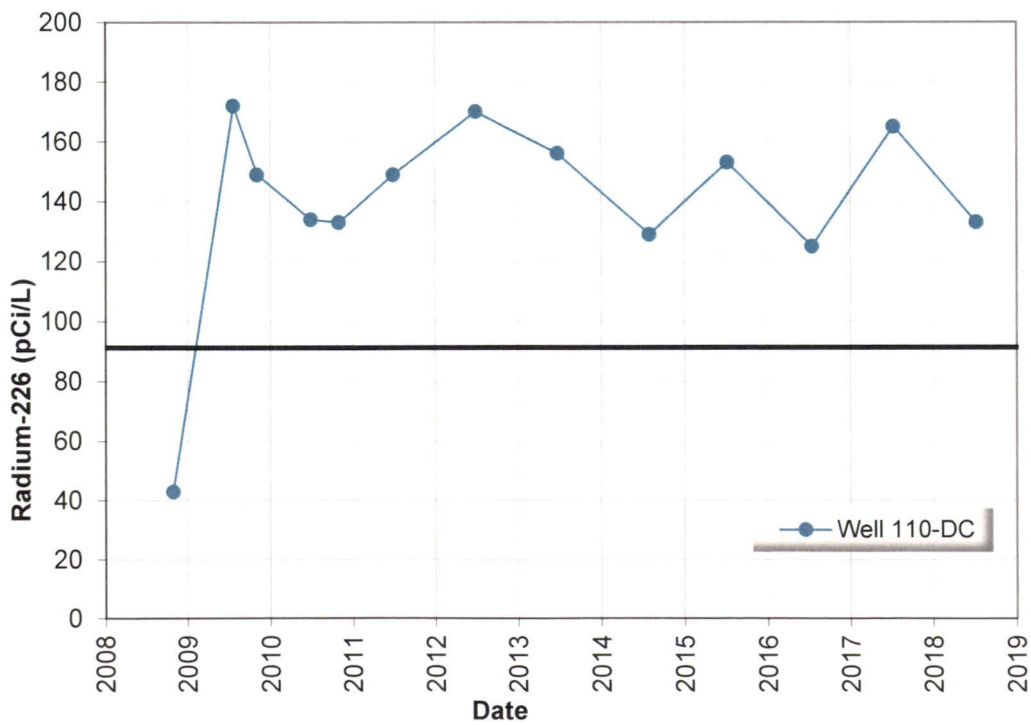
Figure 6-4. Radium-226 Concentrations in Well 110-DC at the Shirley Basin South, Wyoming, Disposal Site

The 2018 water quality results were within the range of historical measurements (Table 6-4 and Table 6-5; Figure 6-3 and Figure 6-4). The exceedances are found in wells near the disposal cell except for the ^{226}Ra exceedance at well 110-DC. Well 110-DC is near a uranium ore deposit, and the ^{226}Ra concentration is around 29 times that of the upgradient POC well 5-DC. Therefore, the ^{226}Ra in well 110-DC is probably naturally occurring (DOE 2011).

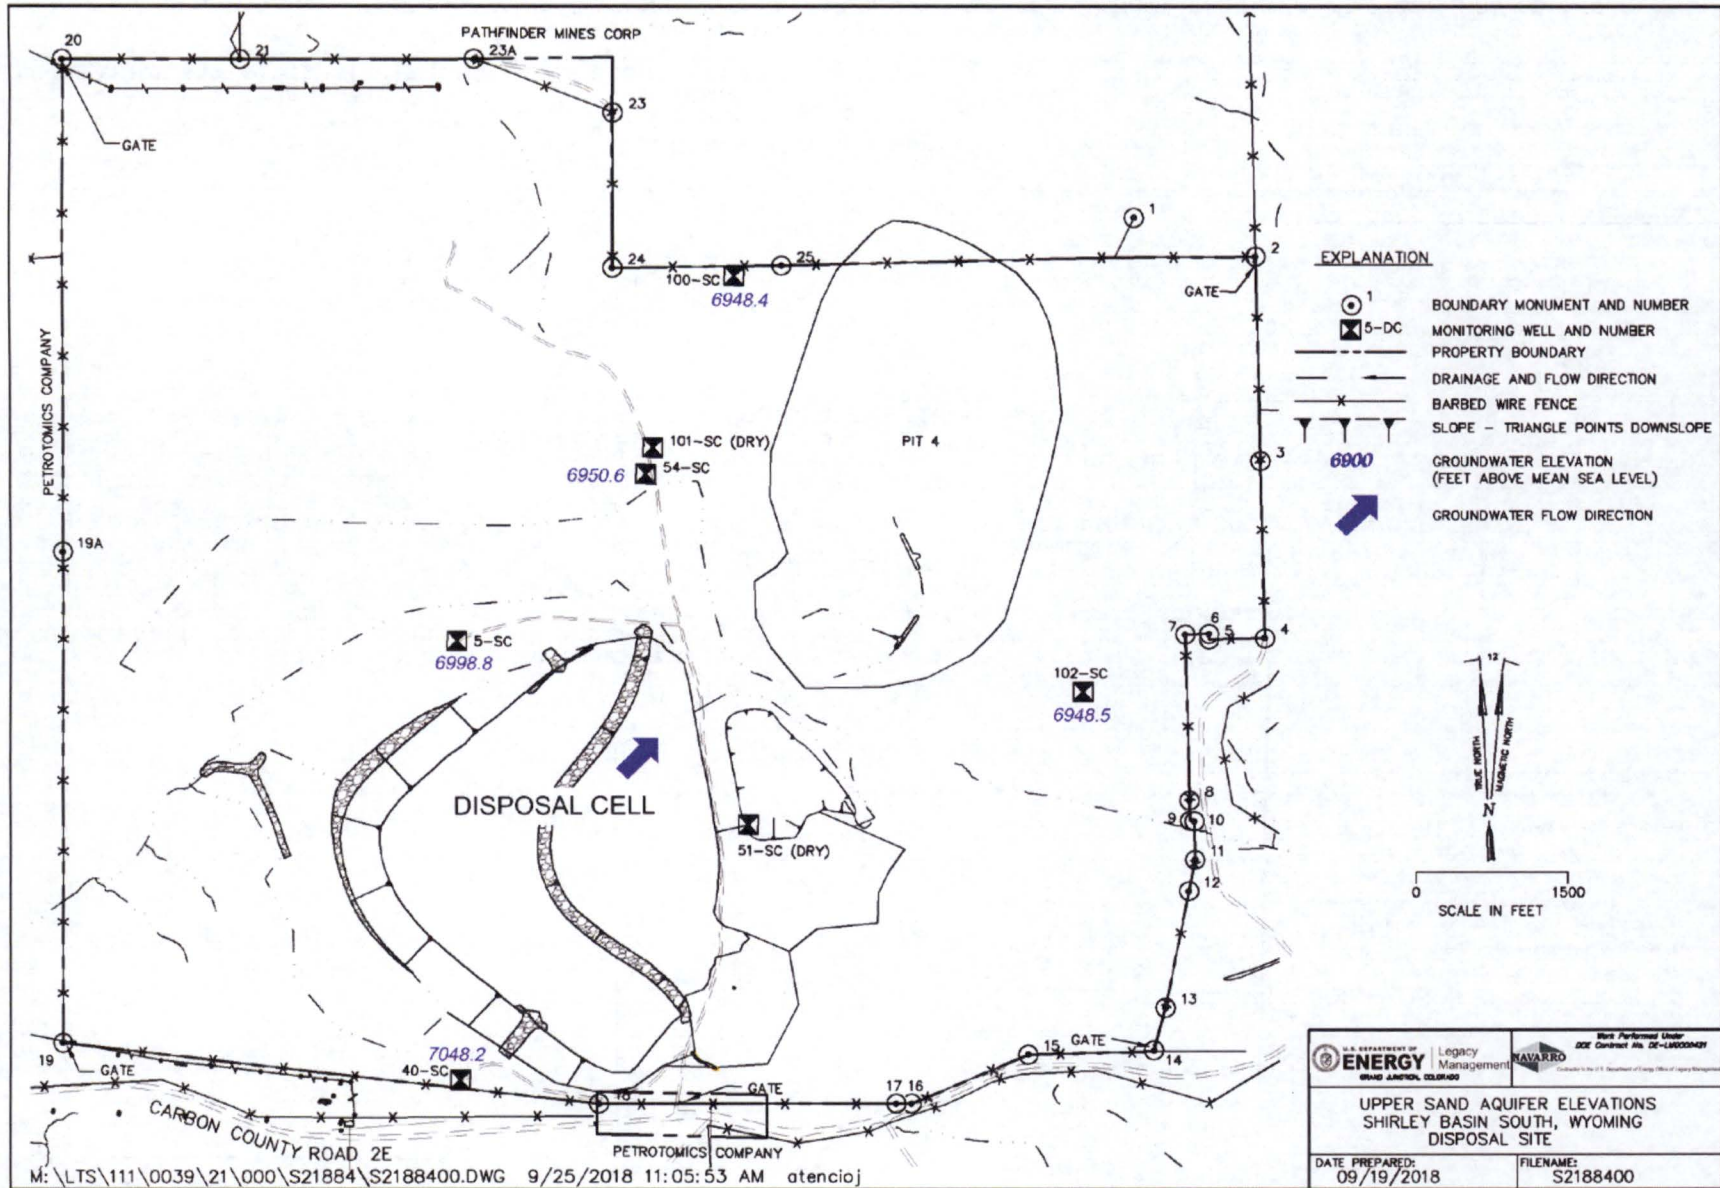
Water-level elevations for the upper sand aquifer are shown in Figure 6-9. Water levels are increasing in wells 100-SC and 102-SC, but they are remaining constant in the other upper sand aquifer wells. The apparent flow direction is to the northeast, along the formation dip and toward Pit 4 (DOE 2011). The dry wells (51-SC and 101-SC) indicate that the upper sand aquifer has not recovered near Pit 4. Because the aquifer is no longer confined at the Pit 4 location and because the flooded open-pit mine on the Ur-Energy property downgradient of the site might be a groundwater sink, aquifer water levels on the site might never recover to their premining elevations (DOE 2011).

Figure 6-9. July 2018 Groundwater Elevations in the Upper Sand Aquifer at the Shirley Basin South, Wyoming, Disposal Site

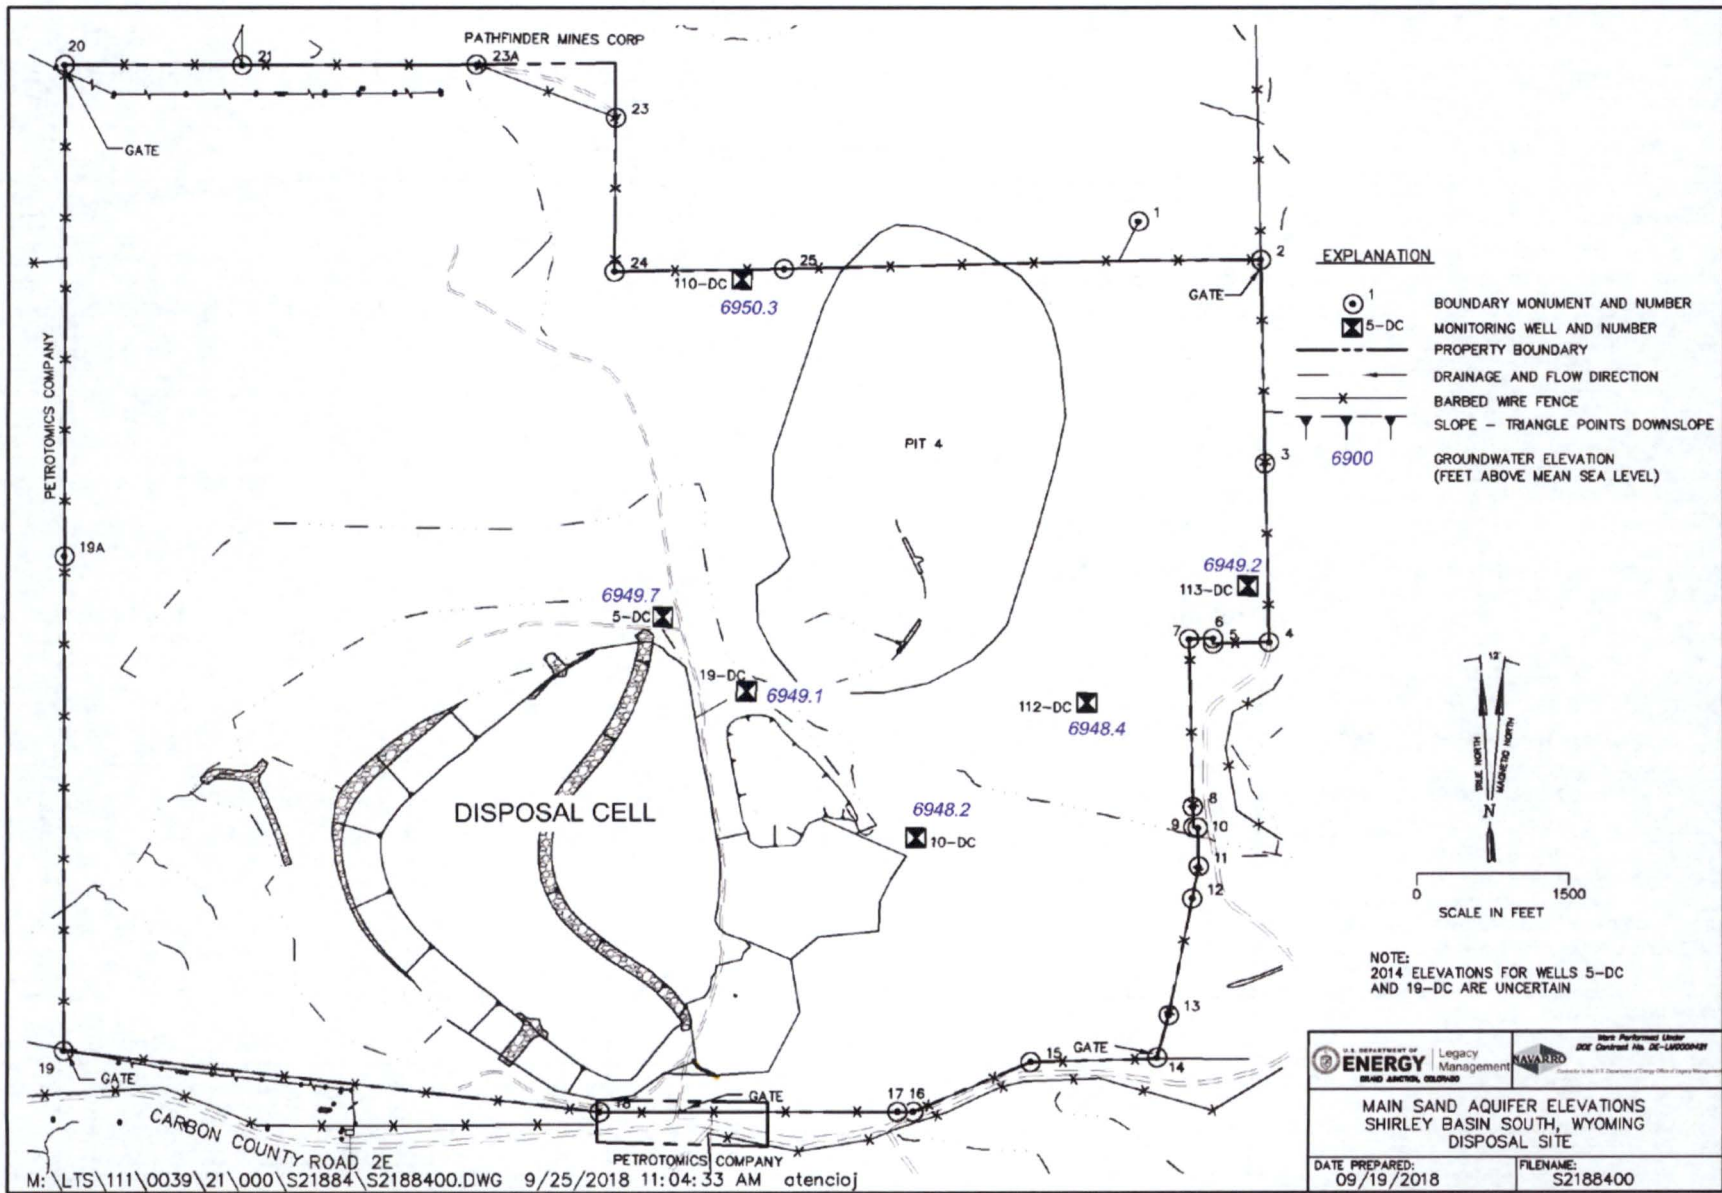
Main sand aquifer water elevations, shown in Figure 6-10, have been gradually rising at all wells since 2000, with an average rate of increase of approximately 0.9 foot per year since LM began monitoring water levels in 2005 (Figure 6-11). The rising levels indicate a gradual recovery of the aquifer. However, the altered conditions at Pit 4 might prevent a return to premining elevations of the water table. Also, the water surface elevation of the downgradient pit lake on the adjacent Ur-Energy property might control the surface elevation of the aquifers on the site. The groundwater elevations, several of which are from wells near Pit 4, do not indicate a definitive flow direction in the main sand aquifer. Local groundwater flow likely is affected by continued recovery of the aquifer and the hydraulic properties of the backfill material in Pit 4. Therefore, a flow direction arrow is not shown in Figure 6-10.

Figure 6-10. July 2018 Groundwater Elevations in the Main Sand Aquifer at the Shirley Basin South, Wyoming, Disposal Site

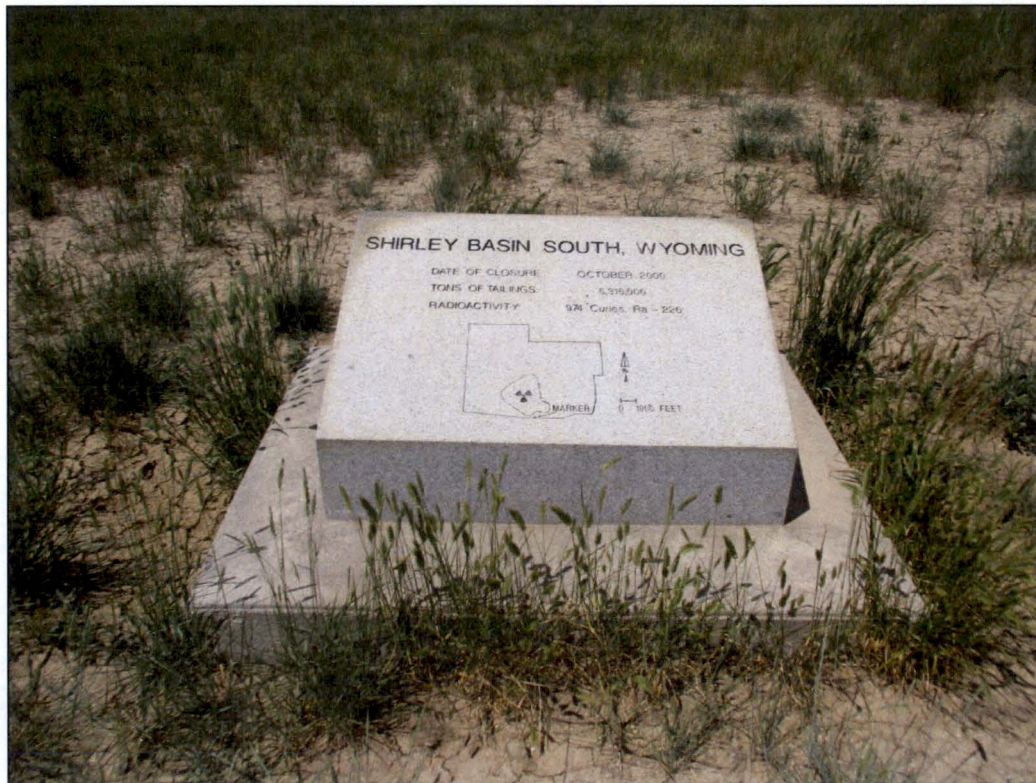
The site has one granite site marker near the site entrance gate (PL-4). No maintenance needs were identified.

PL-4. Site Marker
