DOCKET 50-255 - LICENSE DPR-20 - PALISADES
PLANT - FEED-WATER LINE WATER HAMMER

EVALUATION OF
AUXILIARY FEEDWATER AND MAIN FEEDWATER
WATER HAMMER POTENTIAL AT
PALISADES PLANT

Prepared for
CONSUMERS POWER COMPANY
by
NUCLEAR SERVICES CORPORATION
Campbell, California

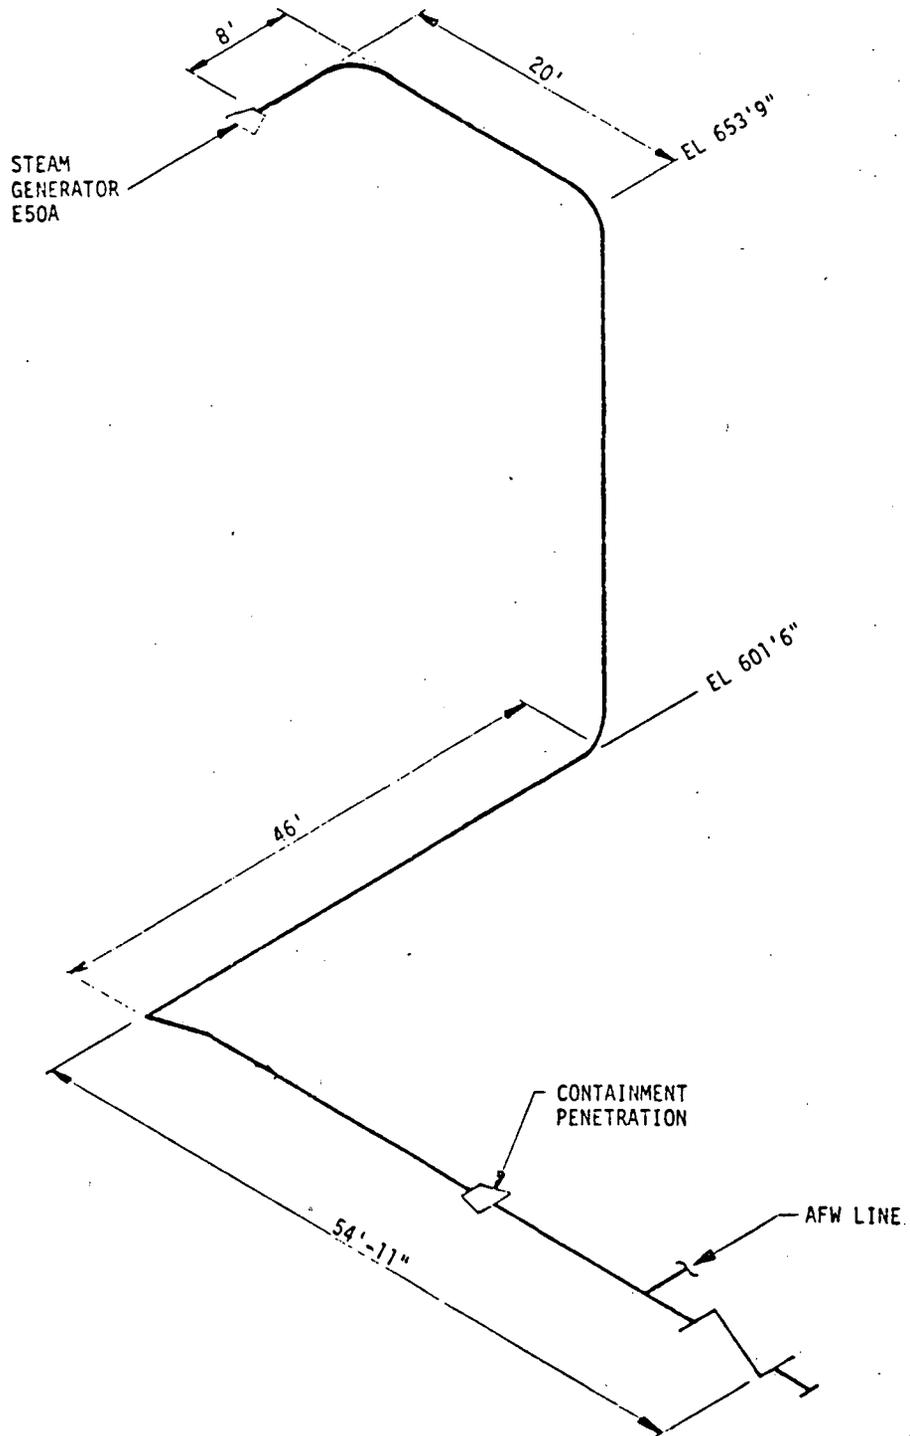
Figure 2-1. Palisades Plant
Feedwater Piping Inside Containment
Loop A (Loop B Opposite Hand)

The FW piping system originates at the two boiler feed pumps located at Elevation 590' of the turbine building. Two 18 inch lines run from the boiler feed pumps to a common header. The header divides into two branches each feeding a high pressure heater and continuing on through the containment. Each line enters the containment at Elevation 601'6" and after a horizontal run rises to Elevation 653'9". The piping after another horizontal run enters the steam generators at this elevation as shown in Figure 2-1. Each line contains a feedwater control valve and shut off valve between the pump and the high pressure heater. There is a check valve in each line just outside the containment penetration.

Inside each steam generator two 12" piping branches carry flow from the feedwater line to the feedwater sparger which is located two feet below the feedwater nozzle as shown in Figure 2-2.

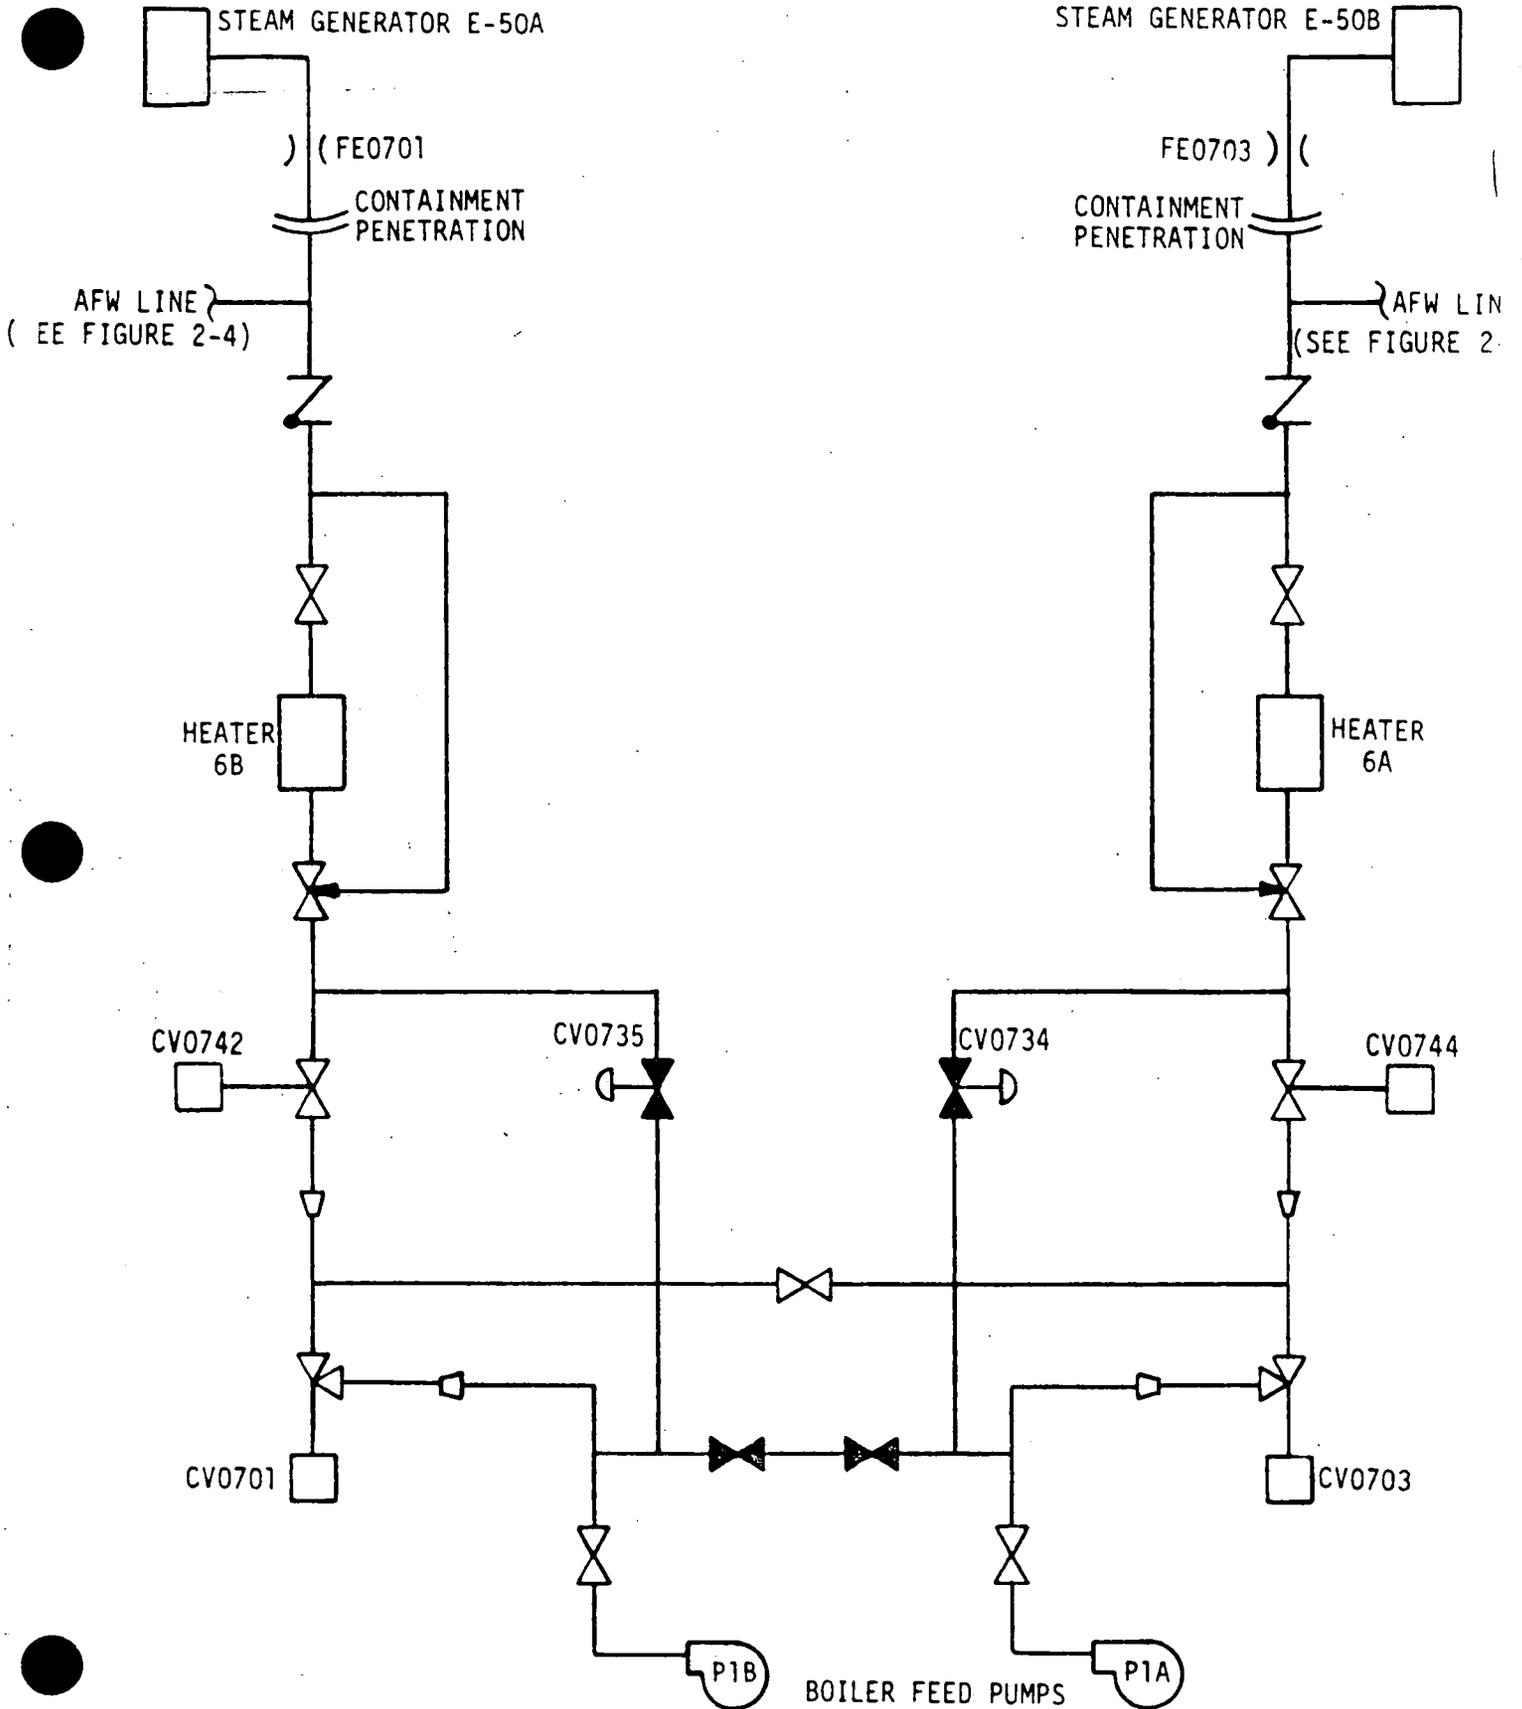
Figure 2-3. Palisades Plant
Simplified Feedwater
Flow Path

Simplified flow diagrams of the FW and AFW systems are shown in Figure 2-3 and 2-4 respectively.

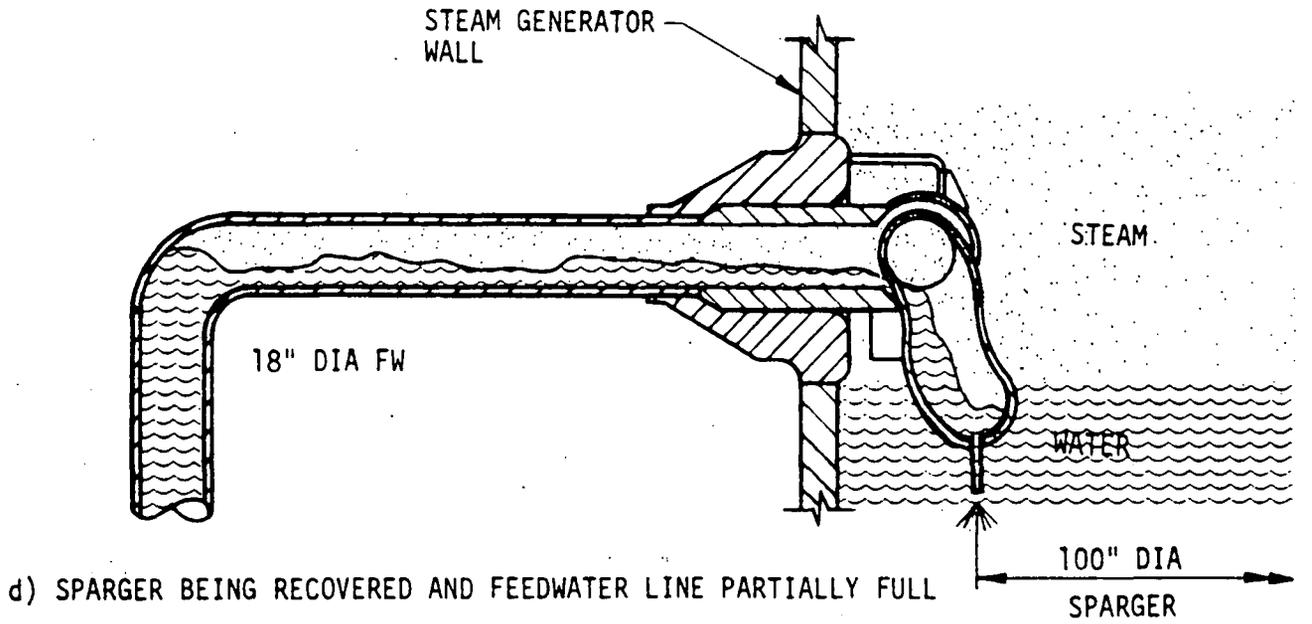
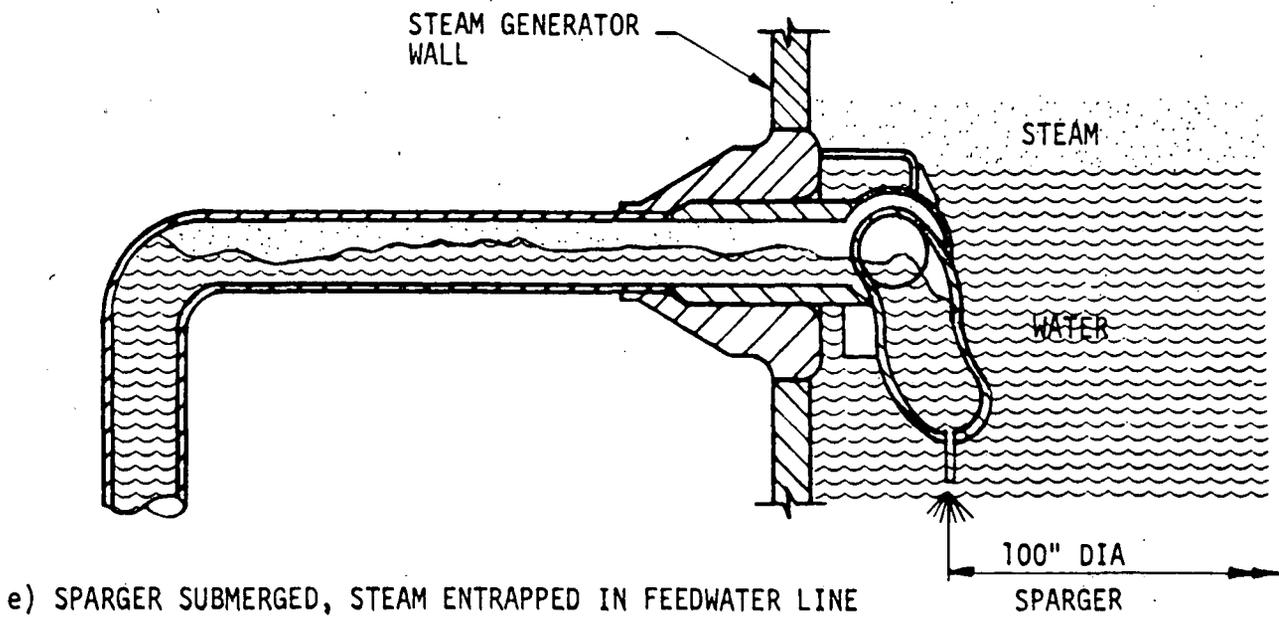
Figure 3-1. Palisades Plant
Sheet 2 Feedwater Sparger Conditions
Following Level Drop

Insufficient data is available to quantitatively identify all parameters and mechanisms conducive to the steam-water slugging water hammer occurrence. However, a mechanism as discussed below is generally accepted as the mechanism for water hammer occurrence. Figure 3-1 shows the sequence of events in the vicinity of the sparger which leads to the uncovering of the sparger and subsequent draining of the feedwater line prior to steam generator water level recovery. Figures 3-2a and 3-2b show the feedline conditions prior to and at the start of feedline slug formation, respectively. The slug seals the main feedwater line and prevents the normal flow of steam from the steam generator to replenish the entrapped steam being condensed by the cold water layer. As steam is condensed at the steam-water interface, the pressure of the entrapped steam drops, accelerating the water slug away from the steam generator, as shown in Figure 3-2c and 3-2d. As the

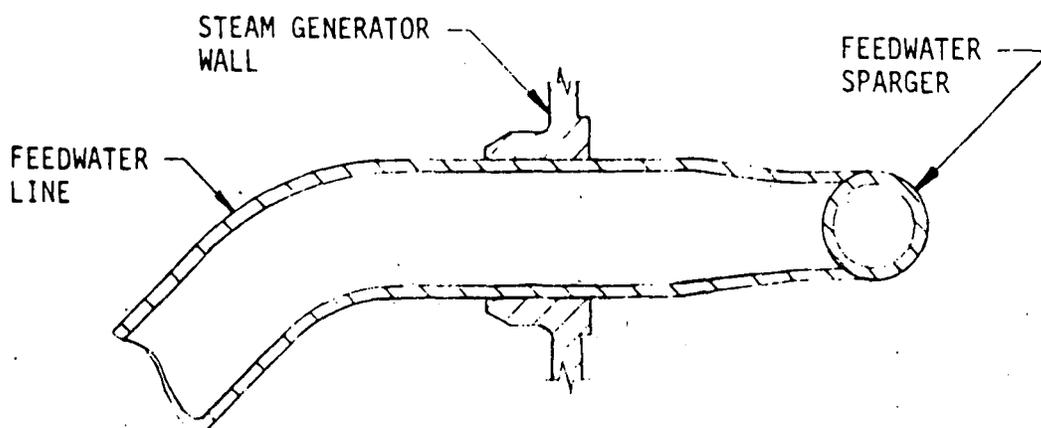
Figure 3-3. Common Feedwater Sparger Design
(Not Used at Palisades Plant)

The design of the Palisades feedwater and auxiliary feedwater system is similar to that of many other pressurized water reactors. The Palisades sparger, however, differs from most plants in its connection to the feedline. In the most common sparger design the sparger centerline is coincident with the feedwater line centerline as shown in Figure 3-3. The Palisades sparger is approximately two feet below the feedline and connected by two branches as shown in Figure 2-2. A study of this design indicates that it contains no unique features that will preclude the water sealing condition conducive to initiation of slugging type water hammers observed in other designs. The remainder of the sparger design is similar to that of other plants examined and should have no unique effects on the probability of water hammer occurrence.

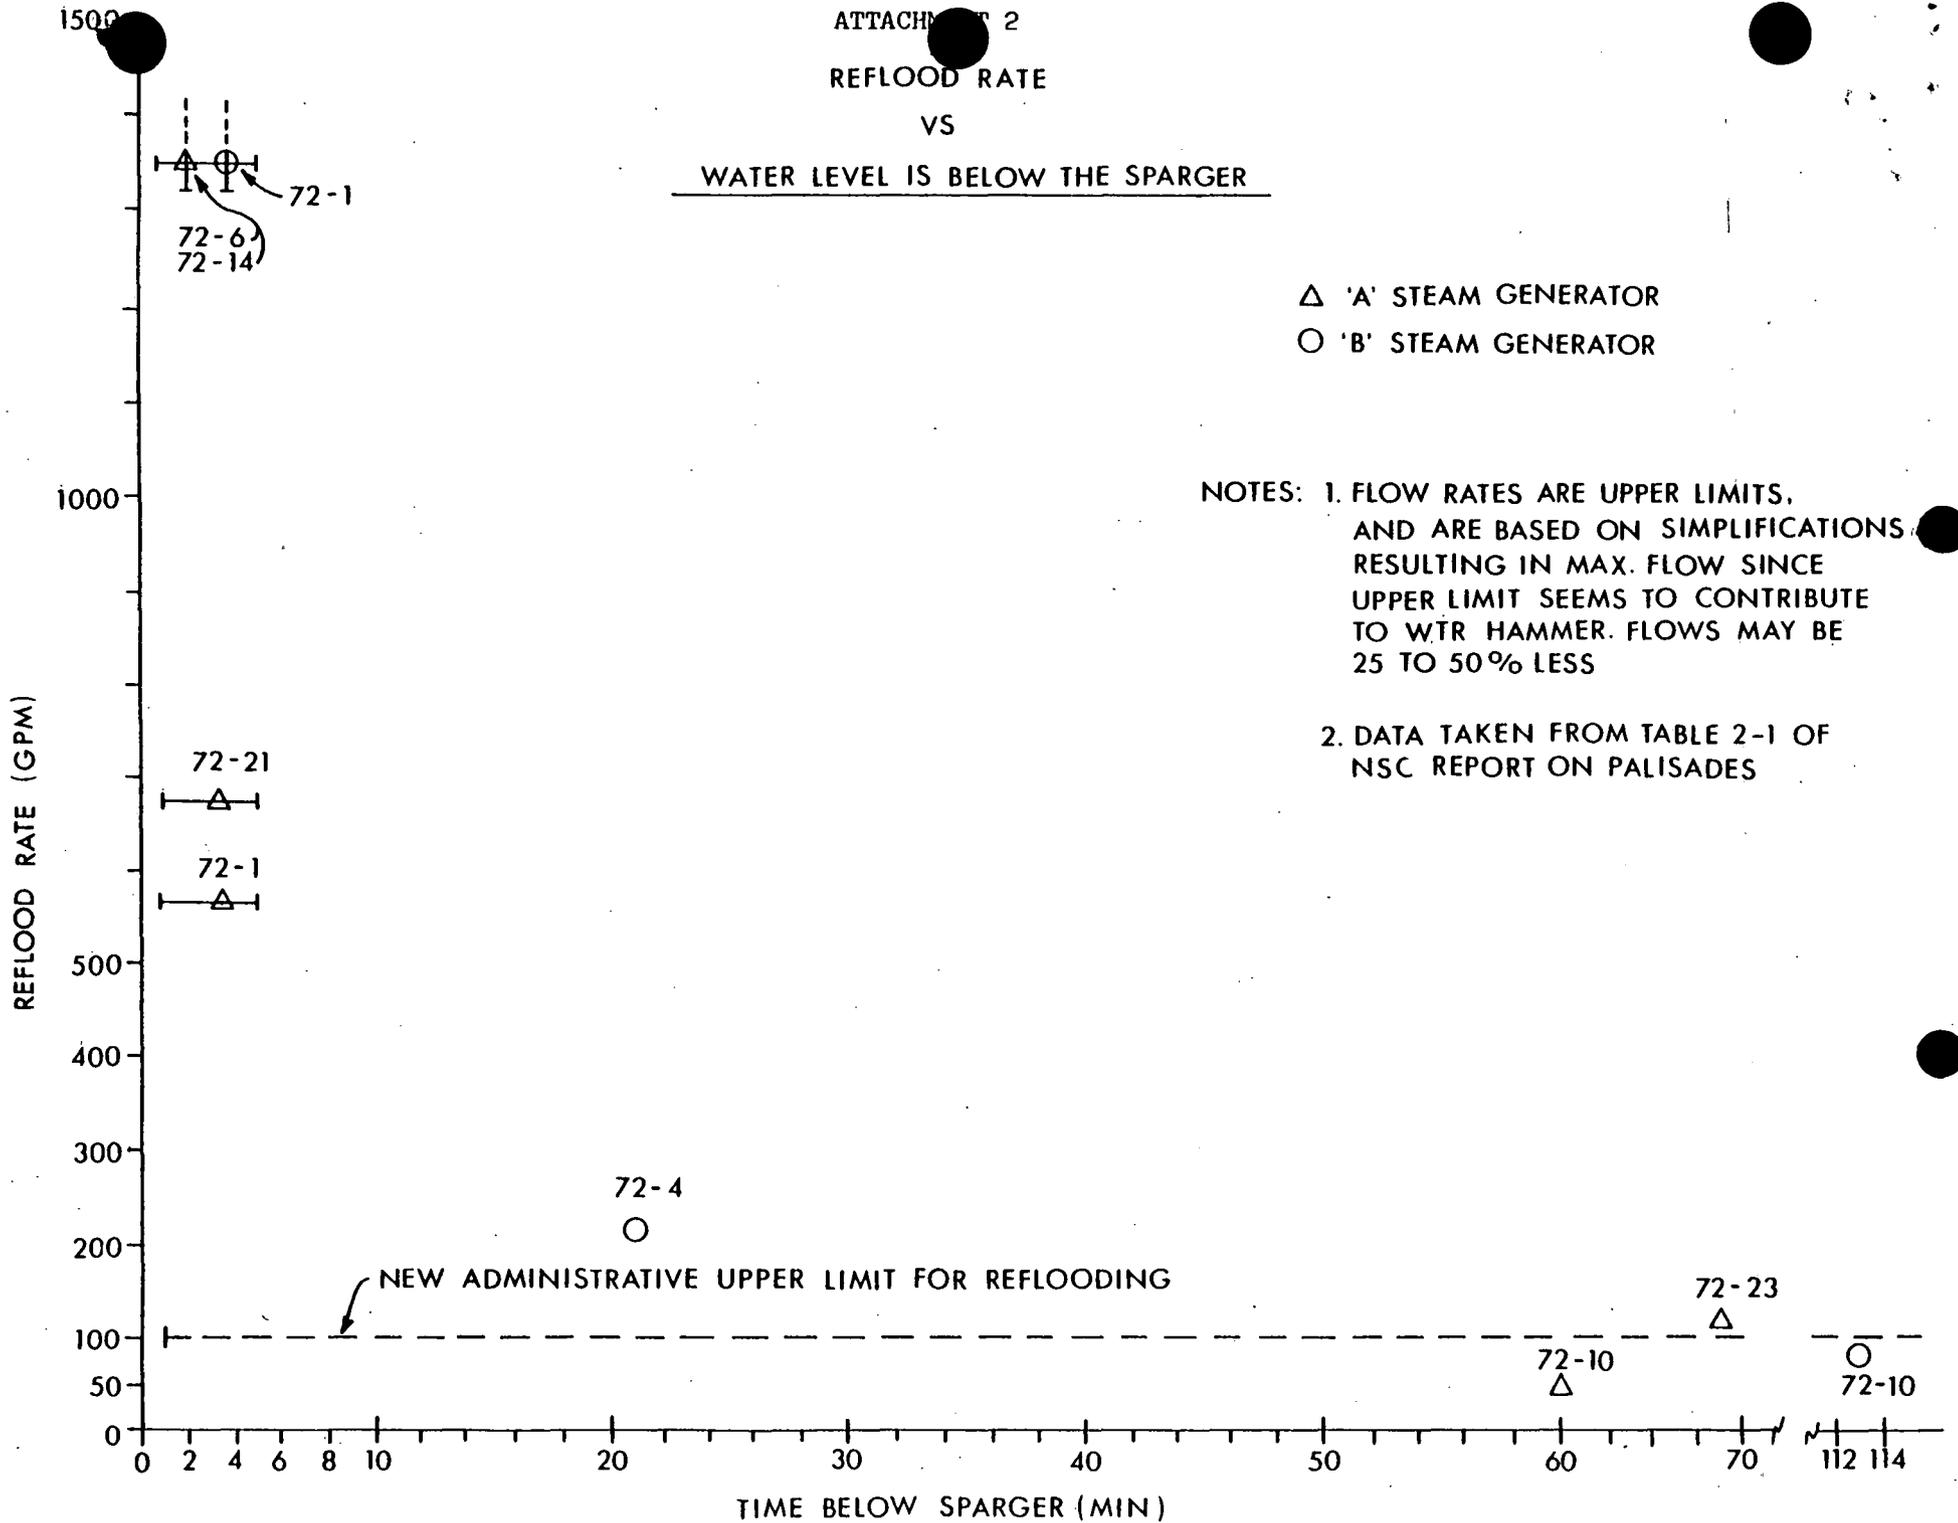
ATTACHMENT 2
REFLOOD RATE
VS

As a result of our consultant's report, Palisades Plant Administrative Procedures were modified to limit steam generator reflooding rate to 100 gpm. (See Attachment 2 for a comparison of various reflood rates and plant trips.)
