**Report No. 10CFR21-0124**  
**Rev. 0: 03/21/19**

**10CFR21 REPORTING OF DEFECTS  
AND NON-COMPLIANCE**

**COMPONENT:** Excitation Transformers for Vickers Voltage Regulator System

**SYSTEM:** Emergency Diesel Generator – Voltage Regulator System

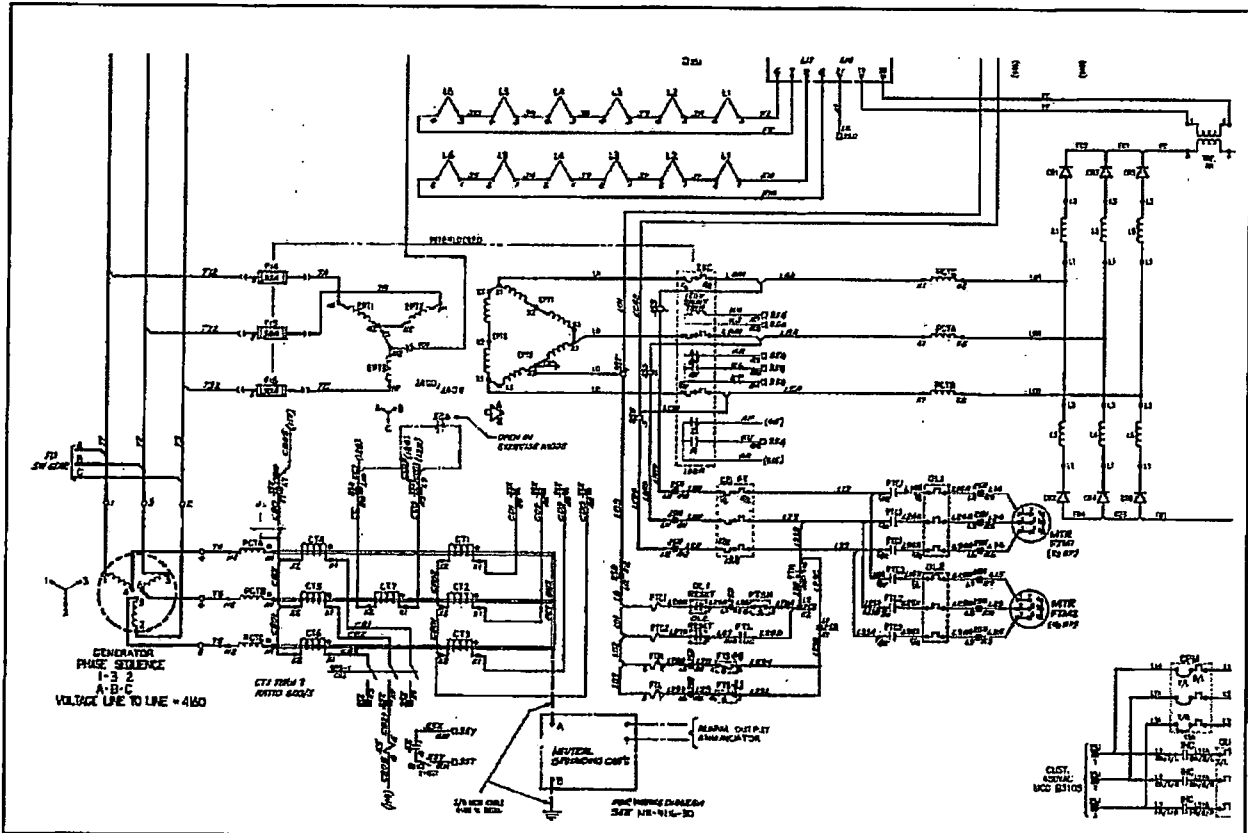
Figure 1: Typical Vickers Voltage Regulator System Schematic

Within the voltage regulator system, the magnetics supply DC excitation current to the generator field based on input from the voltage regulator. A typical schematic is shown in Figure 1 below. The three components in question are the excitation power transformers (identified as EPT1, EPT2, & EPT3), power current transformers (identified as PCTA, PCTB, & PCTC) and saturable reactors (identified as L1 through L6). The issues with each component, as well as outline drawings, are contained on the following pages.
