Repair of Doel 1 NPP Reactor Vessel Head Penetrations

International Workshop on Age-Related Degradation of Reactor Vessels and Internals, USNRC, Washington, 23-24/5/2019

Repair Reactor Vessel Head penetrations Doel 1

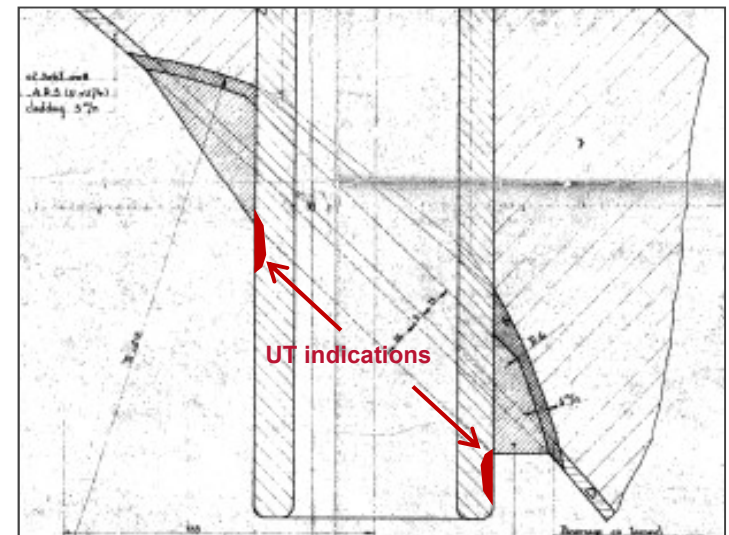
- 49 adapters
- VT: no degradation reported
- UT: 25 relevant indications in 14 adapters
 - OD surface indications, considered axial, close to J-groove weld fusion line
 - Since 2016, 2 new indications and slight growth of known indications (but << to predictions)
 - Justification for Continued Operation up to outage June 2018
 - Qualification of Inside Diameter Temper Bead repair in 2017
 - June 2018: ISI of all 49 adapters, and repair of 14 affected adapters
